# Final Field Report for Baseline Cultural Resources Surveys for the Sea Port in Yap, Federated States of Micronesia

Naval Facilities Engineering Systems Command, Pacific

Cardno GS – AECOM Pacific Joint Venture

October 2023

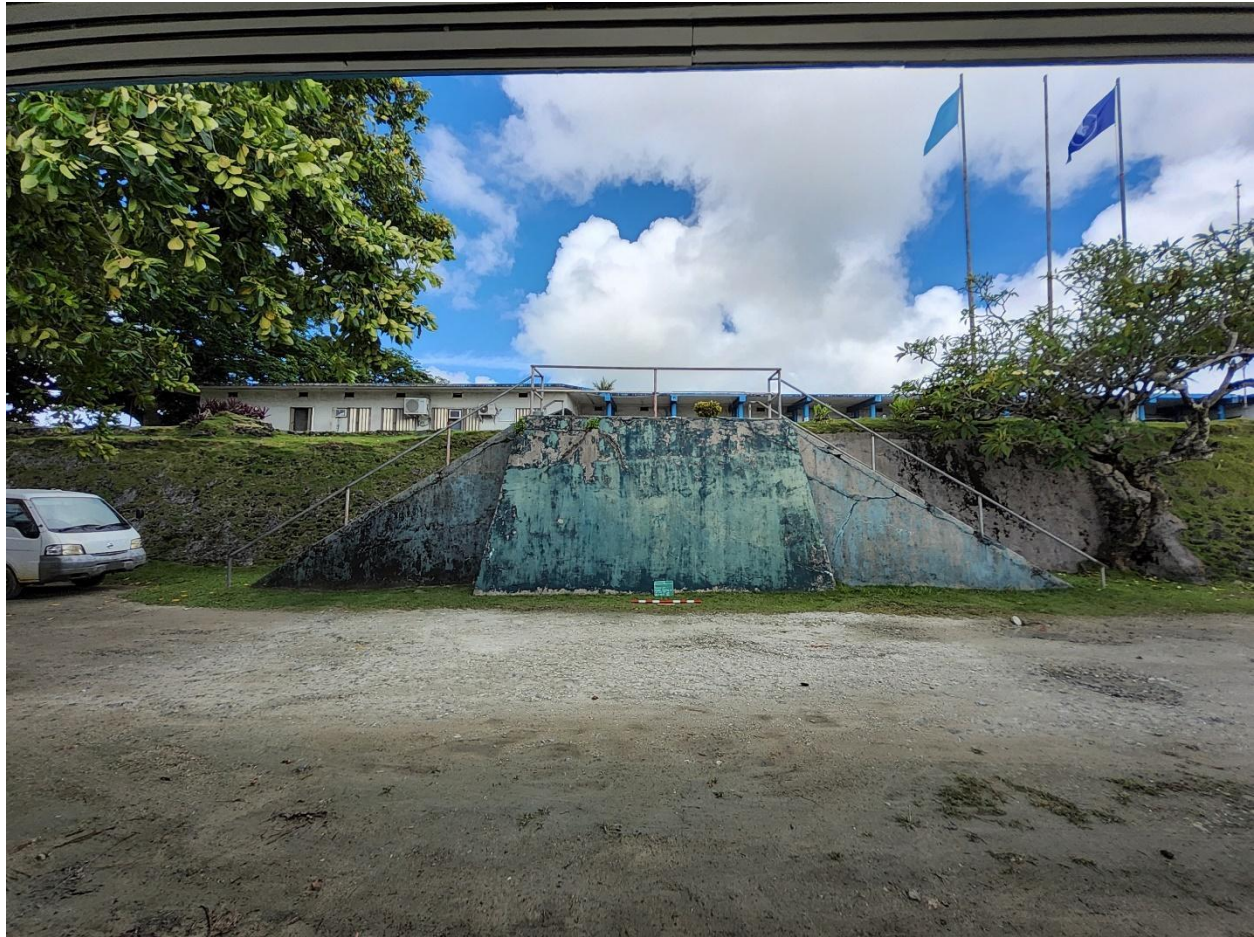
Feature 01 was a pair of concrete staircases leading to a common landing on the east side of the Spanish fort. It is approximately 43.6 feet (13.3 meters) long, 7.6 feet (2.3 meters) wide, and 9.8 feet (3.0 meters) tall (Figure 3-4 and Figure 3-5). The characteristics of the concrete were consistent with other Japanese administration buildings and structures, and local consultants identified Feature 01 as a Japanese modification to the site. A U.S. Coast and Geodetic Survey benchmark was installed on one of the stairs in 1951 (Figure 3-6). The condition of the stairs was good, but some cracks with vegetation were observed.

**Figure 3-4 Feature 01 Overview, a Pair of Large Concrete Staircases Built along the East Side of the Spanish Fort during the Japanese Administration; View West; Staircases Built against Feature 06, the Spanish Colonial Earthen and Masonry Embankment**

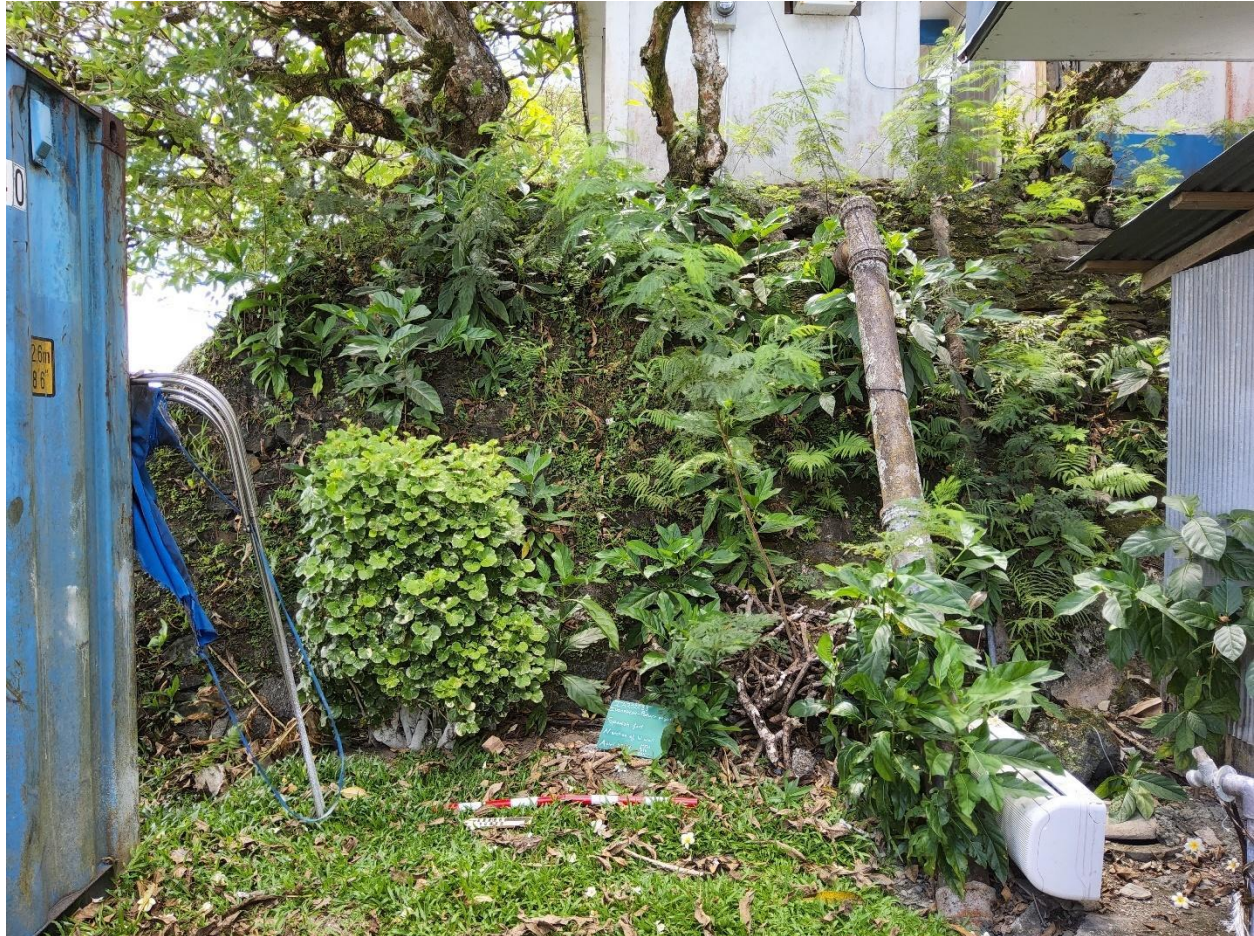
Feature 02 was a drainage or sewer pipe at the northwest corner of the Spanish fort (Figure 3-7). The pipe extended from the top of the Spanish colonial embankment and mound to the exterior grade. It likely originated from the Japanese hospital. The condition of the pipe was fair to good.

**Figure 3-7**      **Feature 02, a Japanese Administration Drainage or Sewer Pipe at the Northwest Corner of the Site**

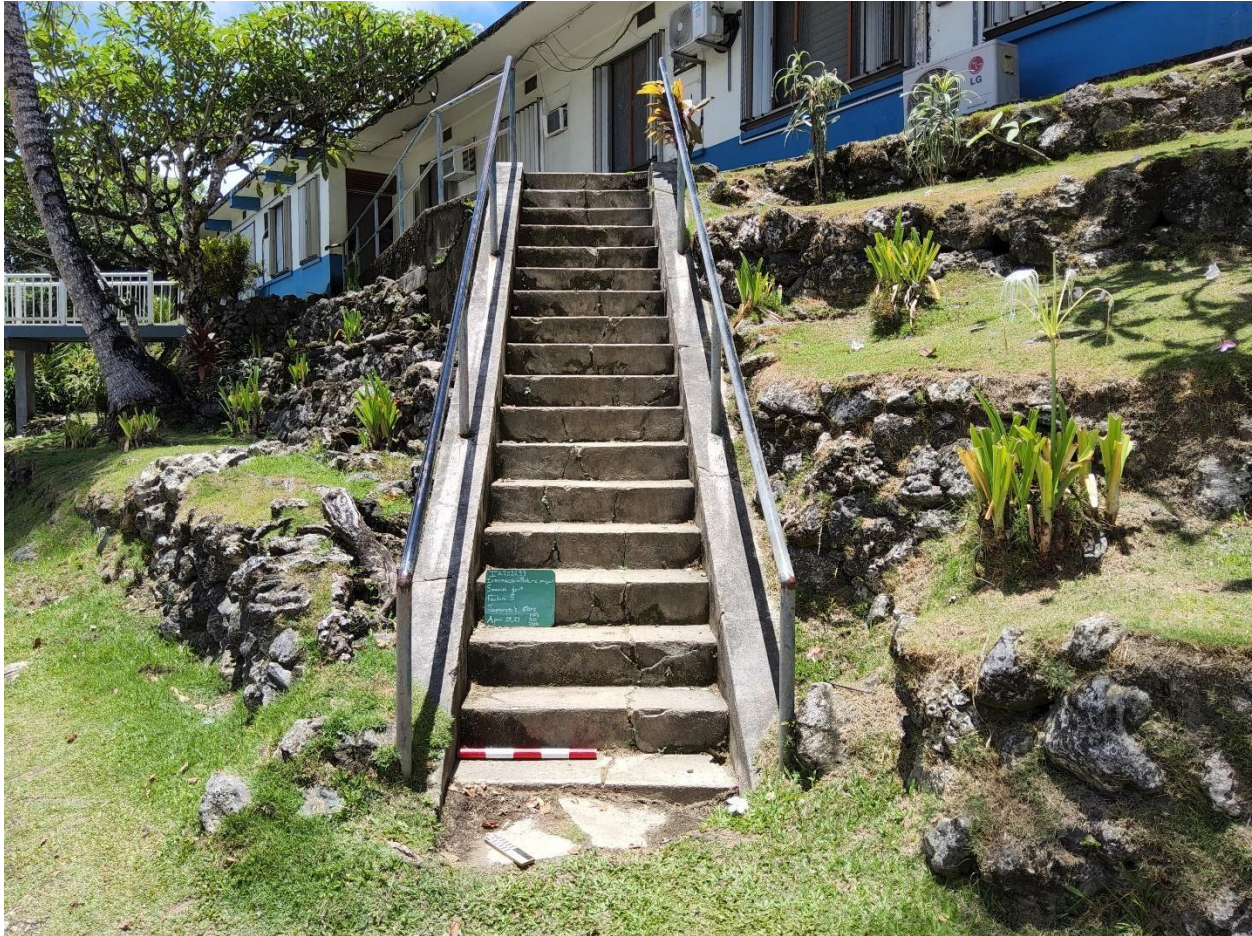
Feature 05 was a concrete staircase along the west side of the Spanish colonial embankment and mound (Feature 06) (Figure 3-13). The staircase was smaller and narrower than the double staircase on the east side of the site (Feature 01). The characteristics of the staircase suggested it was constructed during the Japanese administration. The condition was fair to poor as most of the steps had large cracks.

**Figure 3-13**      **Feature 05, Japanese Staircase on the West Side of the Site; View Northeast**

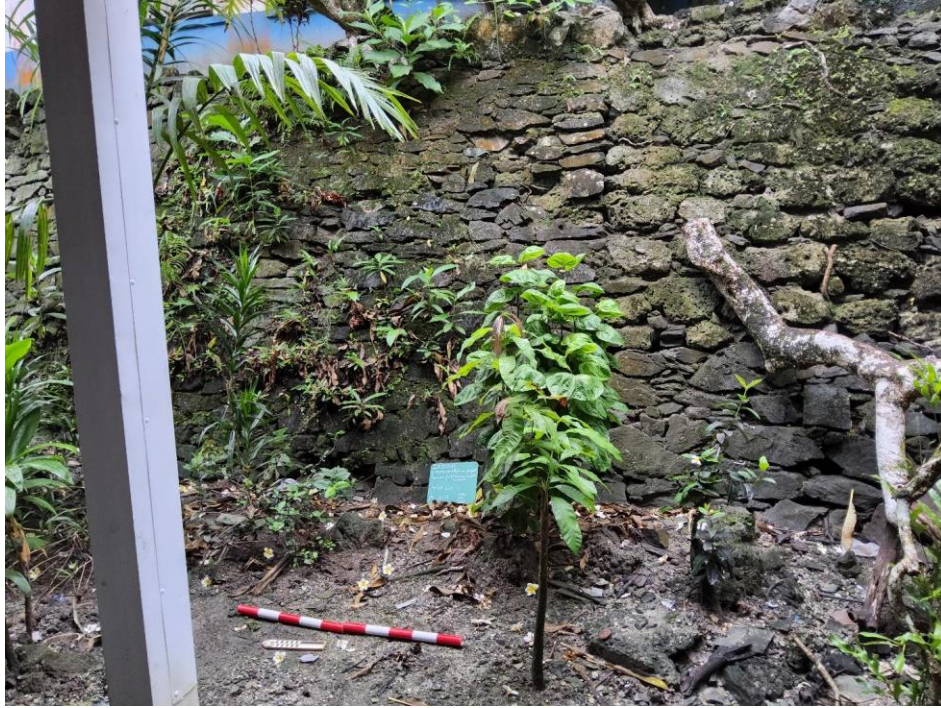
A section of the west foundation wall appeared to have been modified or rebuilt in a more recent construction episode. The stones were smaller, less weathered, and dry stacked, which is more consistent for *chamog* (Figure 3-21). Utility lines have been installed through this section of the embankment, and modification may be associated with these more recent installations. More extensive damage was observed on the south wall, which showed rebuilding using recycled fragments of stone and brick (Figure 3-22).

**Figure 3-21 Feature 06, Section of the West Wall Revealing a Modification Reminiscent of Traditional Yapese Masonry; View East-northeast**

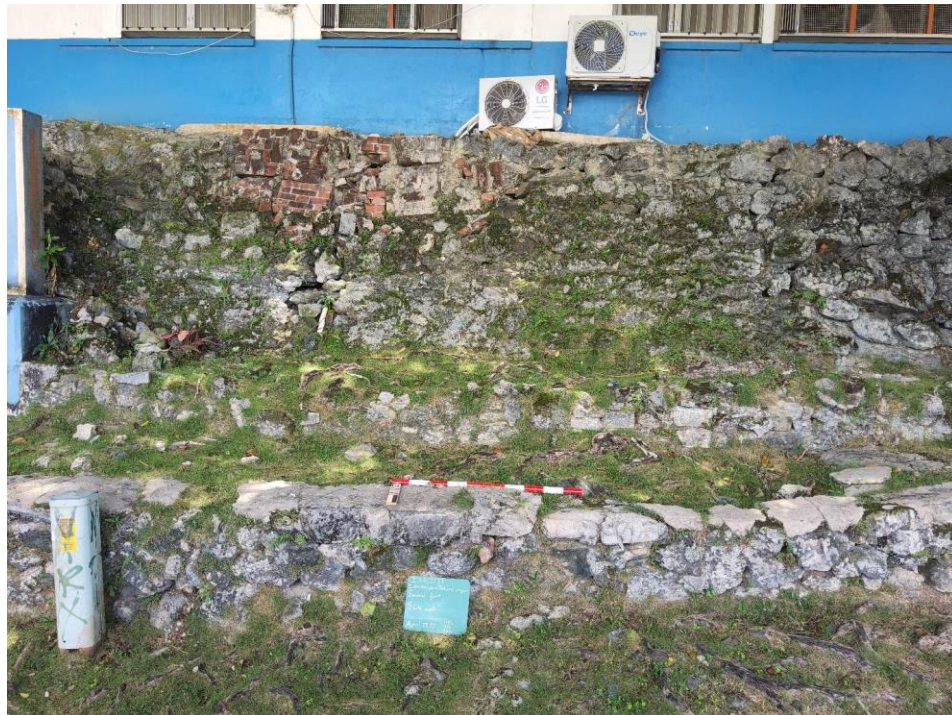
**Figure 3-22 Feature 06, Section of the South Wall Damaged and Rebuilt Using Original Spanish Brickwork Fragments; View North**

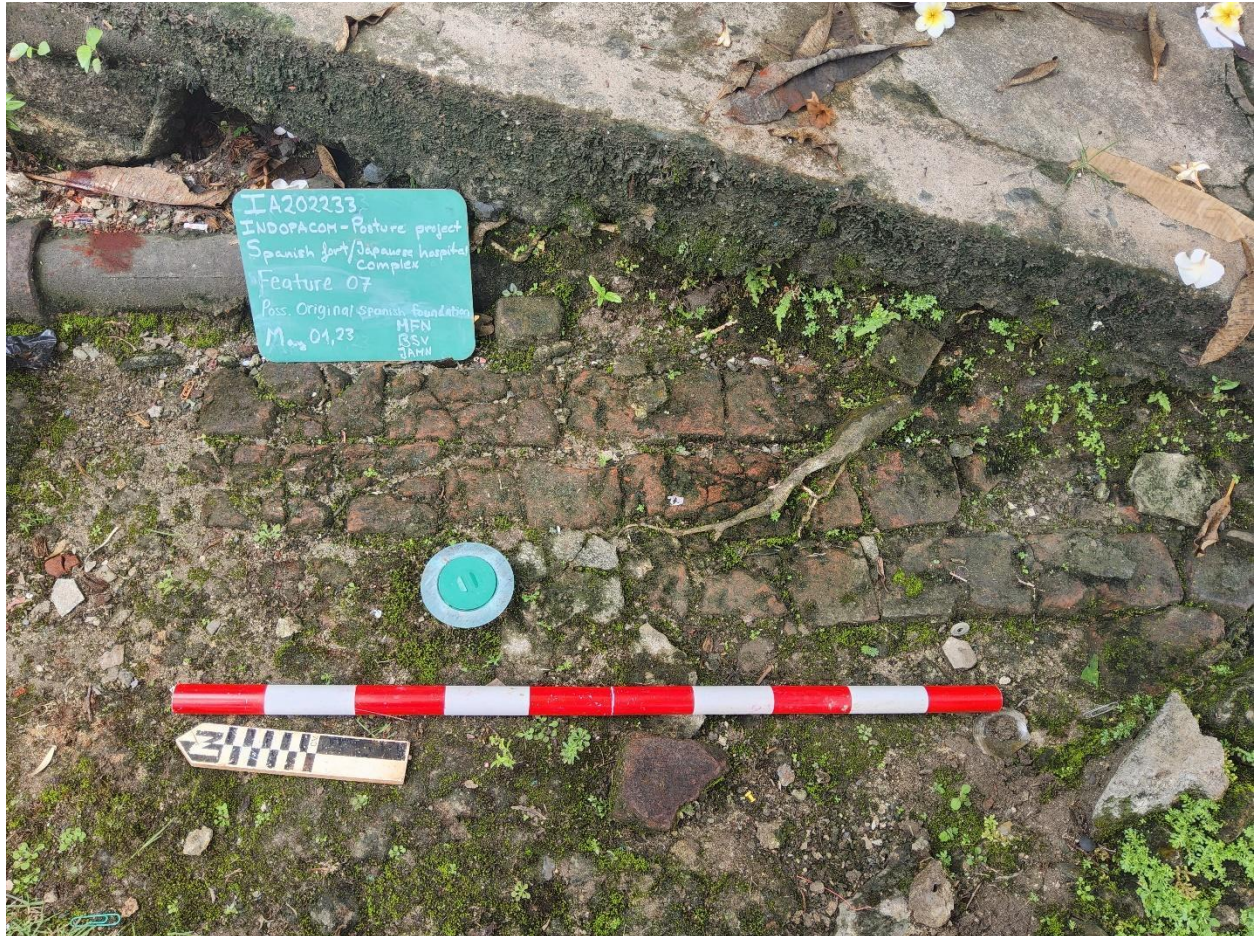
Feature 07 was a short section of Spanish brick inset into the top of the earthen mound (Feature 06) (Figure 3-23). The concrete foundation of the Japanese hospital overlaid a portion of the brickwork, and its full extent was unknown. Based on its location, it is possible that Feature 07 was the remnants of a Spanish colonial building, particularly one of the brick columns (*pilotes*) for the infantry quarters noted in historical documents. The condition was fair because of 20th-century modifications above and around the brickwork.

**Figure 3-23**      **Feature 07, a Small Section of Spanish Brickwork That May Be a Remnant Foundation of a Former Building or Structure**

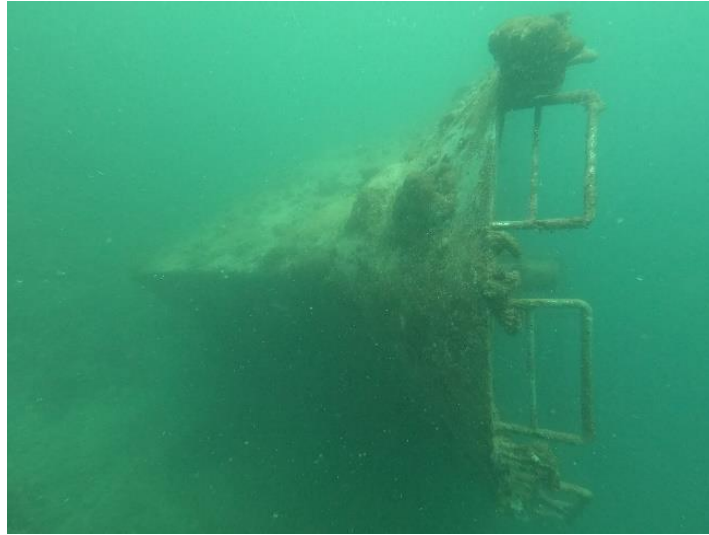
Divers spent 112 minutes investigating Target 09 and confirmed the source as the shipwreck. Target 09 was predominantly intact and lays on its port side along the western side of the Tamil Channel (West) (Survey Area 2) (Figure 3-33). Several ship construction elements were observed, including multiple hatches, the weather deck, the cabin, boat rails, a propeller, a rudder, and a stern frame. The upper decks have collapsed and now rest beside the main structure (Figure 3-34 to Figure 3-36). Local dive operators recalled that the “Circus Wreck” brought elephants and other circus animals to Yap when they were children in the 1980s.

**Figure 3-33 Target 09 Lying on its Port Side (Photo by AECOM)**

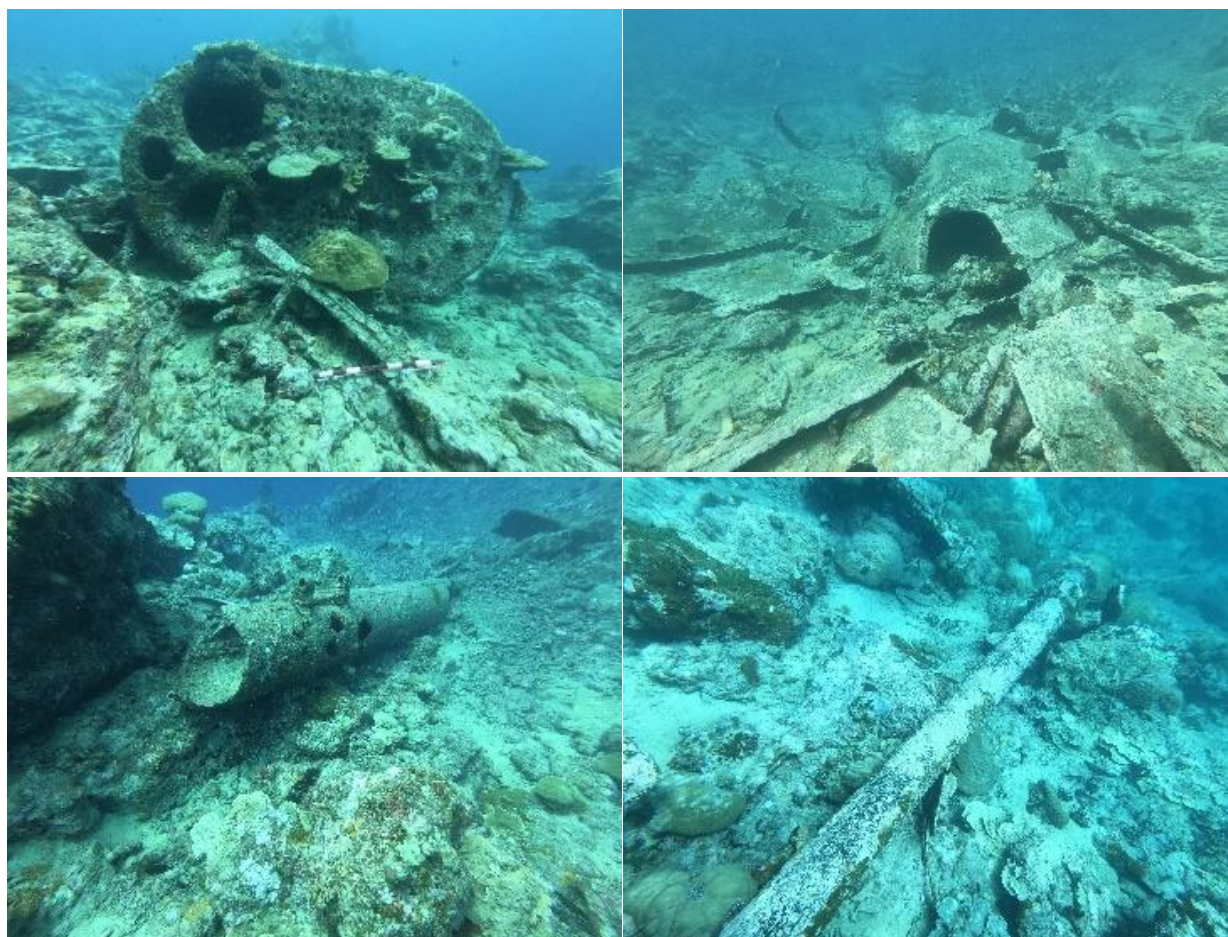
Divers spent 185 minutes investigating Target 24 within water depths approved for diving, while drop camera footage was collected in depths beyond approved diving limits. Target 24 consisted of several ship construction elements including a Scotch boiler, which dates to the mid-19th to early 20th century, a smokestack, and a mast (Figure 3-43). Other ship construction elements included a windlass, metal framing, and exterior hull sheeting with window ports (Figure 3-44). Various sizes of chains were strewn about the site. Archaeologists noted two anchors, with the smaller one resembling a Rodger-style anchor, which dates to the mid- to late 19th century. The larger anchor had a single fluke and portion of the stock visible and exposed portions resemble an admiralty anchor (Figure 3-45).

**Figure 3-43** Target 24 Scotch Boiler (Top Left), Metal Sheeting (Top Right), Smokestack (Bottom Left), and Mast (Bottom Right) (Photos by AECOM)

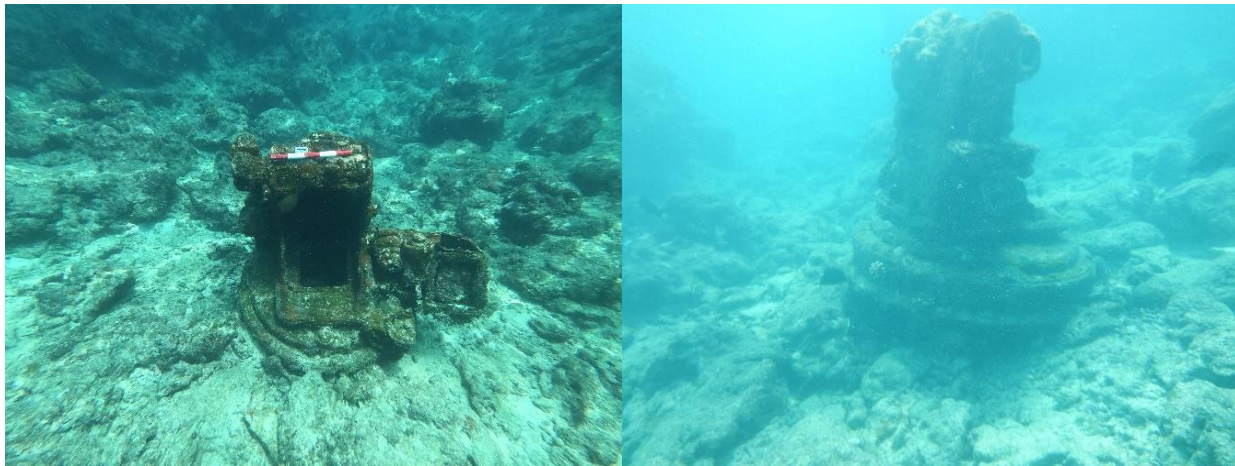
Target 20 was located in Tamil Channel Entrance (West) (Survey Area 3) in 15 feet (5 meters) of water and near Targets 23 and 24. Target 20 was an isolated object measuring 8 feet (2.5 meters) by 6.5 feet (2 meters) (Figure 3-51). Target 20 is an unknown piece of machinery that may be associated with Targets 23 or 24 or may be an isolated find. It is possible that Target 20 may have associated buried material. Based on observed characteristics and available data, Target 20 may be related to Target 23 or 24 and, as such, may retain the potential to yield important information regarding maritime shipping and industry practices significant to Yap and the FSM's history. Due to its potential association with Target 23 or 24, it is recommended treating Target 20 as eligible for listing in the NRHP pending additional information. Target 20 was encompassed within the recommended avoidance zone of Target 24 and may be related; therefore, an additional avoidance buffer for Target 20 is not currently recommended.

**Figure 3-51 Target 20 (Photos by AECOM)**

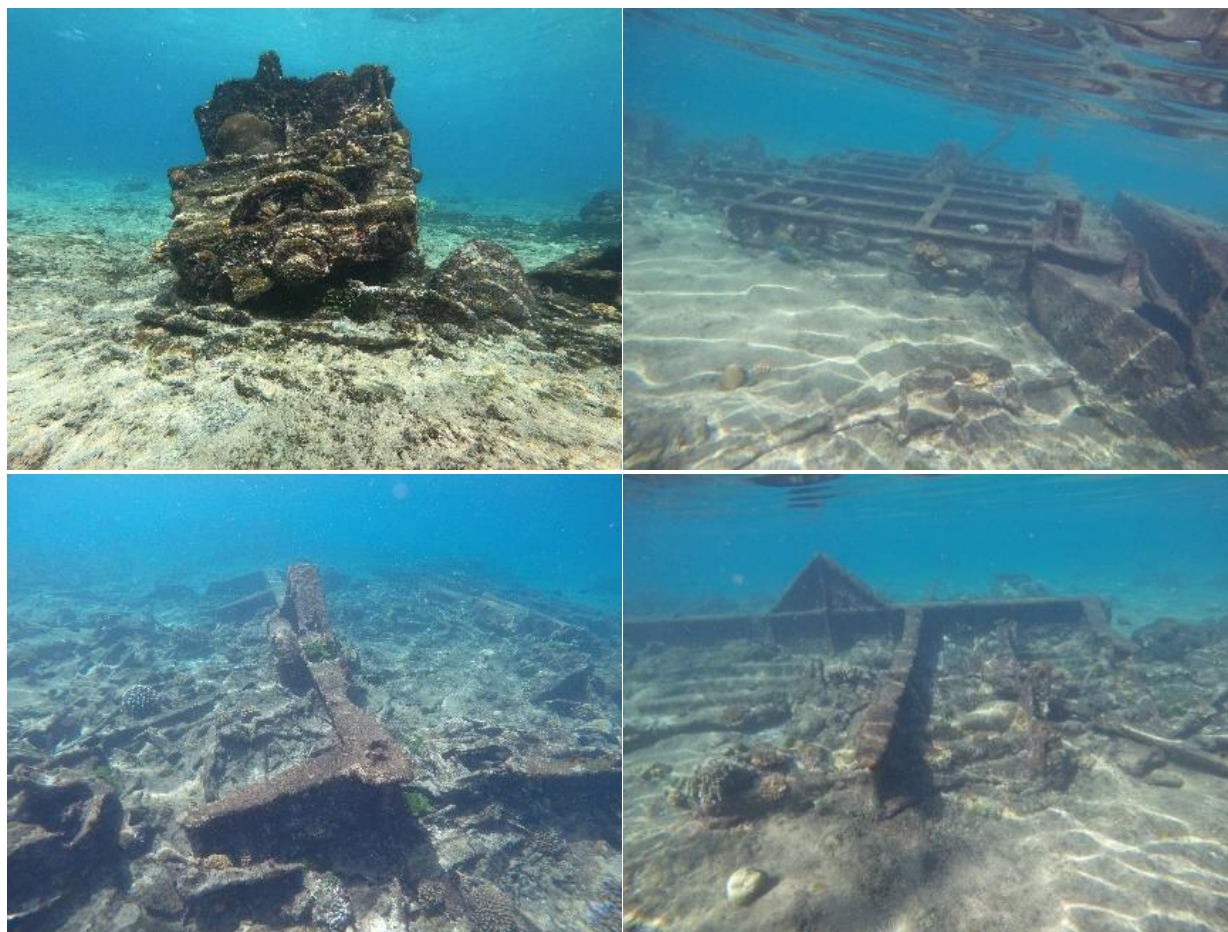
Target 23 was located near Tamil Channel Entrance (West) (Survey Area 3) in approximately 14 feet (4 meters) of water. Target 23 was denoted as kml\_76 in the NOAA ENC shipwrecks database as always dry. Target 23 rests along the edge of the outer reef and, while investigating the target, archaeologists noted that during low tide sections of the wreck became exposed. Divers spent 146 minutes investigating Target 23 and identified the source as a large, early- to mid-20th century wreck. Target 23 was approximately 400 feet (122 meters) long by 100 feet (30 meters) wide and consisted of an early- to mid-20th-century ship with construction features including large engine pieces that may be from an internal combustion engine, large metal frames and outer hull plating, and a reinforced keelson with triangular supports (Figure 3-52). Target 23 also consisted of two propellers, the blades each measuring 3 feet (1 meters) long and 2 feet (0.5 meters) wide, prop shafts, and two propulsion engines (Figure 3-53). Two large anchors that stylistically resemble a Danforth anchor were located near the propeller shafts (Figure 3-54). Additional details were documented, such as a partial serial number on a fitting, two rectangular metal radiator-like objects, and a large variety of cupreous artifacts (Figure 3-55). Observed construction elements such as engine and prop shafts appear to reflect its historic design prior to the wrecking event. Due to heavy amounts of surge and shallow water, the entirety of Target 23 was not observed during diver investigations. Strong surge and waves, as well as tropical weather, may have dispersed the site onto the reef. The wreck is depicted on the U.S. Navy Hydrographic Office (1944) map. Based on the observed construction elements, Target 23 is likely an early- to mid-20th-century vessel. Based on observed characteristics and available data, Target 23 may retain the potential to yield significant information about early- to mid-20th-century shipping and site formation processes. It is recommended treating Target 23 as eligible for listing in the NRHP with an avoidance buffer of 328 feet (100 meters) from the defined site extents, pending additional information.

**Figure 3-52     Probable Diesel Engine (Upper Left) and Large Metal Frames and Hull Sections (Remainder) (Photos by AECOM)**

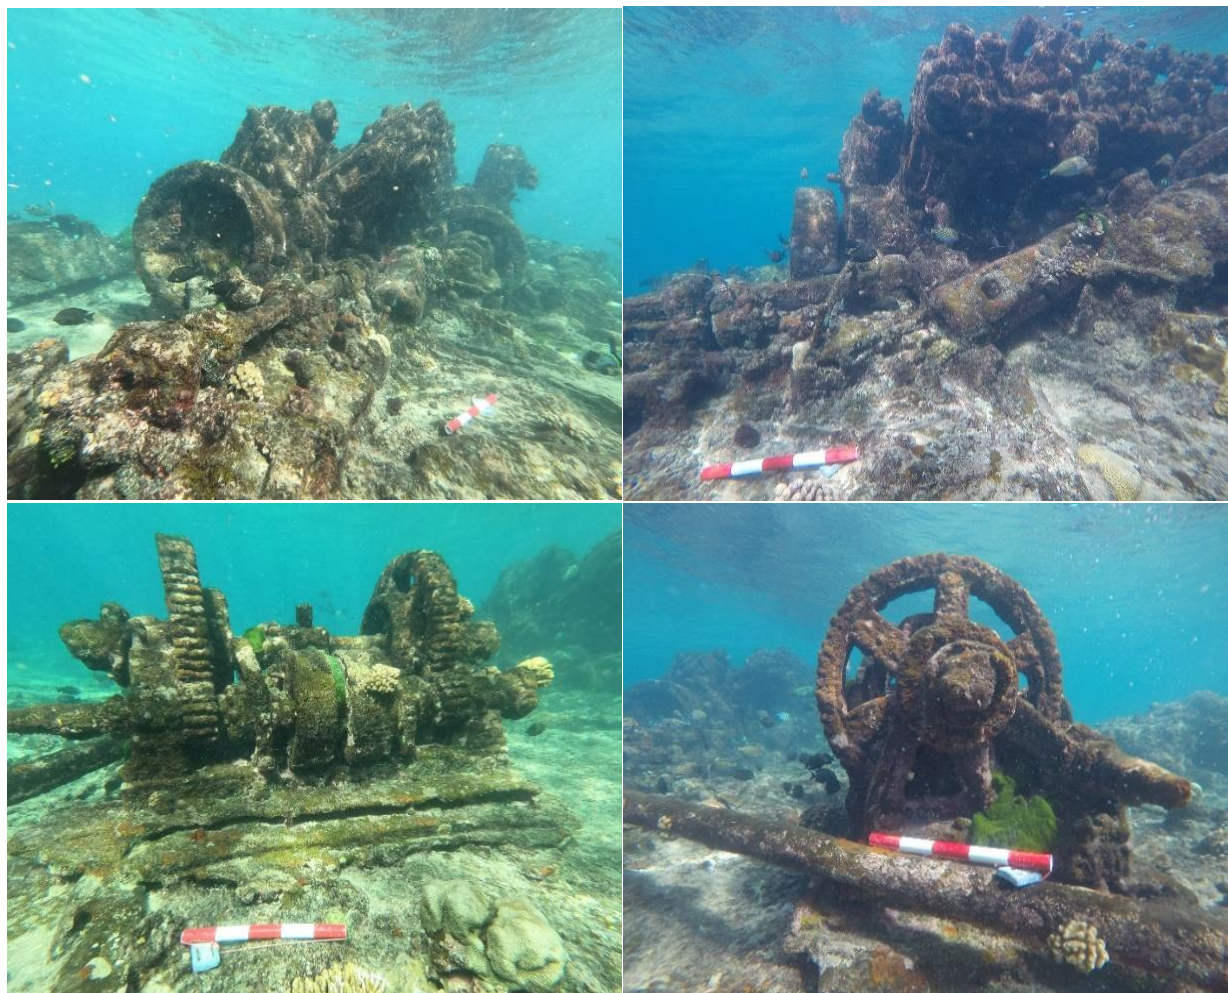
Target 26 was located near Offshore Mooring (Survey Area 1) in approximately 10 feet (3 meters) of water along the edge of a reef. Target 26 was denoted as kml\_77 in the NOAA ENC shipwreck database as a visible shipwreck, always dry. Target 26 rests along the outer edge of the reef and, while investigating the target, archaeologists noted that during low tide sections of the wreck became exposed. Divers spent 34 minutes investigating Target 26 and identified the source as having elements consistent with late-19th-century to early-20th-century ships with construction features including large machinery, such as an engine and a large windlass (Figure 3-56). Target 26 also consisted of two partially buried propellers, the blades each measuring 2 feet (0.5 meters) long and 1 foot (0.4 meters) wide, and prop shafts (Figure 3-57). Two Rodger- or kedge-Admiralty-style anchors, typical of the 19th century, were located near the propellers (Figure 3-58). Archaeologists observed a large gouge in the seabed that led up to the shipwreck, implying the ship ran into the reef during the wrecking event (Figure 3-59). Observed construction elements such as engine and prop shafts appear to reflect its historic design prior to the wrecking event. Due to heavy amounts of surge and shallow water, the entirety of Target 26 was not observed during diver investigation. Strong surge and waves, as well as tropical weather, may have dispersed the site onto the reef. Based on the observed construction elements, Target 26 is likely a late-19th-century to early-20th-century vessel. Based on observed characteristics and available data, Target 26 may retain the potential to yield significant information about late-19th-century to early-20th-century shipping and site formation processes. It is recommended treating Target 26 as eligible for listing in the NRHP with an avoidance buffer of 328 feet (100 meters) from the defined site extents, pending additional information.

**Figure 3-56     Propulsion Engine (Top Left and Top Right) and Windlass (Bottom Left and Bottom Right) (Photos by AECOM)**

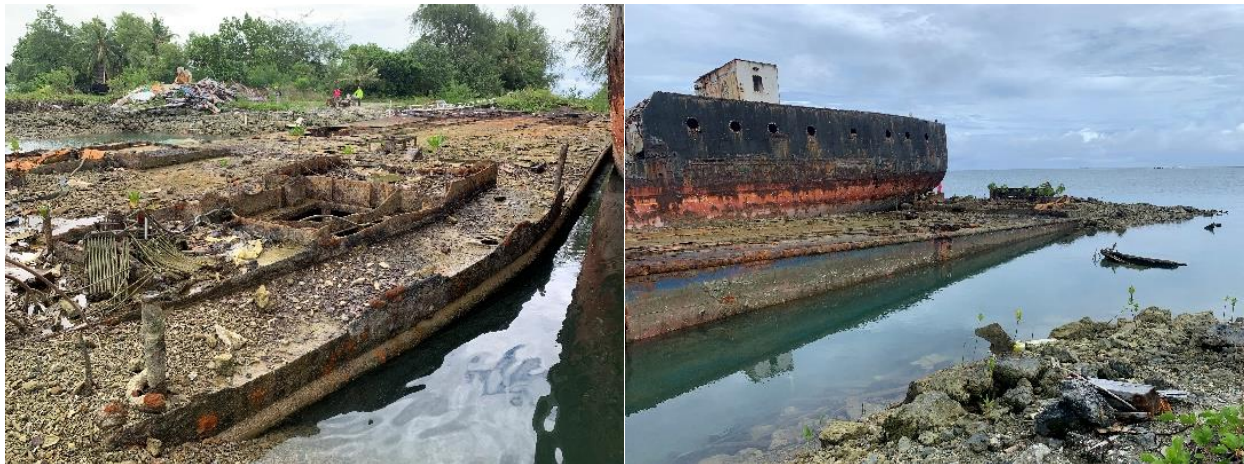
Target 02 was located in Yap Port (Survey Area 4). Target 02 was first identified partially exposed in aerial imagery as an unknown contact measuring 175 feet (53 meters) long and 37 feet (11 meters) wide (Figure 3-68). Target 02 first appeared on aerial imagery in 2013 but is not visible in 2008 aerial imagery (Figure 3-69). Archaeologists conducted a pedestrian survey at low tide and with access around a majority of the target. Archaeologists identified Target 02 as a rectangular barge and observed multiple ship construction elements, including welded deck plating, Plimsoll mark, rub rails, and iron I-beam support/framing (Figure 3-70). Target 02 was partially salvaged, with evidence that a superstructure in the aft section once existed. A partial nameplate remained visible on the stern with, “ANIL\_A\_” legible (Figure 3-71). Attempts to identify the vessel in ship registries were unsuccessful; however, observed construction elements are consistent with late-20th-century, open-ocean barge construction methodologies. Large structural cracks observed along the hull and its location near other identified vessels imply Target 02 was likely pulled ashore to facilitate the salvage/scrapping process. Based on observed construction elements and vessel size, Target 02 was likely an ocean-going barge. Based on observed characteristics and available data, Target 02 has been substantially salvaged and no longer retains integrity as it relates to its original use. Additionally, the presence of construction materials such as PVC piping and rubberized electrical coating suggest a recent construction date. Target 02 is recommended as not eligible for listing in the NRHP.

**Figure 3-68 Target 02 (Photos by AECOM)**

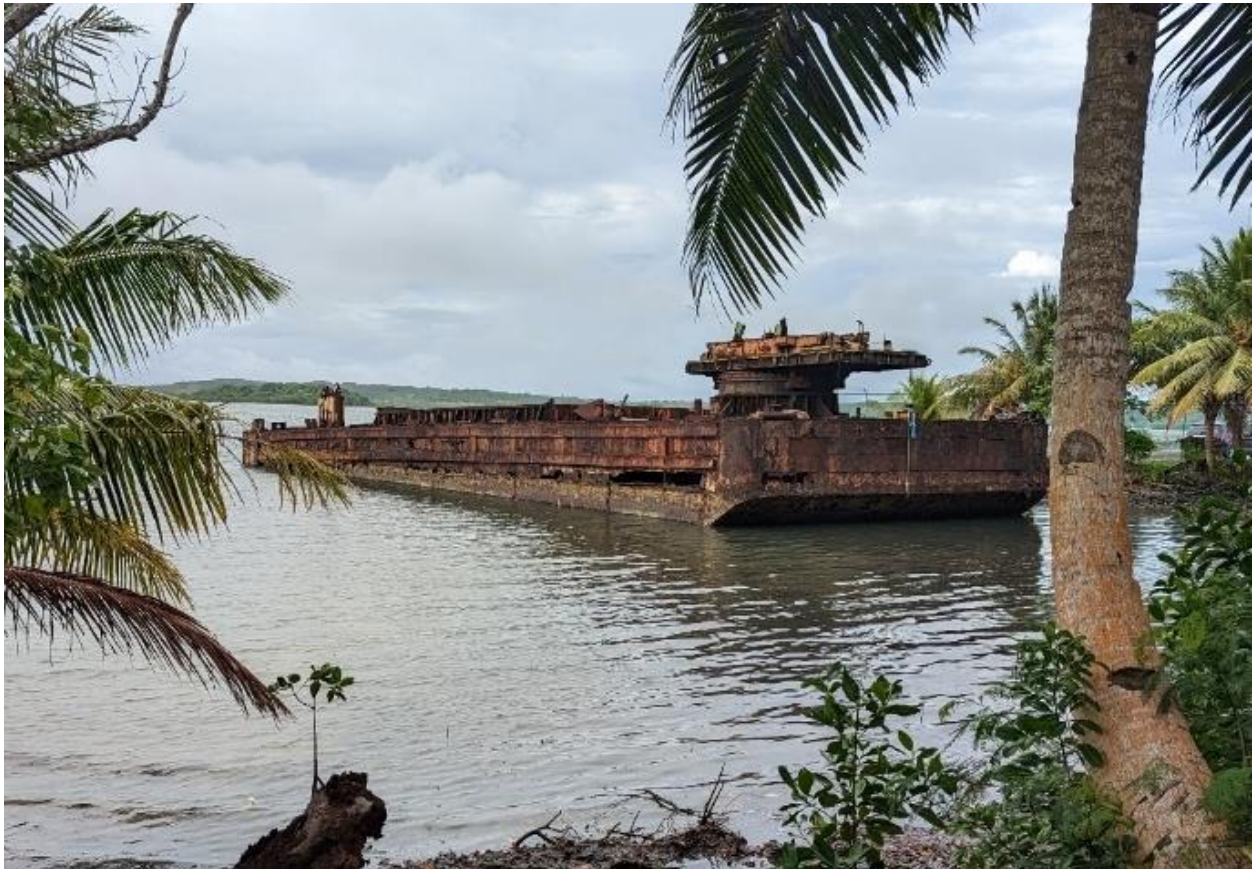
Target 06 was located in Yap Port (Survey Area 4) (Figure 3-82). Target 06 was identified as an unknown contact partially exposed in aerial imagery measuring 120 feet (36 meters) long and 45 feet (14 meters) wide. Target 06 first appeared on aerial imagery in 2013 but was not visible in 2008 aerial imagery (Figure 3-83). Archaeologists conducted a pedestrian survey at low tide and surveyed from a boat at high tide, with access around a majority of the target. Archaeologists identified Target 06 as a rectangular crane barge and observed multiple ship construction elements, including welded deck plating, mooring bitts—some with dock line still threaded—and a large support for a mounted crane. Target 06 was partially salvaged with evidence that the crane and boom have been removed. Archaeologists could not locate an identifying name or nameplate, and attempts to identify the vessel in ship registries were unsuccessful; however, observed construction elements are consistent with late-20th-century crane barge construction methodologies. Based on observed construction elements and vessel size, Target 06 was likely a crane barge. Based on observed characteristics and available data, Target 06 may retain the potential to yield important information regarding maritime shipping and industry practices significant to Yap and the FSM's history. It is recommended treating Target 06 as eligible for listing in the NRHP with an avoidance buffer of 164 feet (50 meters) from the defined site extents, pending additional information.

**Figure 3-82 Target 06 (Photo by AECOM)**

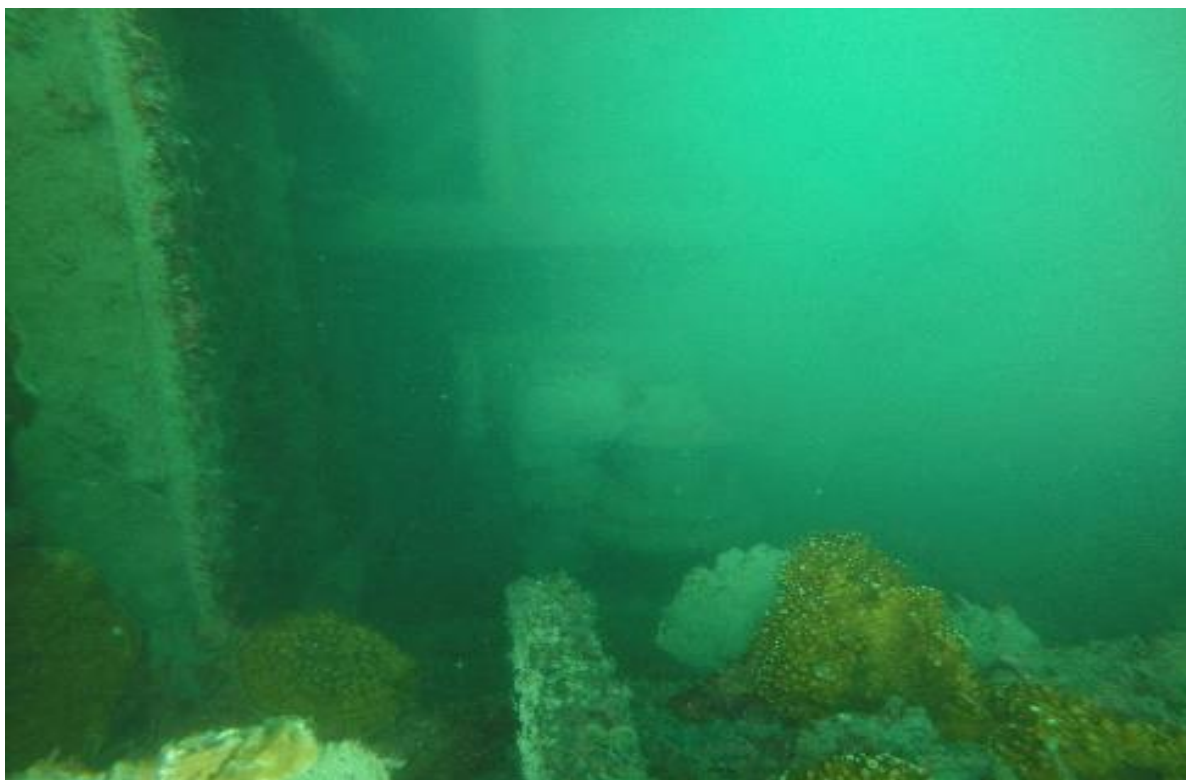
**Figure 3-109 Missing Deck Plating, Exposed Engine Parts on Target 16 (Photo by AECOM)**

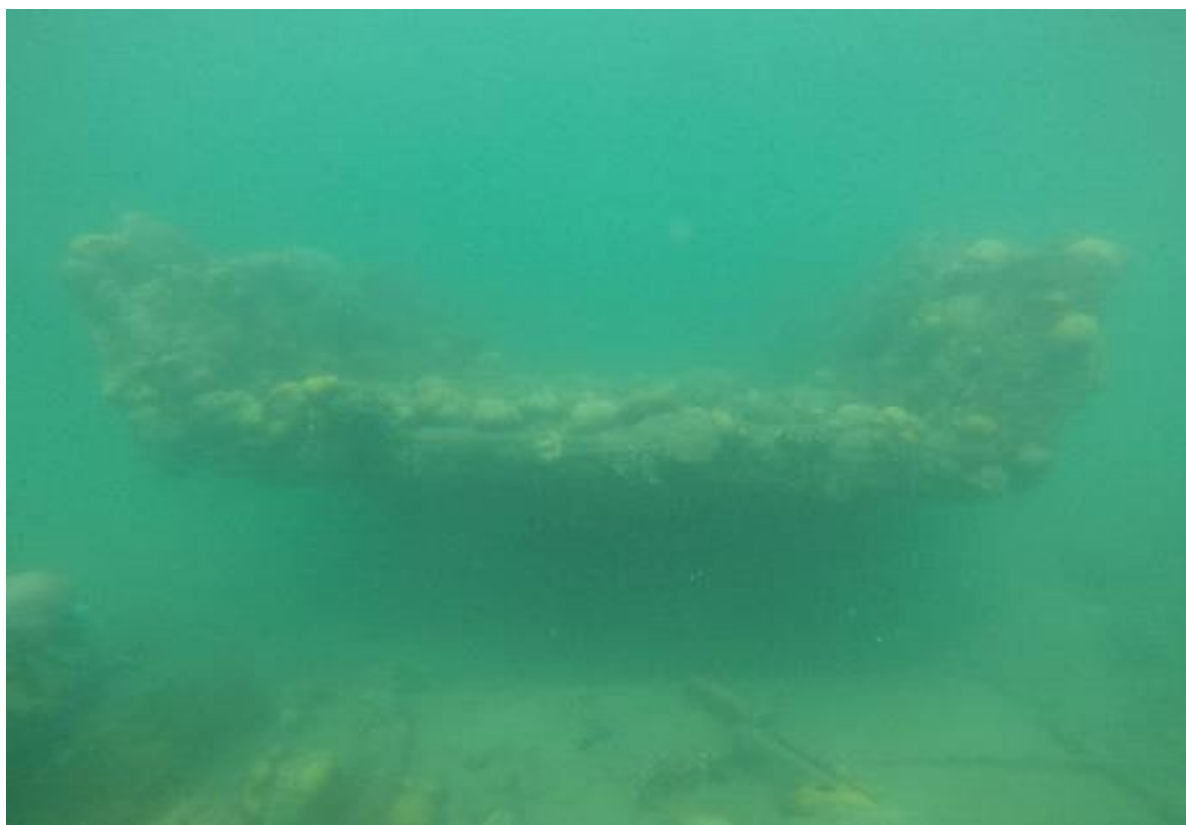
**Figure 3-110 Detached Ramp of Target 16 (Photo by AECOM)**
