**Naval Facilities Engineering Systems Command Pacific
JBPHH HI**

Phase I Environmental Site Assessment

Yap Seaport

May 2024

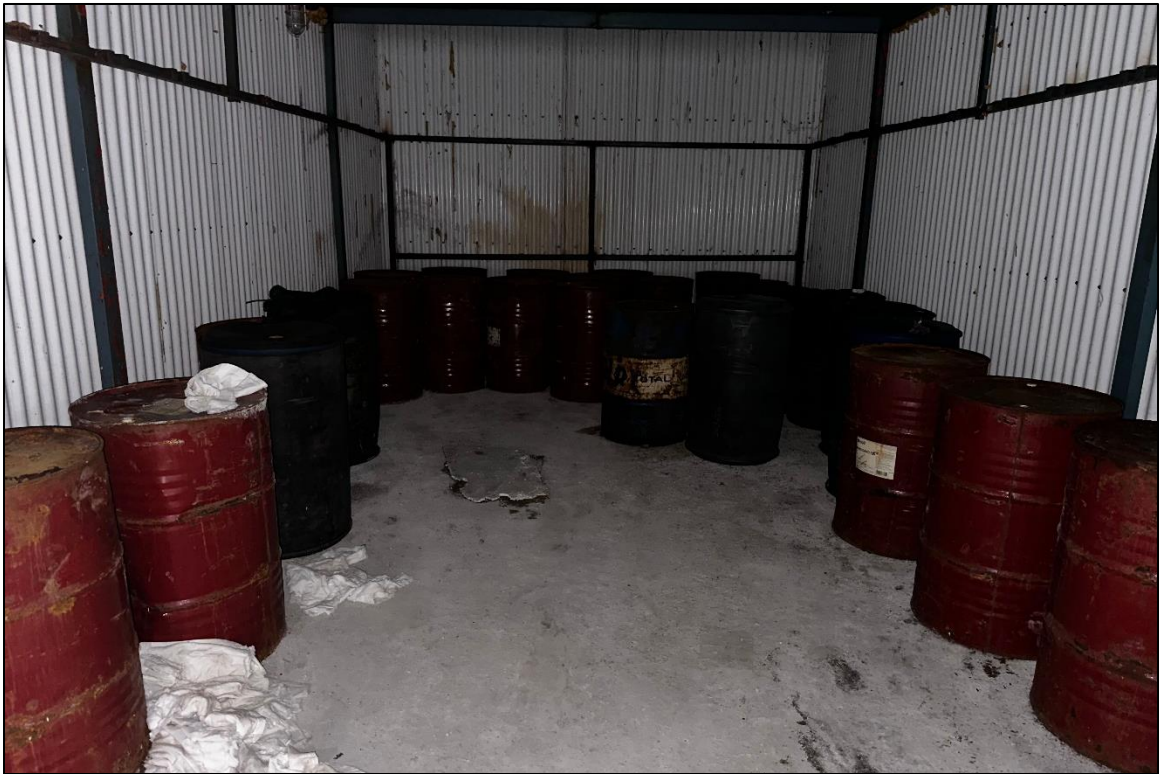
- Sixty-seven 55-gallon drums at the former tuna processing facility. Thirty-eight of the 55-gallon drums were observed in an enclosed room on a concrete floor, lacking spill pallets (Appendix A, Photos 1 and 2). Two 55-gallon metal drums were observed with corrosion and a dark colored oily substance present at their base. Only 10 of the 55-gallon drums contained labeling—Mobil Gard 525, 412, ADL 40, and 300 C—indicative of diesel engine oil. Based on gently touching each drum, it was suspected that all 38 drums in the room contained some amount of fluid (i.e., none were suspected to be empty).

Photo 1: Thirty-eight 55-gallon metal drums observed in a room near the side entrance of the former tuna canning facility.

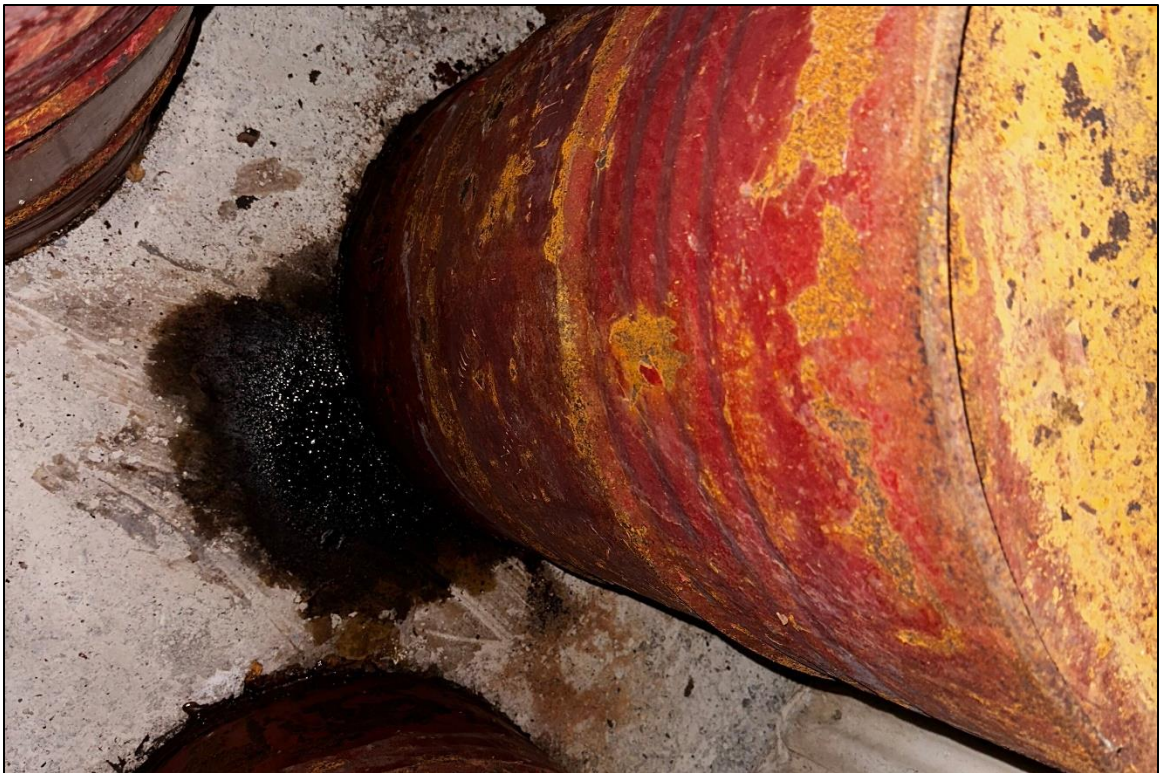
Photo 2: Close-up view of one of the drums leaking de minimis amounts of oily substance on the concrete floor.

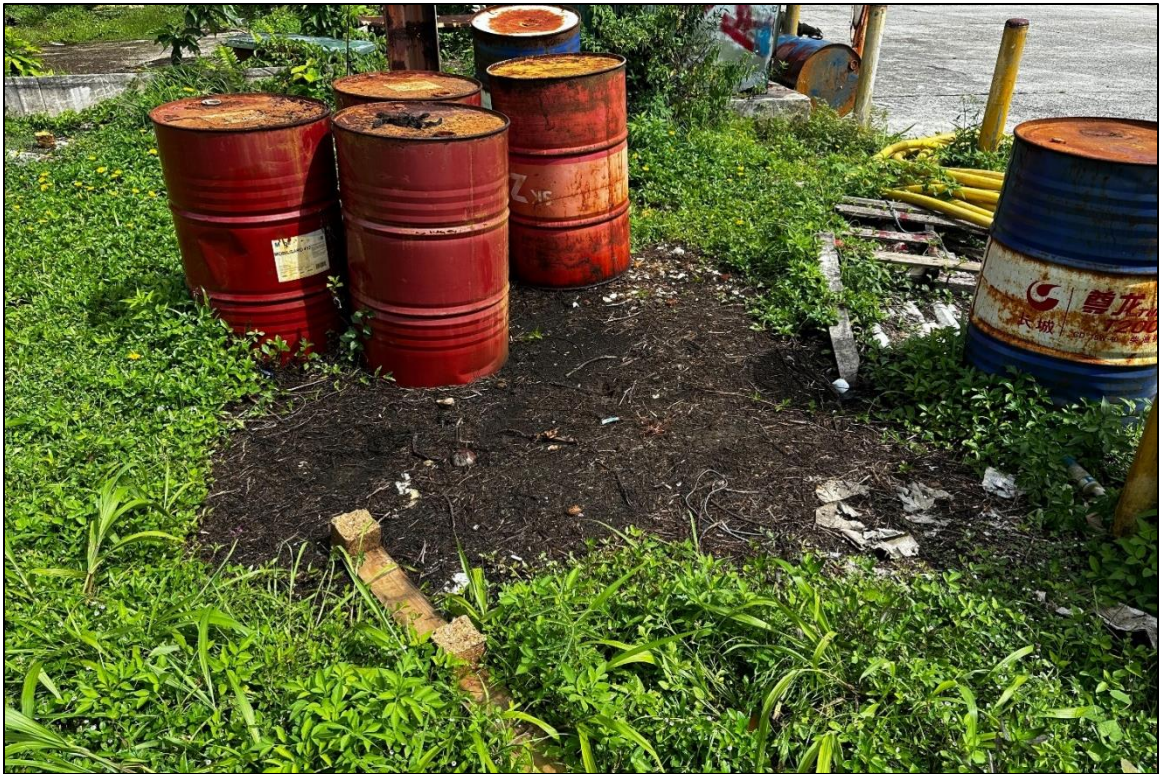
- The release of a suspected petroleum substance from four empty and unlabeled 55-gallon drums near the former tuna processing facility building is a REC, in AECOM's opinion. The approximately 20 square-foot stained area had a petroleum odor, and no vegetation was growing within the staining. Furthermore, the empty drums suggest that a significant volume of product may have leaked.

- Eight empty and unlabeled metal 55-gallon drums were observed approximately 30 feet to the northeast of the northeast corner of the former tuna processing facility building. The drums were not covered and directly on the ground surface (Appendix A, Photos 3 and 4). Dark, oil staining, with a petroleum odor was observed at the base of four of the drums (approximately 50 square feet in area). No vegetation was observed growing in the stained soil area, although the surrounding area contained grass and other shrubs. Mr. Siugwemal, port officer at the Division of Sea Transportation, was not aware of the drums, their prior contents, or their origin.

Photo 3: Four empty 55-gallon metal drums observed near the northeastern corner of the former tuna canning facility. Note stressed vegetation surrounding the drums. Photo is looking northwest.

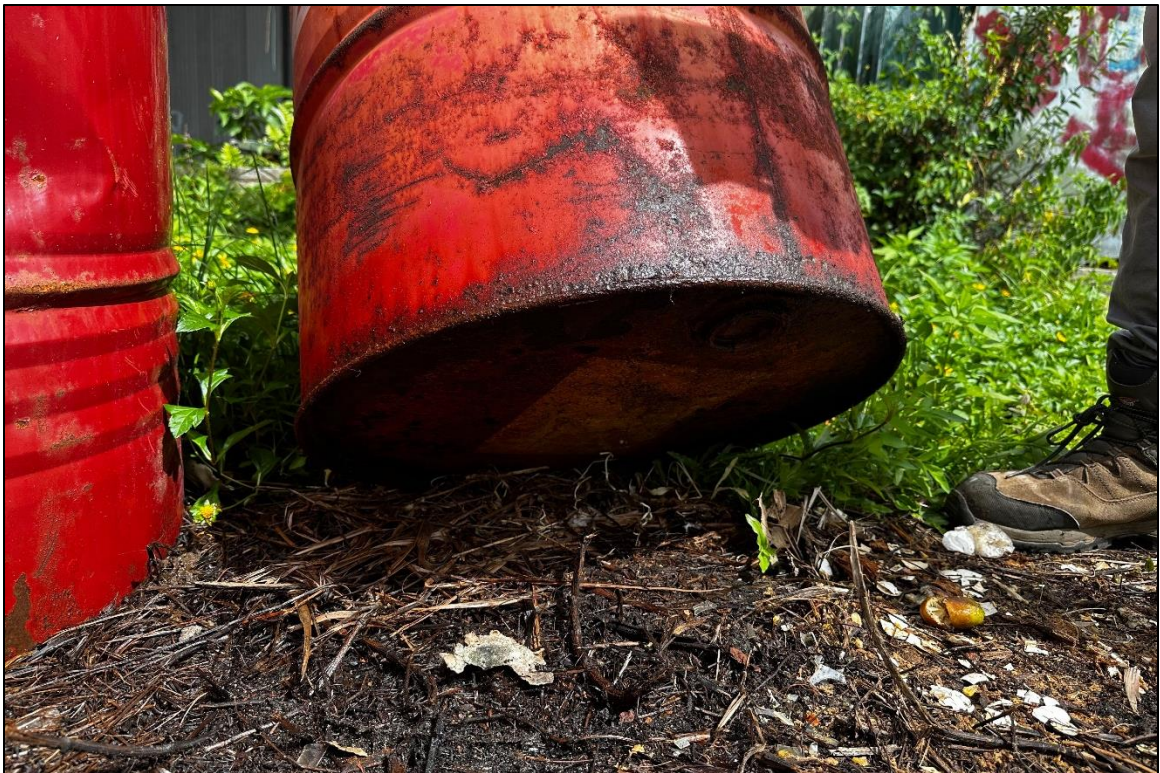
Photo 4: Close-up view of one of the four drums suspected to have leaked oily contents. Distinct petroleum odor noted emanating from dark and moist soil.

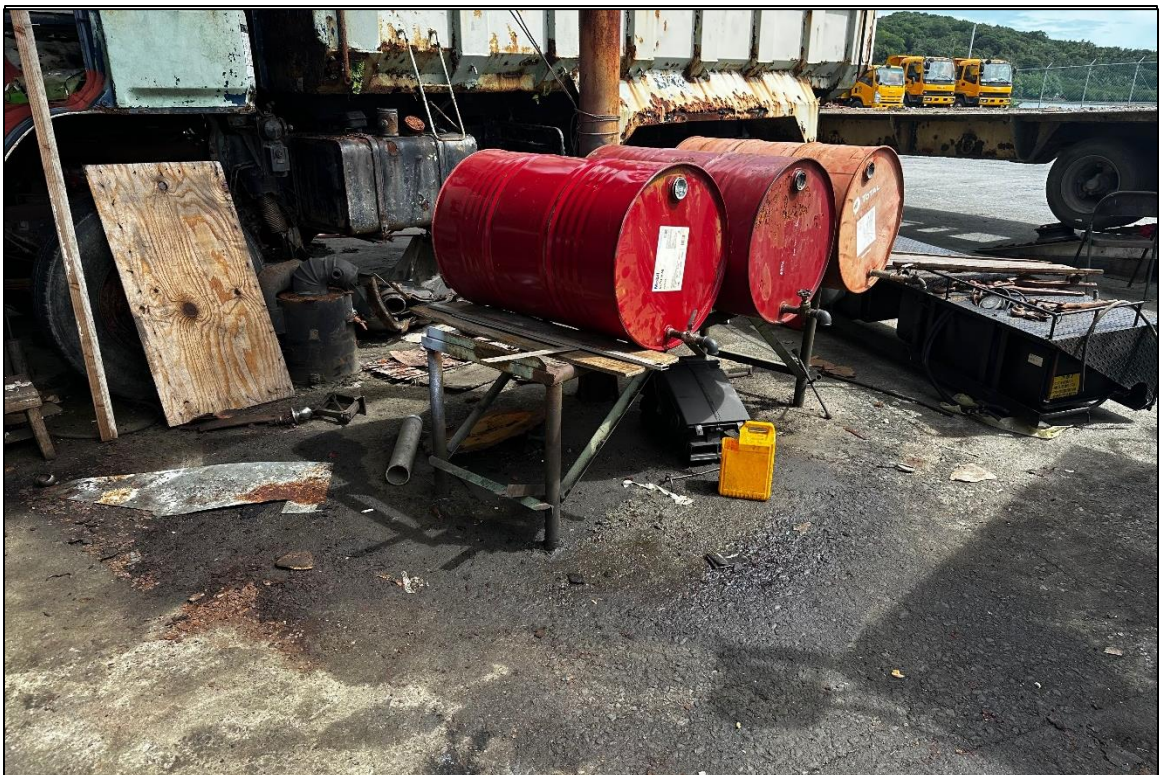
- Extensive oil staining at the Division of Sea Transportation maintenance shop, encompassing an area of approximately 200 square feet, is considered a REC, in AECOM's opinion. Petroleum hydrocarbons have likely leached to underlying soil and entered floor and trench drains.

Photo 6: Closer look at three 55-gallon drums containing hydraulic oil. Note: Extensive staining observed on the concrete surface. This type of staining was observed throughout the premises. Photo is looking north.

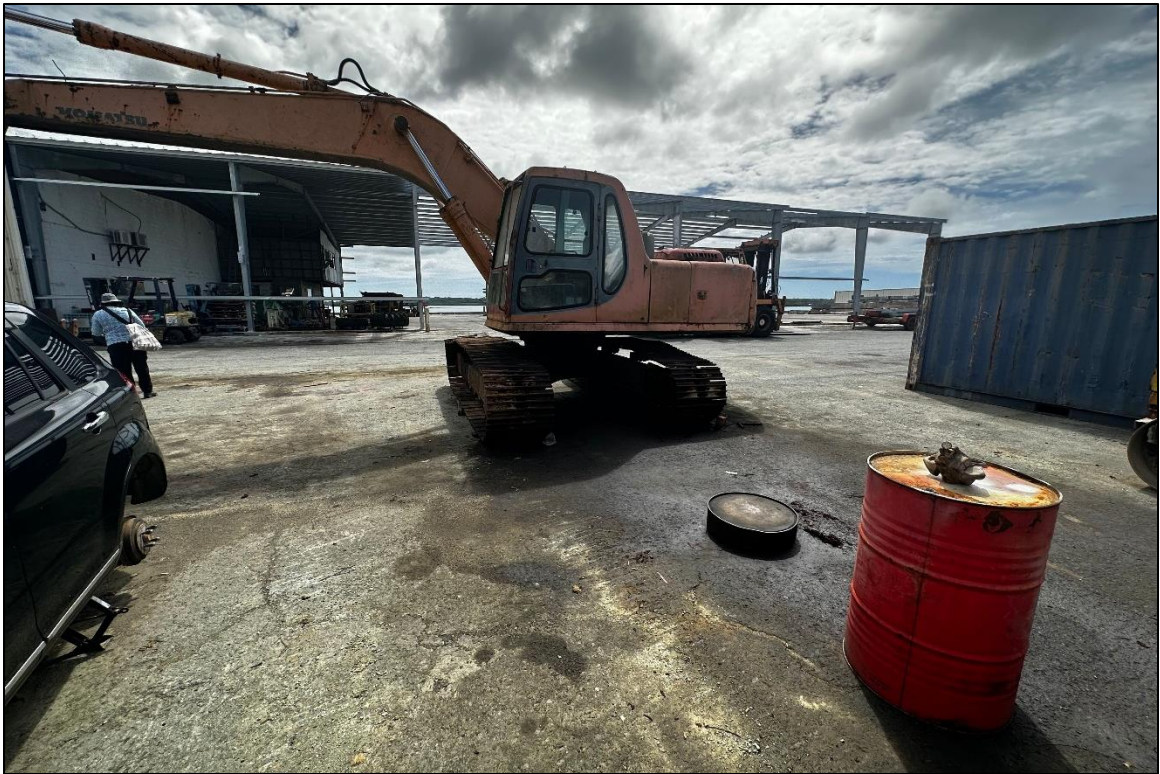
Photo 7: Closer look at other area within the main port maintenance shop displaying concrete staining. Photo is looking northeast.

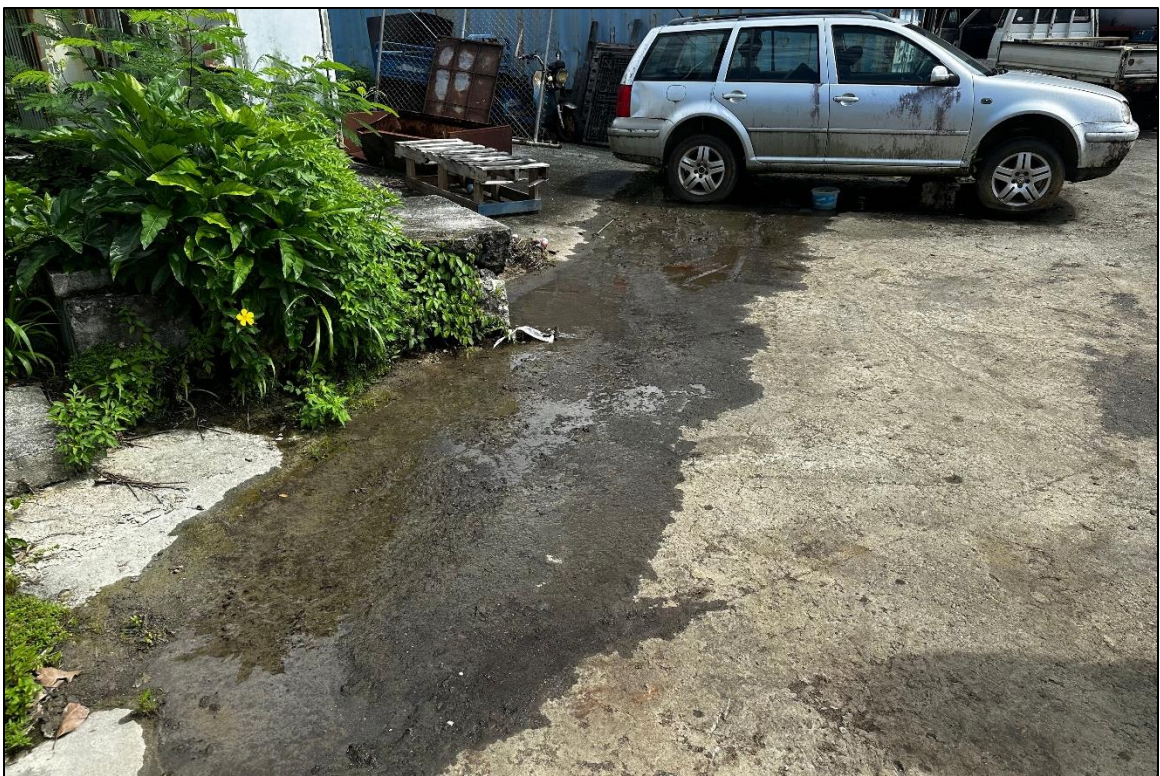
Photo 8: Runoff from washing activities at the maintenance shop heading toward a drainage channel nearby. Photo is looking northwest.

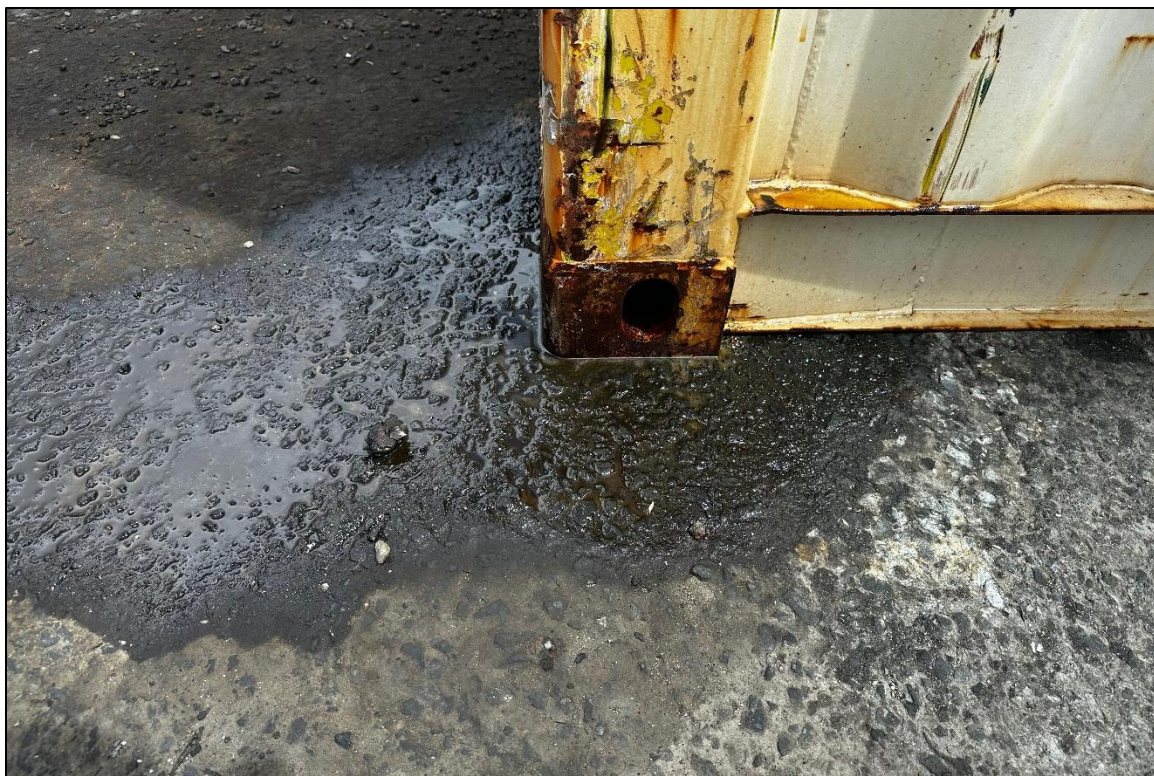
- A shipping container managed by Waab Transportation Company of unknown origin was observed leaking small quantities of a viscous, yellowish substance. The Port Officer at the Division of Sea Transportation Office was not aware of the contents of the container; however, due to the localized nature of the release, AECOM considers this staining a DMC.
- Four small oil stains (less than 2 square feet each) observed at the Yap Fishing Authority maintenance shop. Given the localized nature, AECOM considers this staining a DMC.

Photo 10: Close-up view of shipping container managed by Waab Transportation Company of unknown origin observed leaking small quantities of a viscous, yellowish substance.

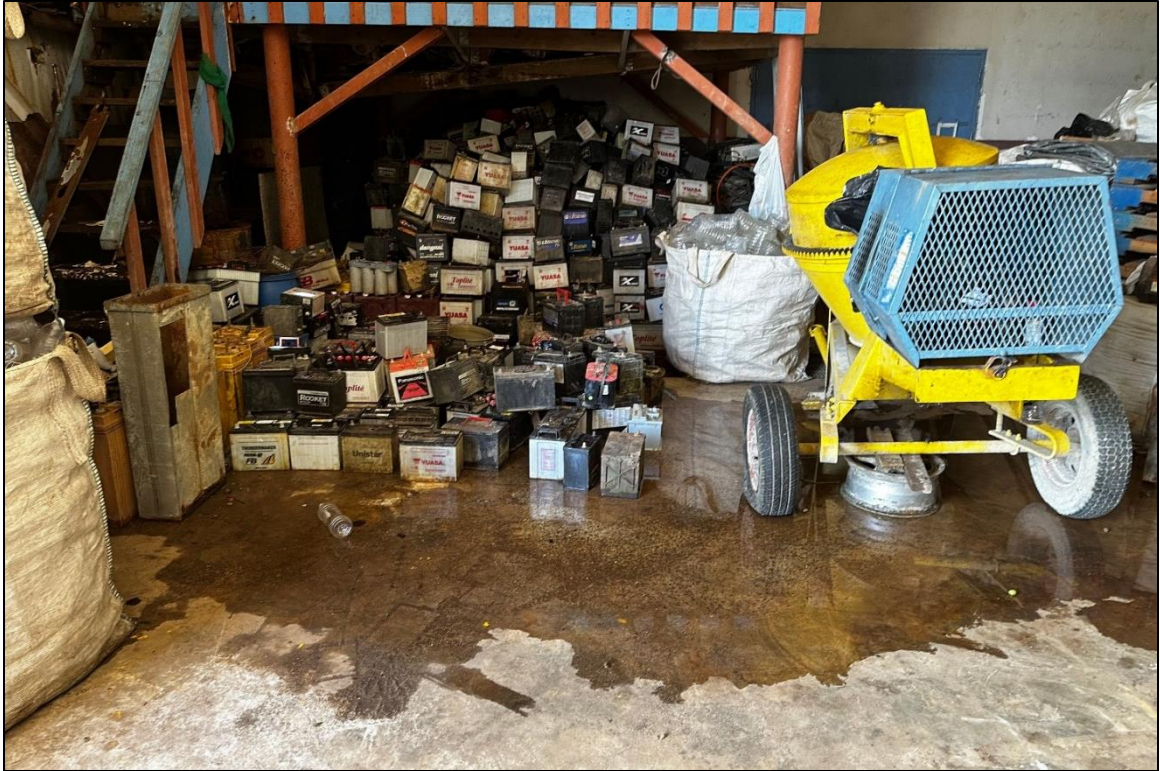
- A stockpile of automobile and other equipment batteries at the Recycling Center is a REC, in AECOM's opinion. These batteries were situated on a concrete floor atop a substantial pool of liquid, reportedly identified as rainwater by personnel on site. Although no significant floor cracks were observed, various floor drains were observed in the vicinity of the batteries.

Photo 15: Overview of a lead-acid battery pile located inside the Recycling Center observed sitting on a large puddle of rainwater. Approximately 200–300 batteries were estimated. Photo taken standing on top of floor drain.

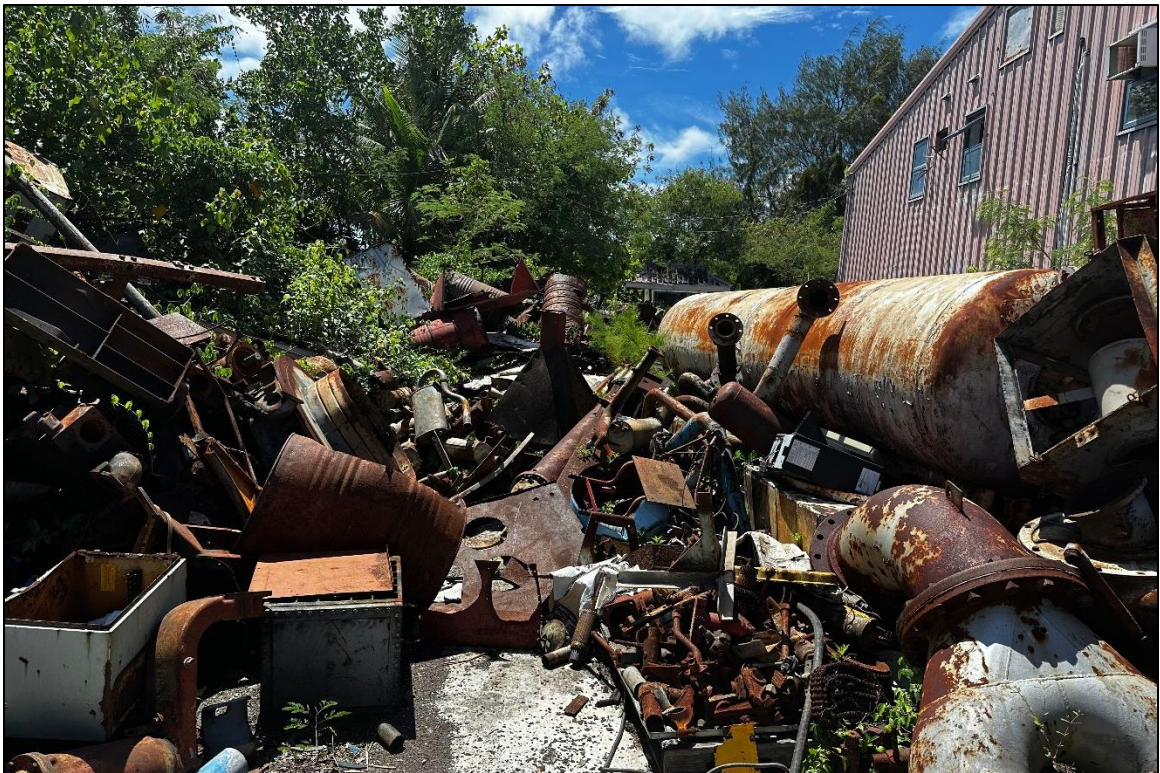
- Three piles of metal debris, primarily consisting of abandoned automobiles and automotive parts are present in the salvage yard within the subject property. The piles measured approximately 7,000, 1,500, and 1,300 square feet. In addition, a deteriorated 20-foot metallic tank marked as "unleaded gas," was identified and exhibited substantial corrosion and perforations. The condition of such an abandoned tank may indicate a release of hazardous substances or petroleum products into the surrounding environment. The piles have not been previously investigated, and it is unknown whether metals or other contaminants are present at concentrations that represent a hazard to human or ecological health; therefore, this finding is considered a REC in AECOM's opinion.

Photo 18: Overview of an approximately 1,500-square-foot scrap metal pile located adjacent to the Recycling Center. Photo is looking east.

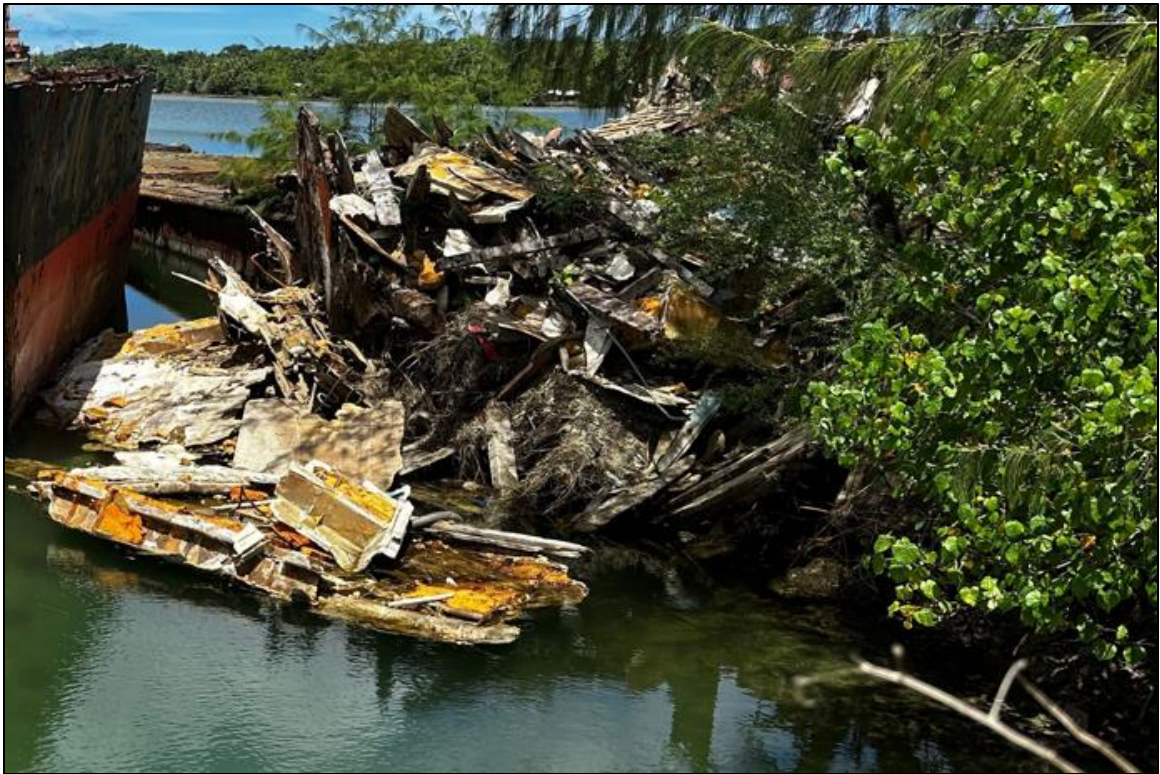
Photo 19: Overview of demolition debris mound located in the southeasternmost point of the subject property. A portion of the mound was observed eroding into the ocean. Photo is looking southeast.

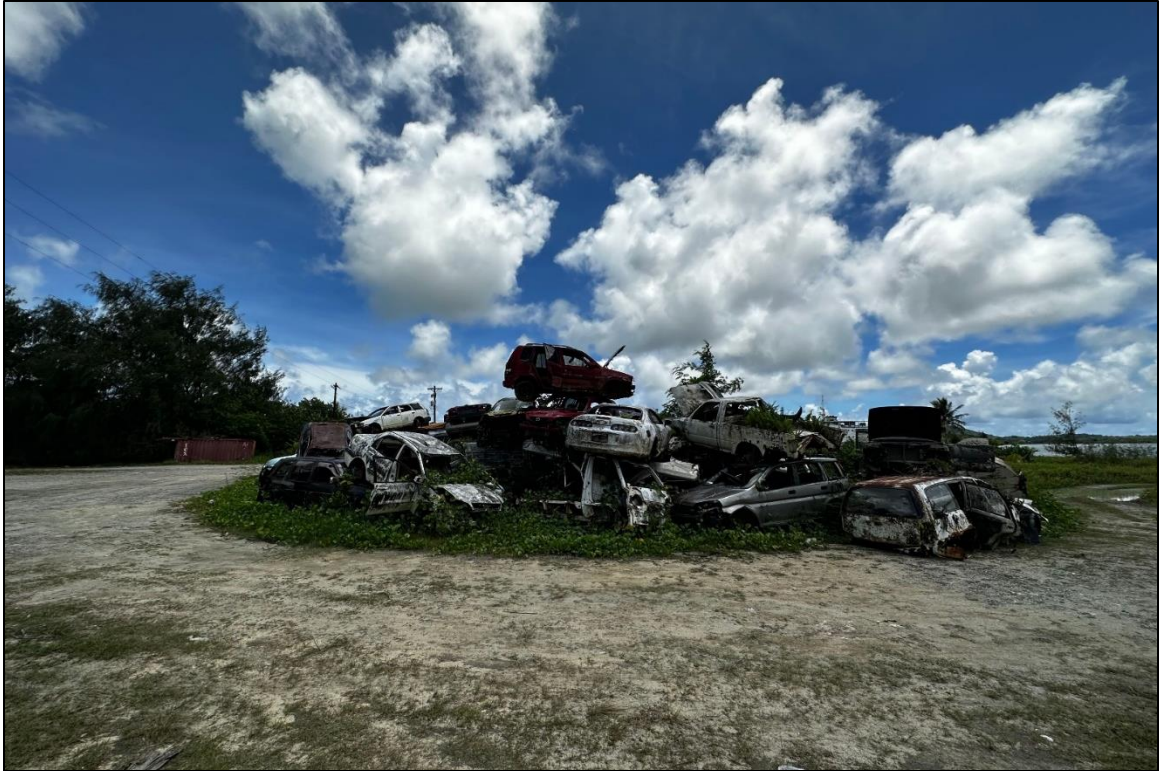
Photo 21: Overview of one of the three non-contiguous abandoned vehicle piles. Photo is looking north.

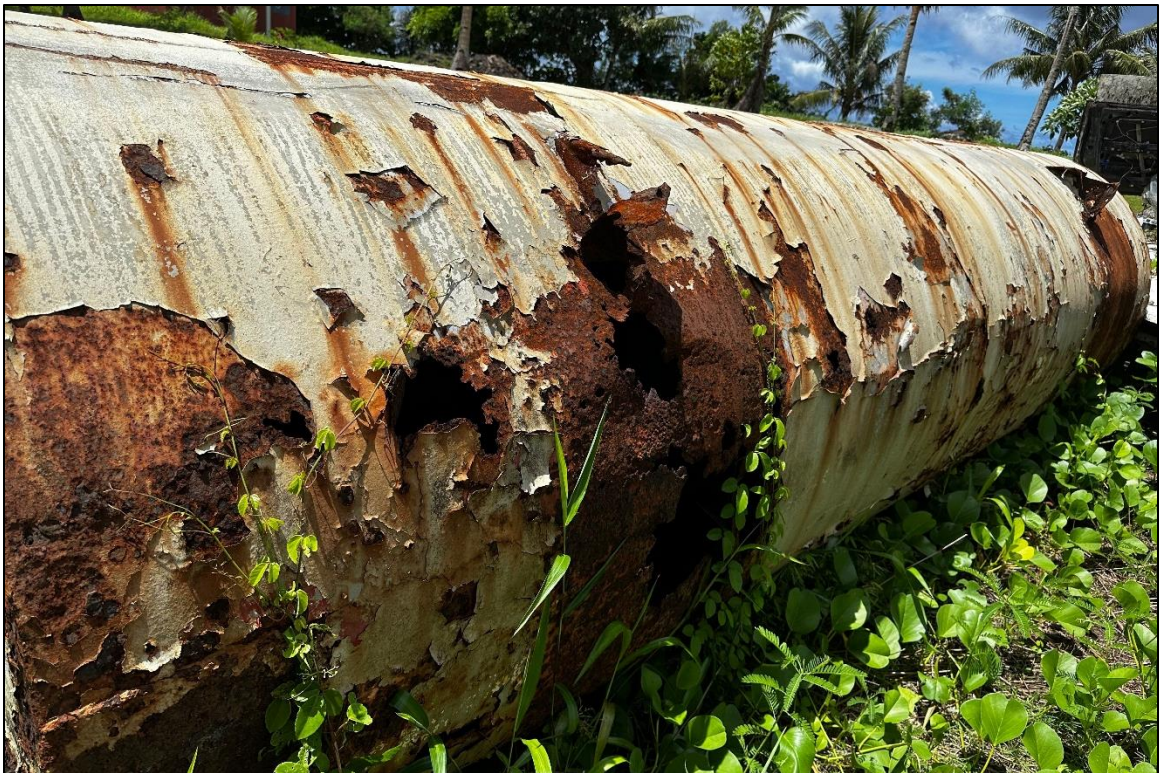
Photo 22: Close-up view of empty, deteriorated AST observed adjacent to the abandoned vehicle piles. Photo is looking west.

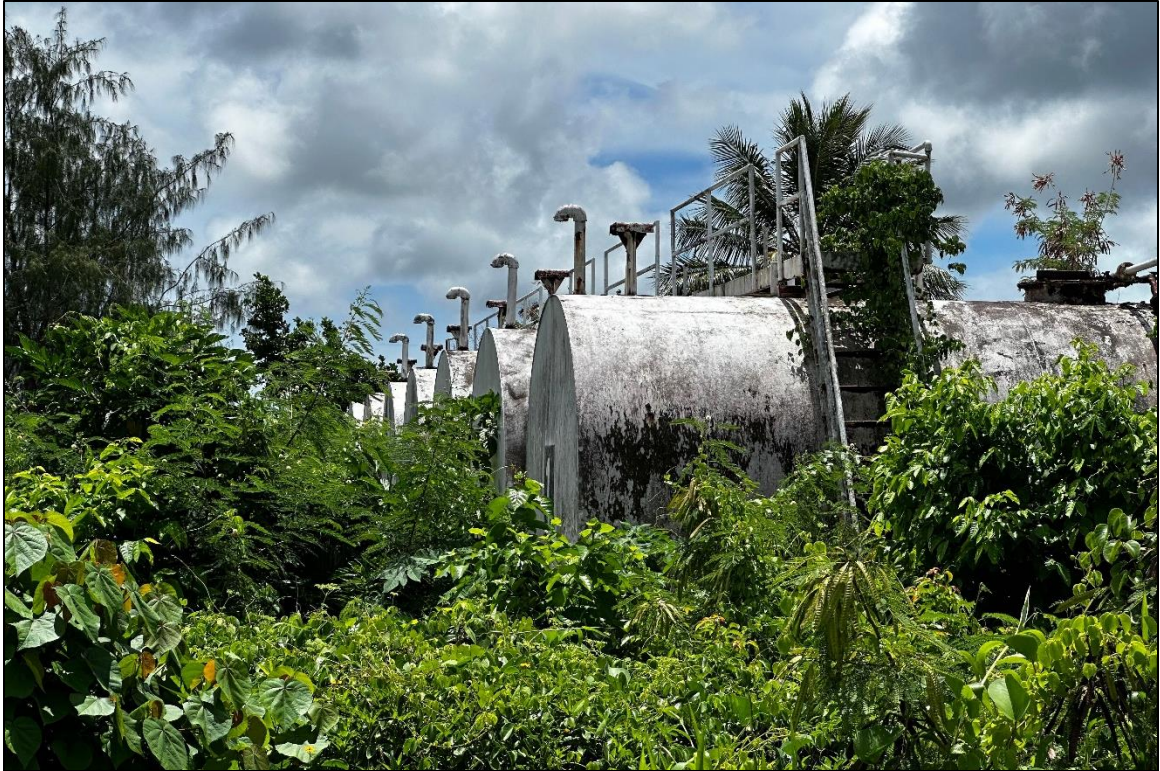
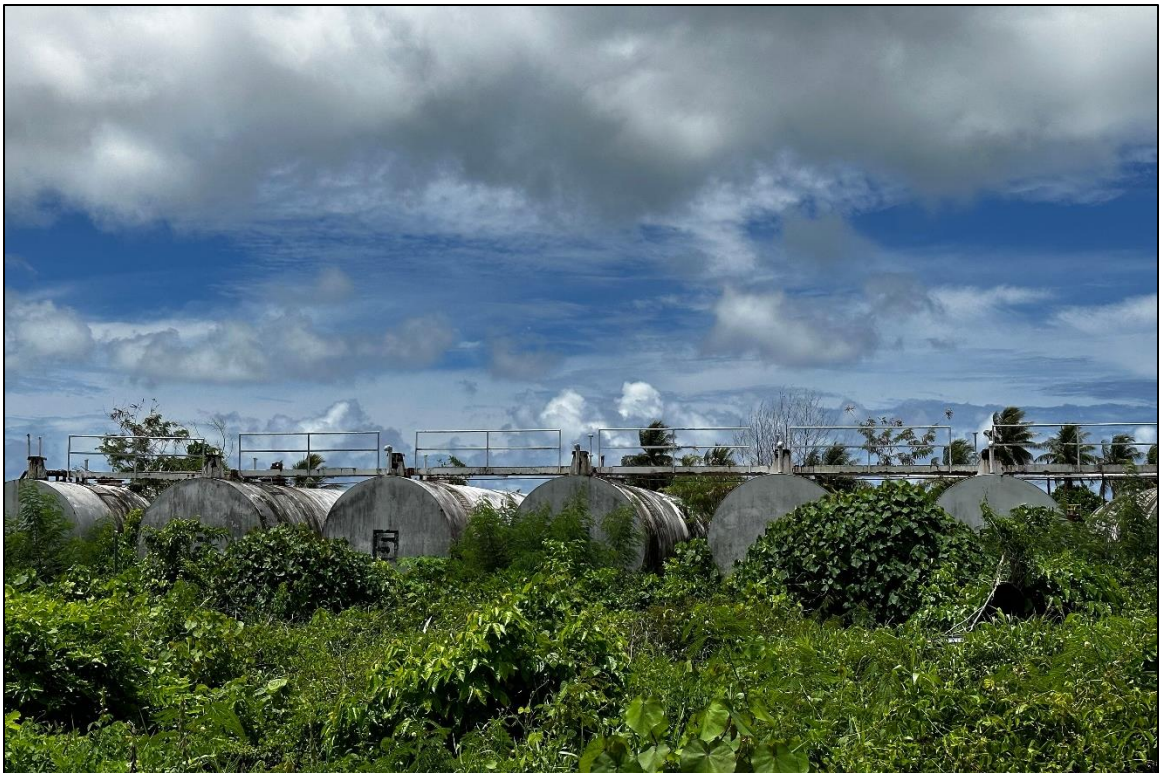
- Seven fuel tanks previously utilized by the U.S. Coast Guard on the subject property are considered a REC, in AECOM's opinion. The ASTs could only be observed from a distance during the site visit because of overgrown dense vegetation and the surrounding terrain; however, they appeared to be slightly corroding. It was not ascertainable from interviews whether any fuel remains in the ASTs and abandonment documentation was not available.

Photo 23: Zoomed-in photograph of the seven abandoned former U.S. Coast Guard fuel tanks.
Photo is looking southeast.

Photo 24: Zoomed-in photograph of the seven abandoned former U.S. Coast Guard fuel tanks.
Photo is looking west.

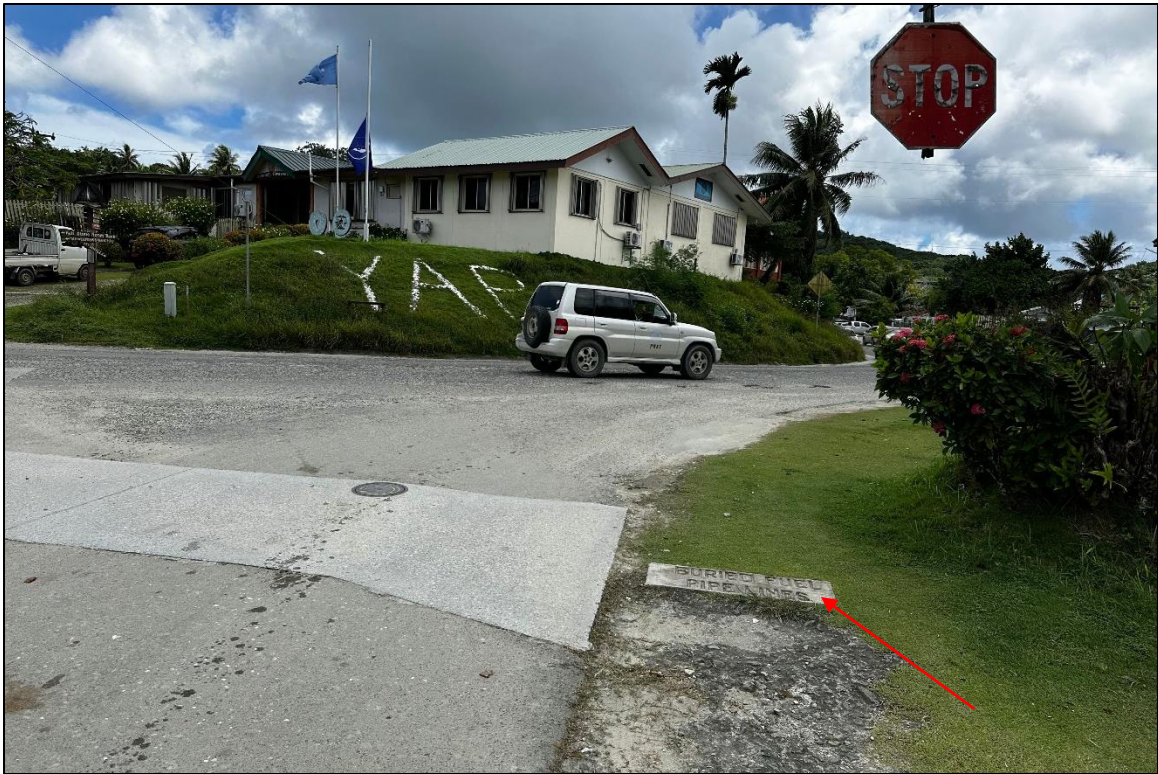
- The underground fuel pipeline that transports fuel from the PetroCorp fuel farm to the port is present throughout the subject property. It could not be determined during this Phase I ESA whether the pipeline is regularly leak tested, the leak testing methods, and testing results. Based on this lack of information, the pipeline represents a material threat of a potential future release and a REC, in AECOM's opinion.

Photo 25: Overview of the northern border of the subject property. Note: A buried fuel line marking exists on the street (denoted by red arrow). Photo is looking northwest.

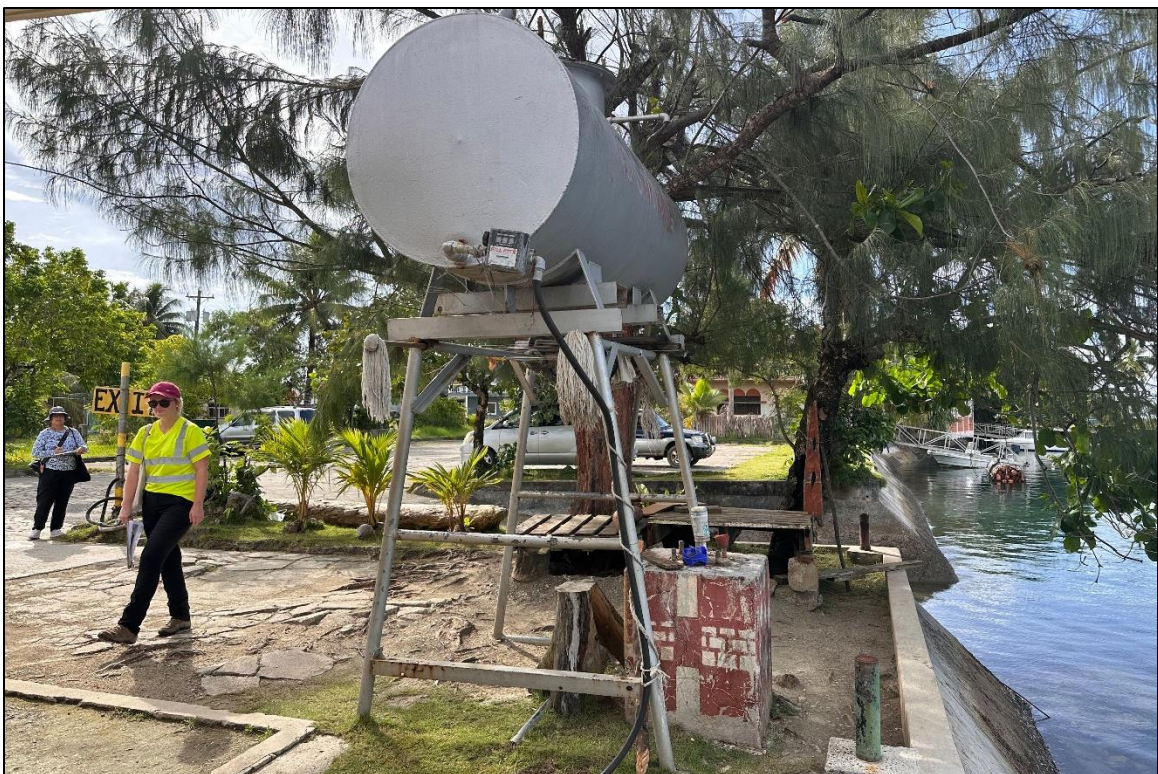
Photo 28: Overview of 320-gallon kerosene AST lacking secondary containment. Photo is looking east.

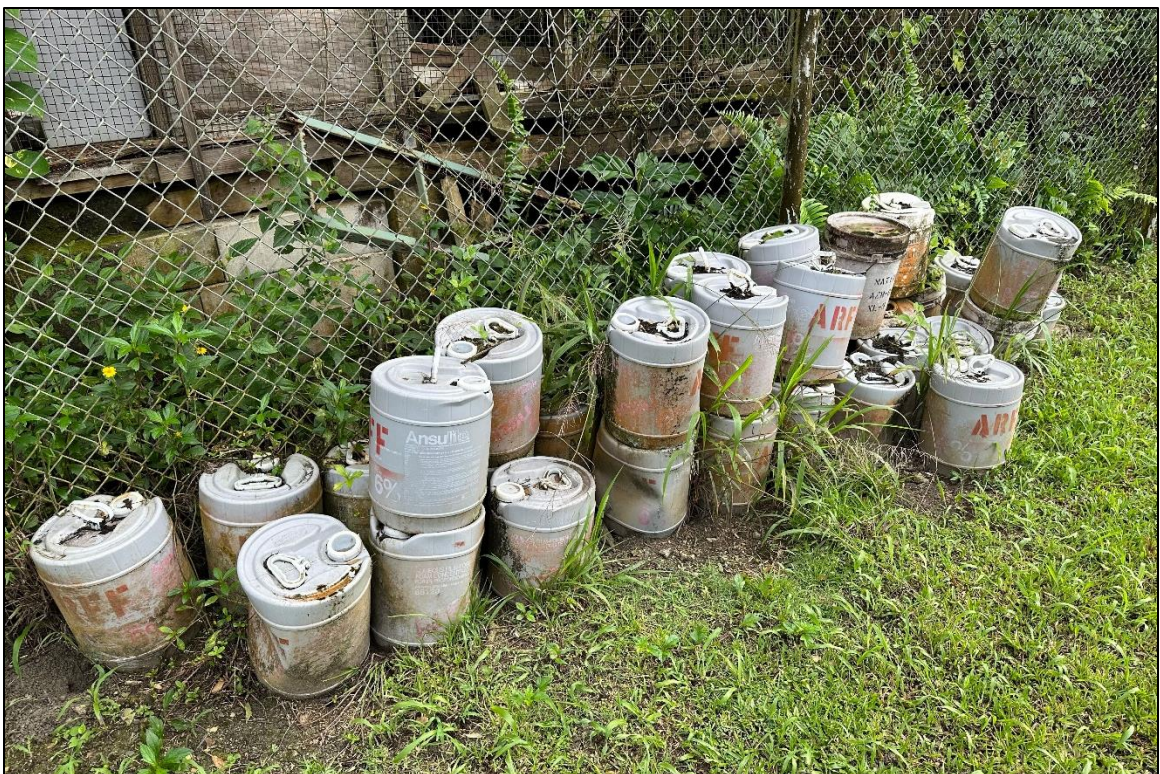
Photo 32: Close-up view of 55-gallon Ansulite buckets sitting on the lawn at the rear end of the fire department building.
