# Final Field Report for Baseline Cultural Resources Surveys for the Sea Port in Yap, Federated States of Micronesia

Naval Facilities Engineering Systems Command, Pacific

Cardno GS – AECOM Pacific Joint Venture

October 2023

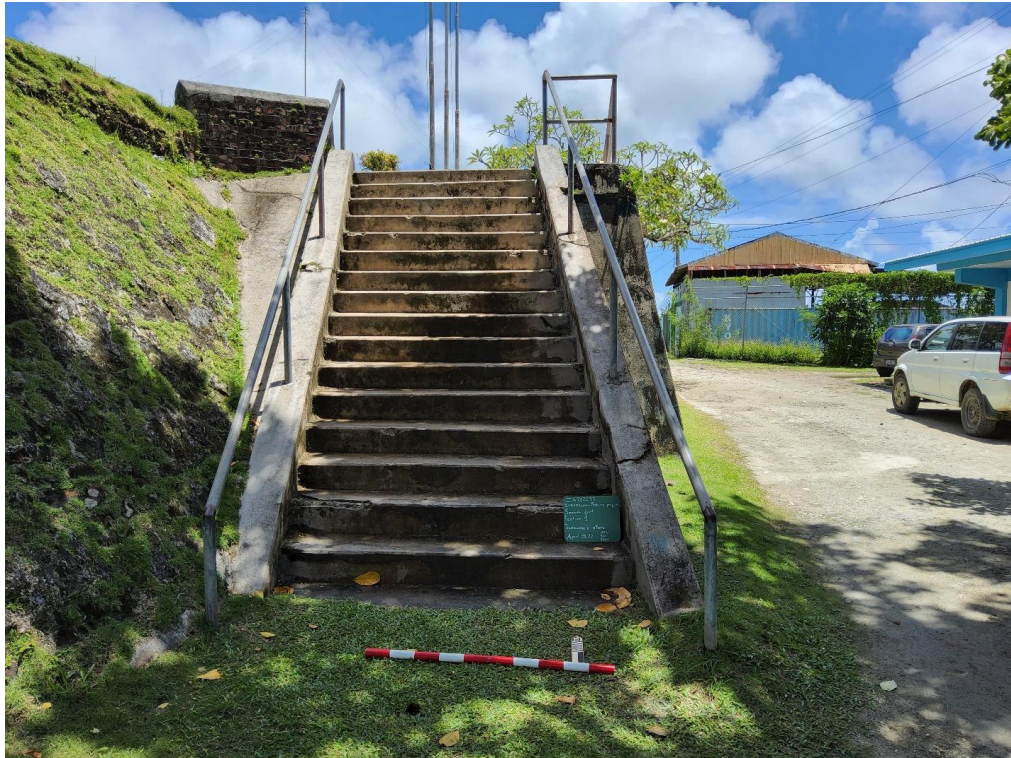
Feature 01 was a pair of concrete staircases leading to a common landing on the east side of the Spanish fort. It is approximately 43.6 feet (13.3 meters) long, 7.6 feet (2.3 meters) wide, and 9.8 feet (3.0 meters) tall (Figure 3-4 and Figure 3-5). The characteristics of the concrete were consistent with other Japanese administration buildings and structures, and local consultants identified Feature 01 as a Japanese modification to the site. A U.S. Coast and Geodetic Survey benchmark was installed on one of the stairs in 1951 (Figure 3-6). The condition of the stairs was good, but some cracks with vegetation were observed.

**Figure 3-5** Feature 01, Close-up of One Flight of the Japanese Administration Stairs on the East Side of the Site; View North

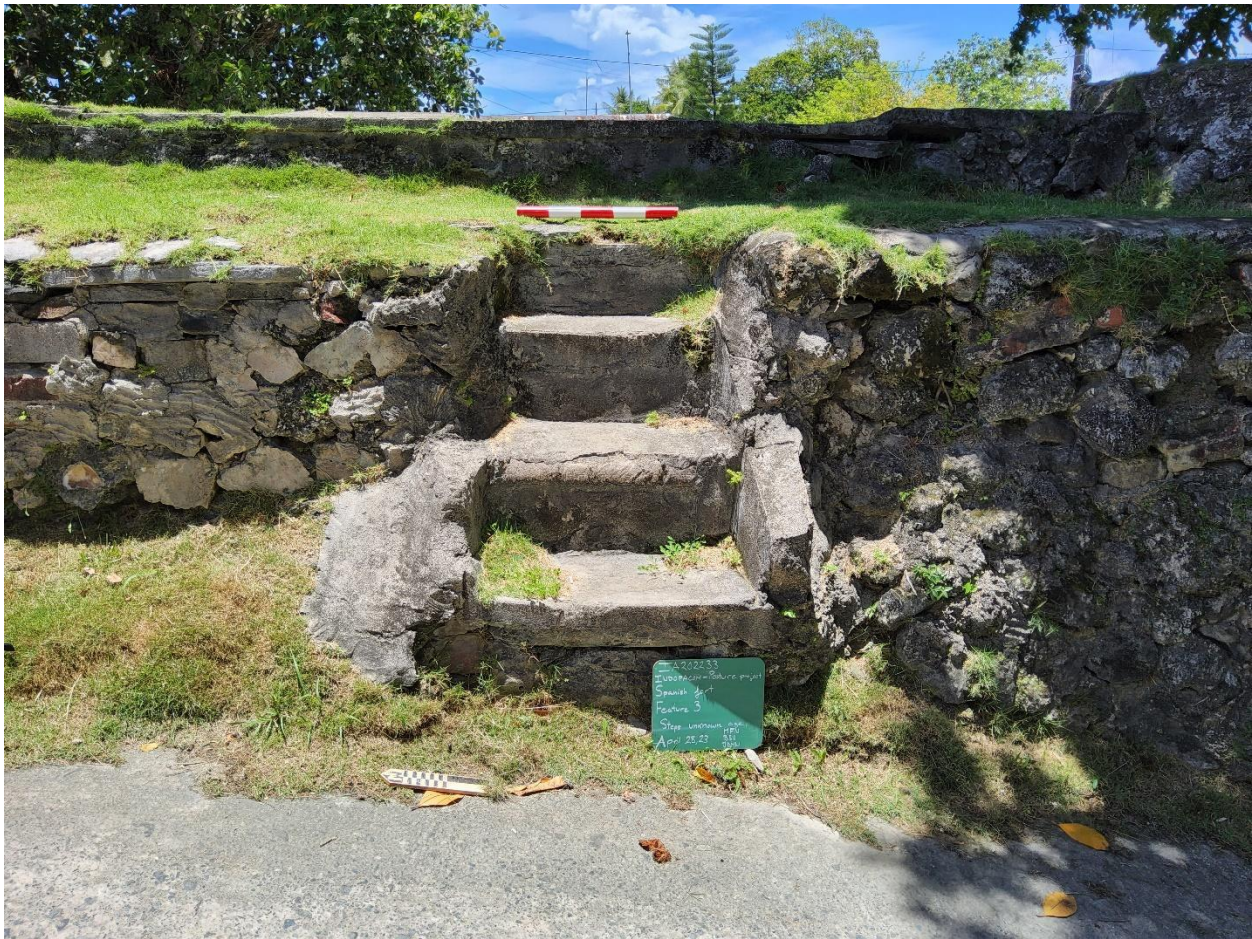
Feature 03 was a sitting area comprised of a staircase, a pair of terraces, and circular planters (Figure 3-8). It was adjacent to the driveway leading to the Japanese hospital (the driveway may be a modification of one of the two original Spanish access routes). The short staircase had three concrete steps that lead to a narrow, grass-covered terrace. Above the lower terrace was a second narrow terrace with two circular planters. The retaining walls for the terraces were constructed with stone, coral, concrete, and brick; the brick may be reused material from earlier Spanish colonial construction. The planters were made from concrete, stone, and coral. Vegetation covers some of the steps and the surface of the sitting area had some fractures, though overall, the area was maintained. Feature 03 was inferred to date to the Japanese administration based on the construction characteristics and spatial association with the driveway leading to the Japanese hospital (though it could have been a later modification). The condition was fair to good, and this area is still used as a sitting area.

**Figure 3-8**      **Feature 03, Sitting Area Comprised of Stairs, a Level Area, a Terraced Sitting Area, and Planters; View East**

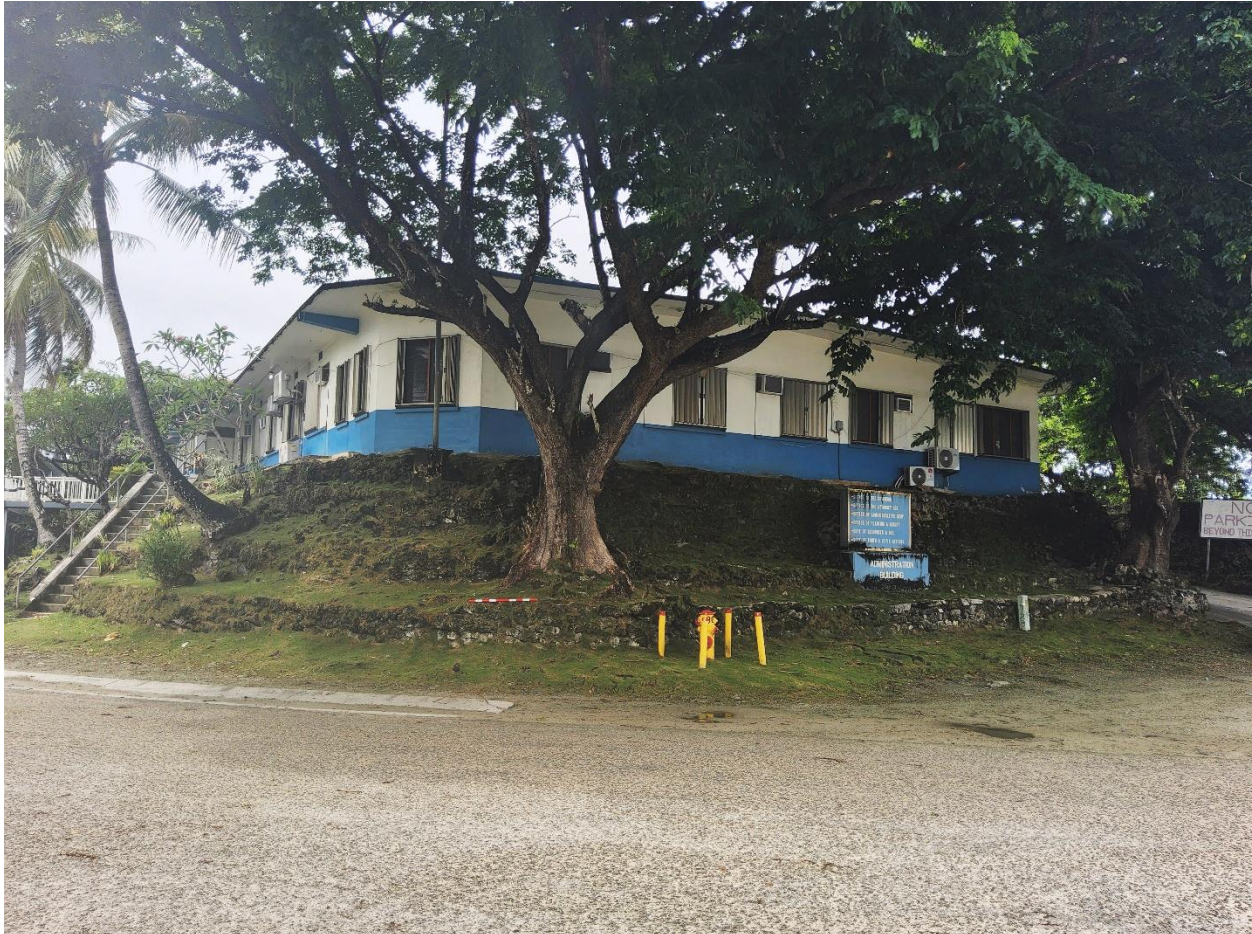
Feature 04 was a 20th-century Yapese terrace set built along the south and west sides of the embankment (Feature 06) (Figure 3-9 to Figure 3-12). Four terrace tiers were present, with the facings built of stone with some coral. The lowest terrace was the longest, with each successive terrace shorter in length; the uppermost tier was present along a short section on the west side of Feature 06. The terraces were built around a Japanese staircase on the west side (Feature 05). The surfaces of each terrace were covered with grass and ornamental plants. The terrace set is inferred to be a 20th-century Yapese addition based on construction characteristics and its placement around the pre-existing Japanese staircase.

**Figure 3-9 Feature 04, Traditionally Constructed Yapese Terraces Built along the South and West Sides of the Spanish Colonial Embankment and Mound (Feature 06); View Northeast; the Building is the Former Japanese Hospital**

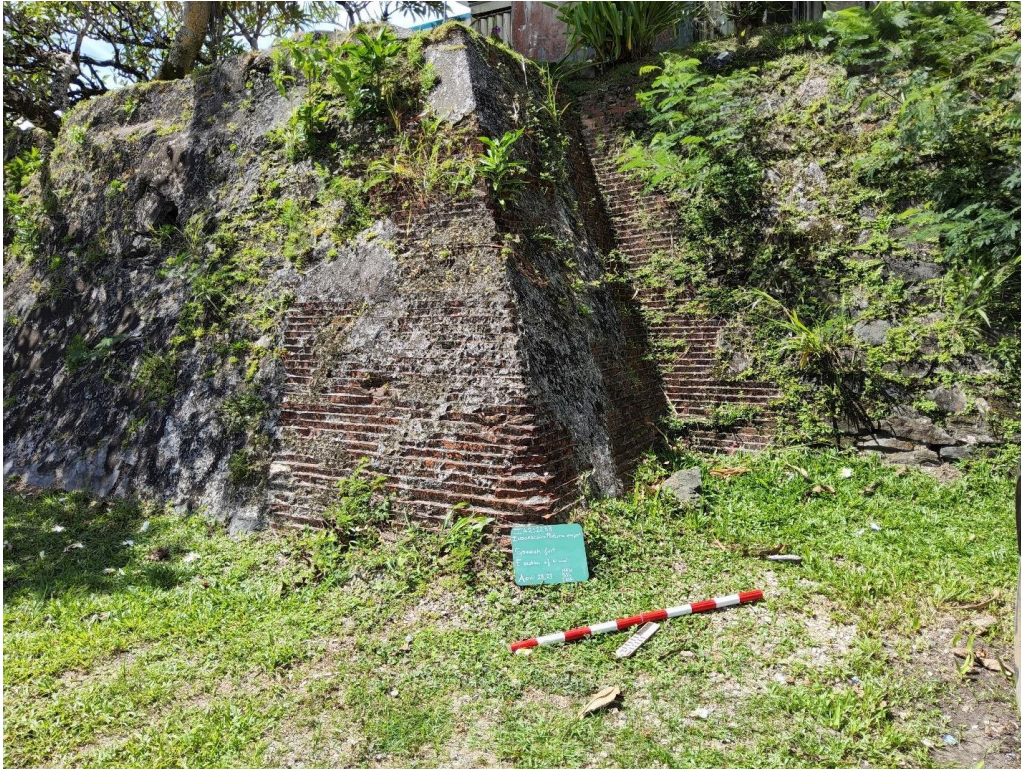
Masonry reinforcement included segments of square, hand-cut stone masonry or rough ashlar (also known as large square-cut stone) (*silleria*) (Figure 3-14) with mortared fired clay bricks and formed three of the extant corners (southeast, northeast, and northwest) (Figure 3-15 to Figure 3-20); the southwest corner was destroyed or removed and had a traditional Yapese terrace set (Feature 04). The southeast corner was an exemplar of the different masonry techniques that were applied. Coursed, mortared bricks form the bulk of the corner, including the exterior faces. Abutting the brickwork on the interior edge was *silleria*. This, in turn, was covered by mortared rubble masonry, which formed the interior surface of the embankment. The original masonry that was plastered though portions of this finish have since eroded.

**Figure 3-17** Feature 06, Northeast Corner Built of Coursed, Mortared Brick; View Facing Southeast; Note the Remnant Plaster

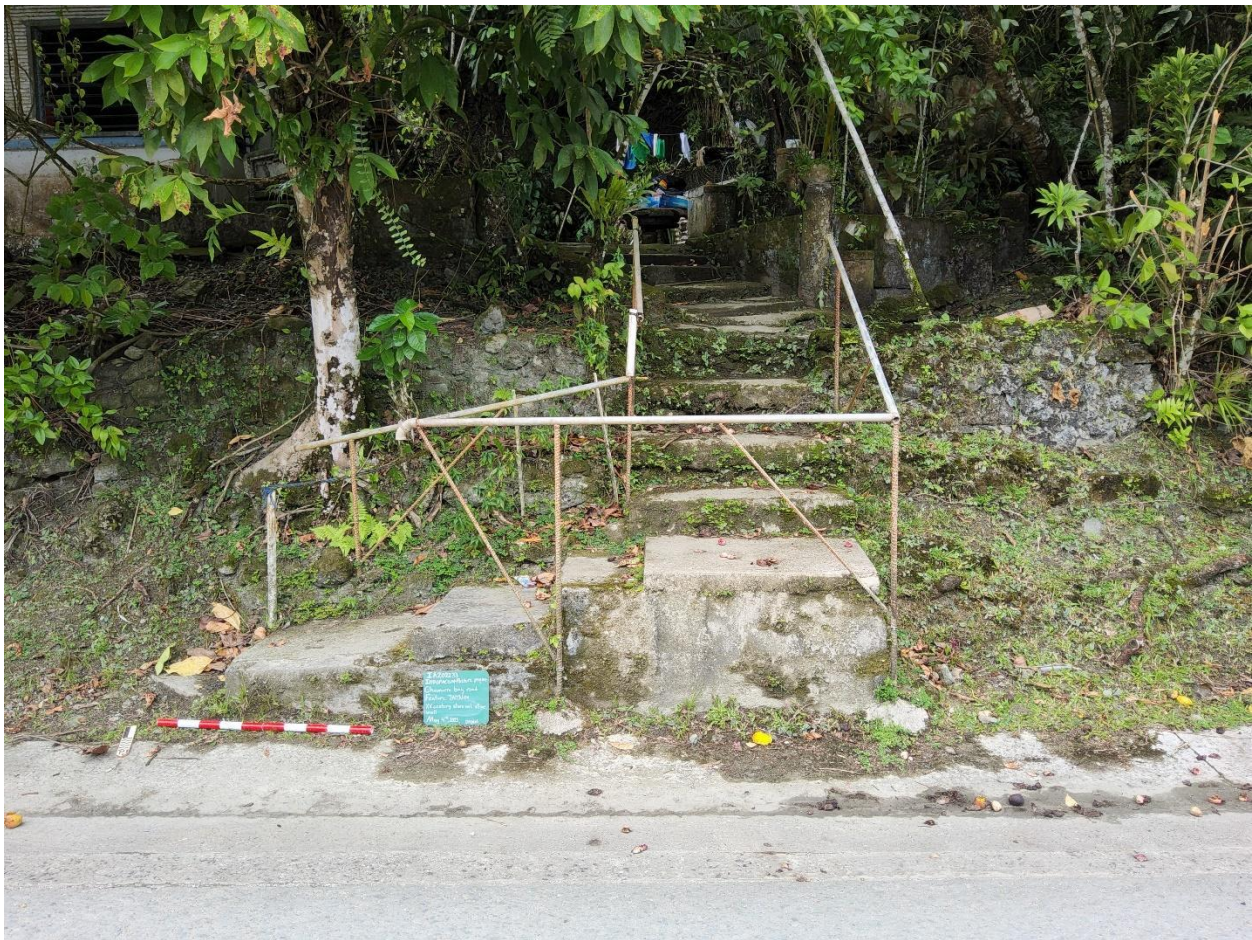
Temporary Site 01 was a stone and coral retaining wall with a concrete staircase (Figure 3-27). The wall was approximately 70 feet (21 meters) long and 6 feet (1.8 meters) high. It was built along the south edge of the road around Chamorro Bay in the village of Woorwoo, Rull Municipality. The retaining wall was on privately owned property. The concrete steps were similar to Japanese-administration-era structures, and a local consultant with family from this village stated the stairs were built by the Japanese. While the retaining wall was built in a traditional Yapese fashion, its construction date was uncertain. The stairs are an example of structural modifications to village features during the Japanese administration. Temporary Site 01 was in good condition; it is recommended as eligible for listing in the NRHP.

**Figure 3-27 Temporary Site 01, Stone and Coral Retaining Wall with Japanese-era Concrete Steps, in Woorwoo Village, Rull Municipality; View South**

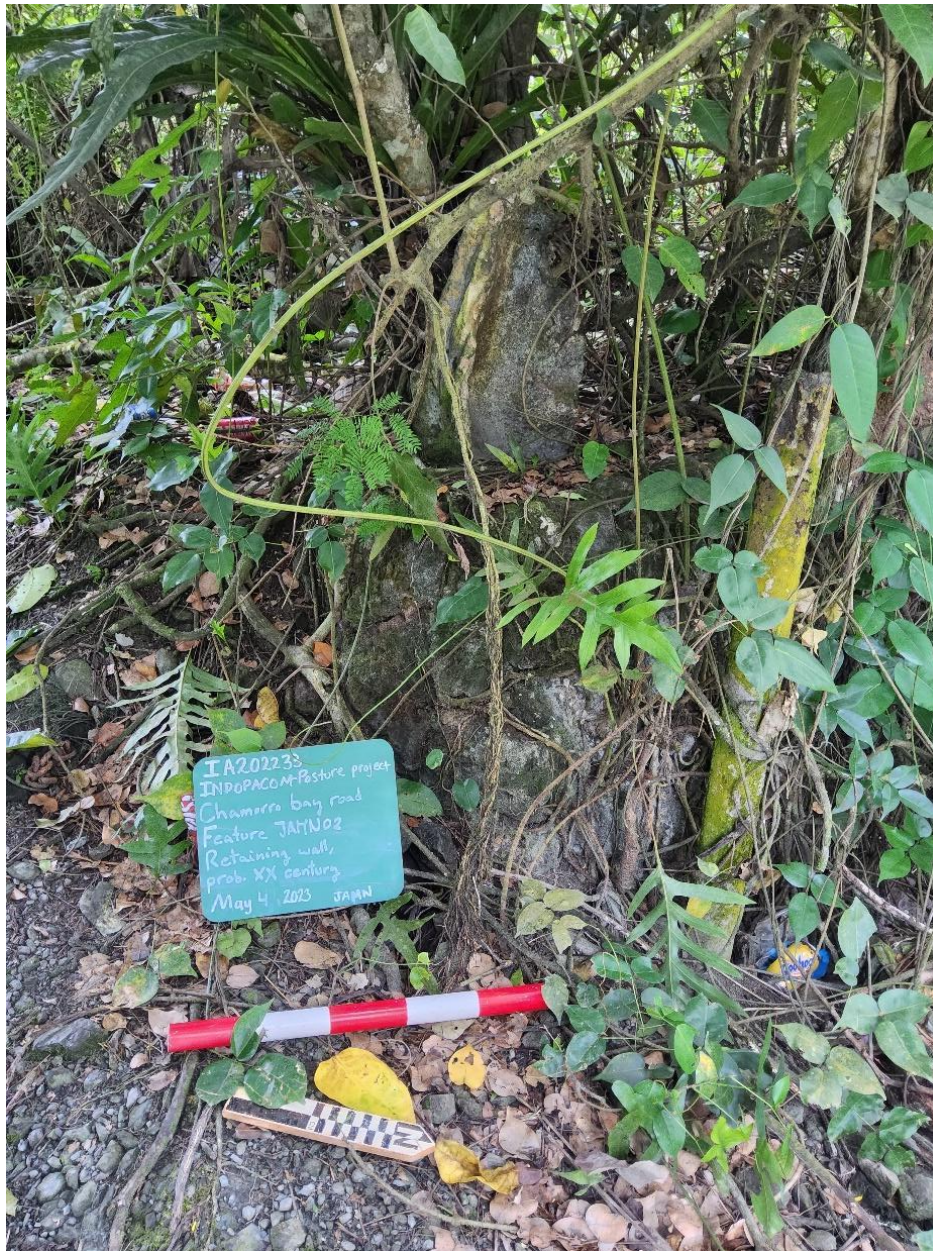
Temporary Site 02 was a stone and coral retaining wall (Figure 3-28). It was approximately 85 feet (26 meters) long by 3 feet (0.9 meters) high. It was approximately 16 feet (5 meters) south of the road around Chamorro Bay in the village of Woorwoo, Rull Municipality. The retaining wall was on privately owned property adjacent to a drainage leading into Chamorro Bay. In Yapese, this type of erosion control retaining wall is known as *tanayboch*. A large, vertically placed *Tridacna* sp. shell is at the southeast corner of the wall and the feature was covered with vegetation. The age of Temporary Site 02 was unclear, but a local consultant indicated its construction was approximately contemporaneous to Temporary Site 01. Temporary Site 02 was in good condition; it is recommended as eligible for listing in the NRHP.

Figure 3-28 Temporary Site 02, Stone and Coral Retaining Wall in Woorwoo Village, Rull Municipality; View West

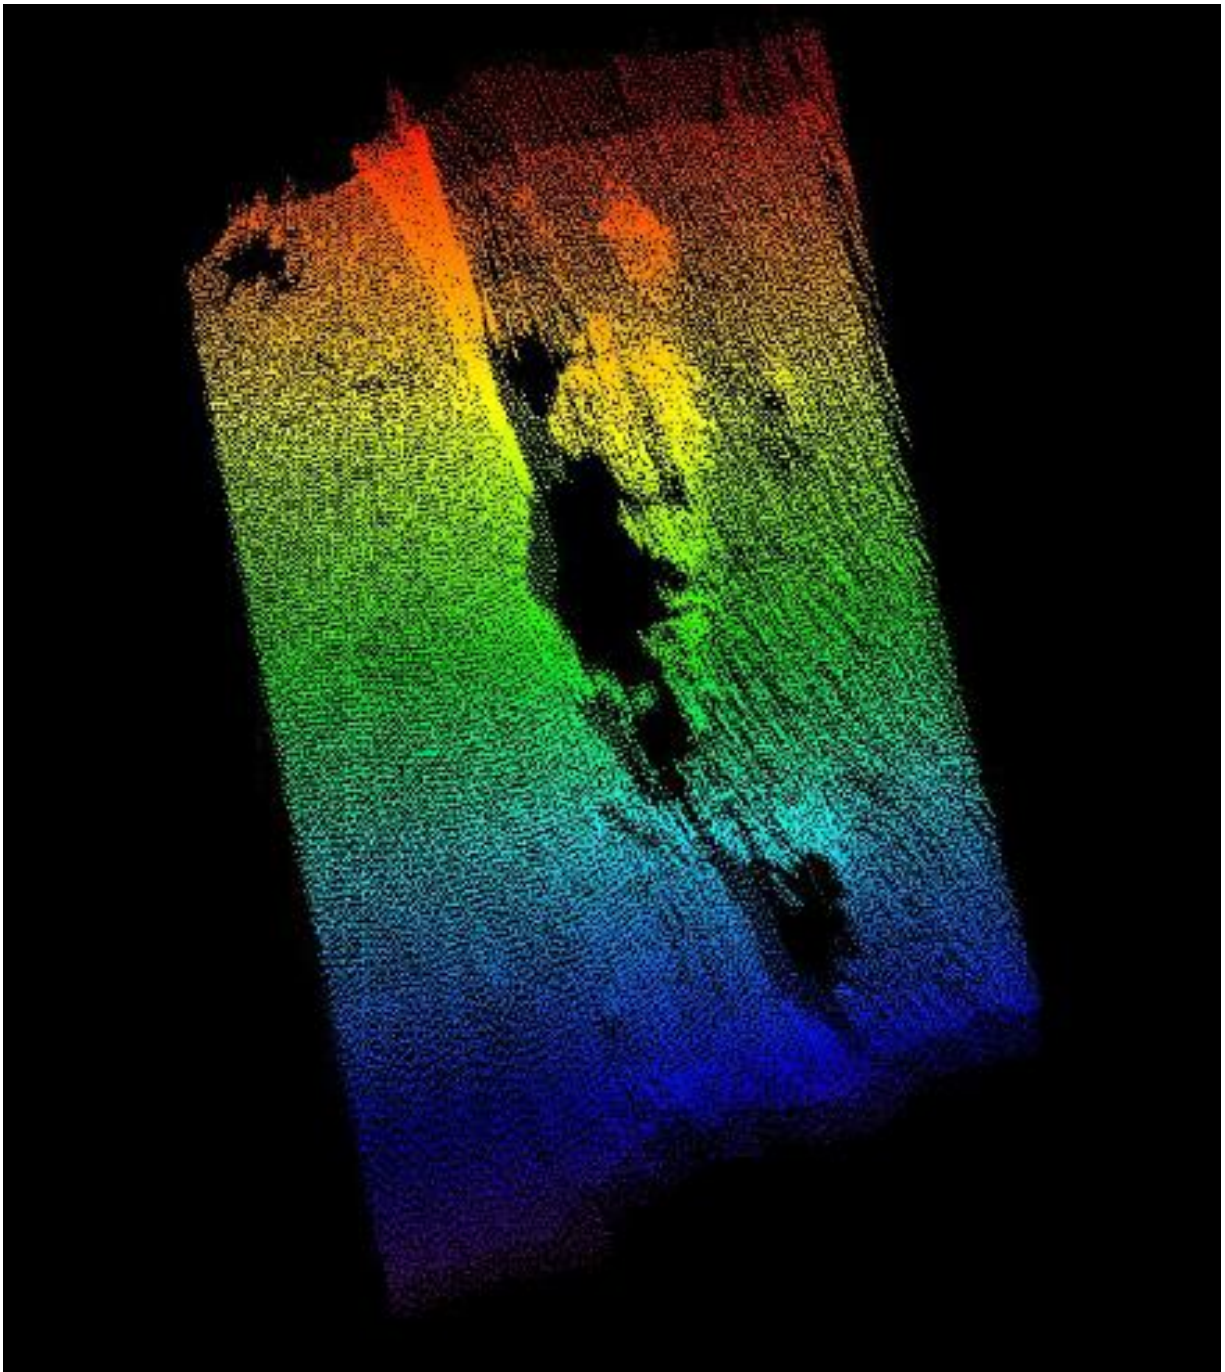
**Figure 3-37 Target 10 (Navy Seabee MBES image)**

Target 10 was located in approximately 45 feet (13 meters) of water (Figure 3-37). Divers did not identify any acoustic contact in the vicinity of Target 10. The source of Target 10 was a natural coral head, a non-anthropogenic object. Navy Seabee MBES data denotes Target 10 as a wreck, 30 feet (9 meters) long and 16 feet (5 meters) wide, exposed approximately 18 feet (5.6 meters) above the sea bottom.

Divers spent 18 minutes investigating Target 10 and identified the source as a coral head with substantial relief. The coral head was bulbous and elongated, which was consistent with recorded MBES data.

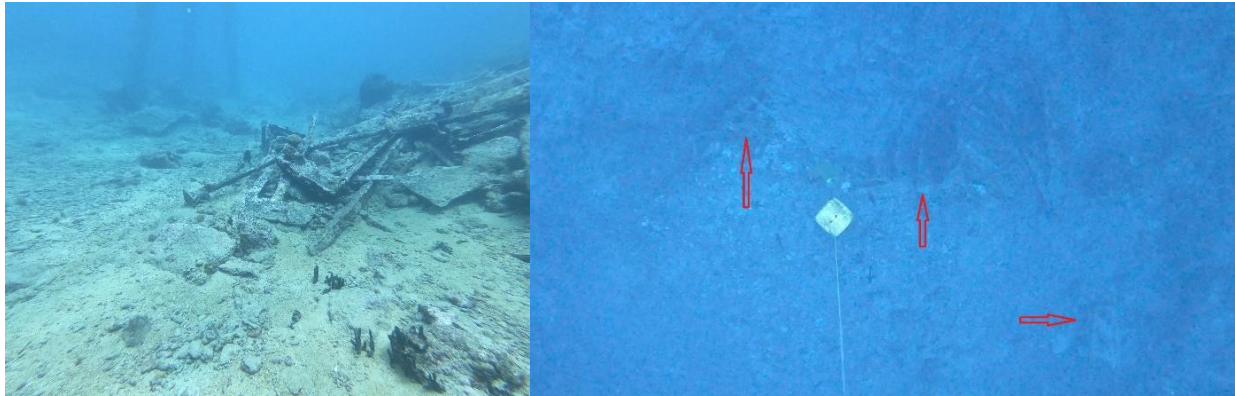
**Figure 3-42 Target 24 with 2 Pin in Background (Left; Photo by AECOM) and Target 24 as Seen by the Drop Camera (Right; Photo by SEI)**

Target 24 was recorded as Acoustic Contact S018 and was a large debris field that extended from the navigation channel marker number 2 (2 pin) across the navigation channel in water depths between approximately 20 feet (6.1 meters) to over 100 feet (30.1 meters) (Figure 3-42). The eastern portion of Target 24 was recorded within acoustic imagery. The wreck was depicted on the U.S. Navy Hydrographic Office (1924) map. The source of Target 24 was identified as the scattered remains of a late-19th-century to early-20th-century steam vessel, possibly identified as either the SMS *Planet*, a German survey vessel, or the *Kokura Maru*, a cargo vessel.

Based on observed characteristics and available data, Target 24 may retain the potential to yield significant information about late-19th-century to early-20th-century shipping. It is recommended treating Target 24 as eligible for listing in the NRHP with an avoidance buffer of 328 feet (100 meters) from the defined site extents, pending additional information.

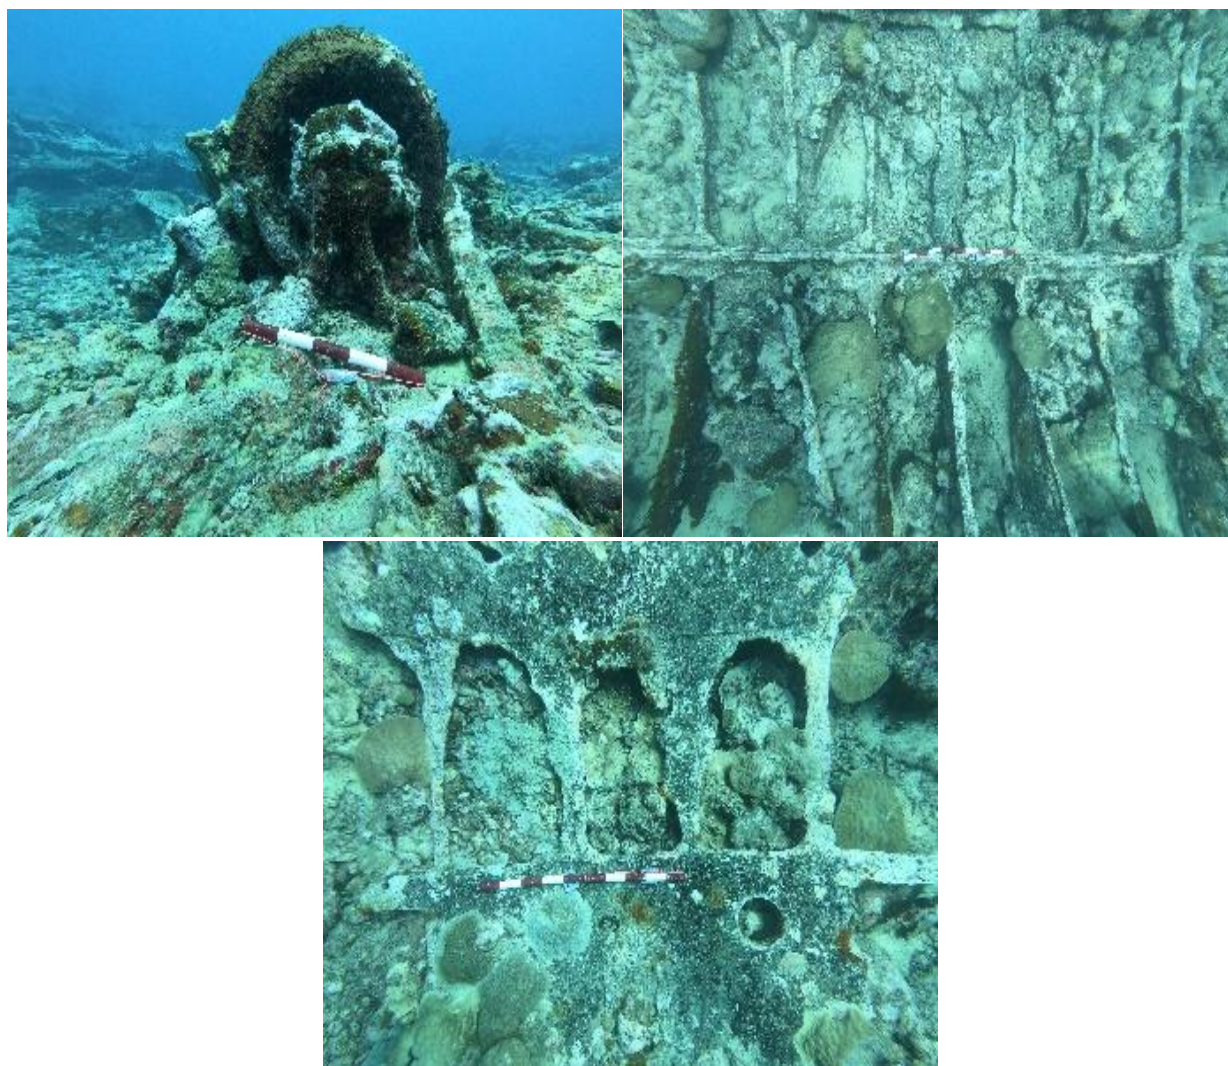
**Figure 3-44** Target 24 Windlass (Top Left), Metal Framing (Top Right), and Exterior Hull Plating with Window Ports (Bottom) (Photos by AECOM)

Divers spent 185 minutes investigating Target 24 within water depths approved for diving, while drop camera footage was collected in depths beyond approved diving limits. Target 24 consisted of several ship construction elements including a Scotch boiler, which dates to the mid-19th to early 20th century, a smokestack, and a mast (Figure 3-43). Other ship construction elements included a windlass, metal framing, and exterior hull sheeting with window ports (Figure 3-44). Various sizes of chains were strewn about the site. Archaeologists noted two anchors, with the smaller one resembling a Rodger-style anchor, which dates to the mid- to late 19th century. The larger anchor had a single fluke and portion of the stock visible and exposed portions resemble an admiralty anchor (Figure 3-45).

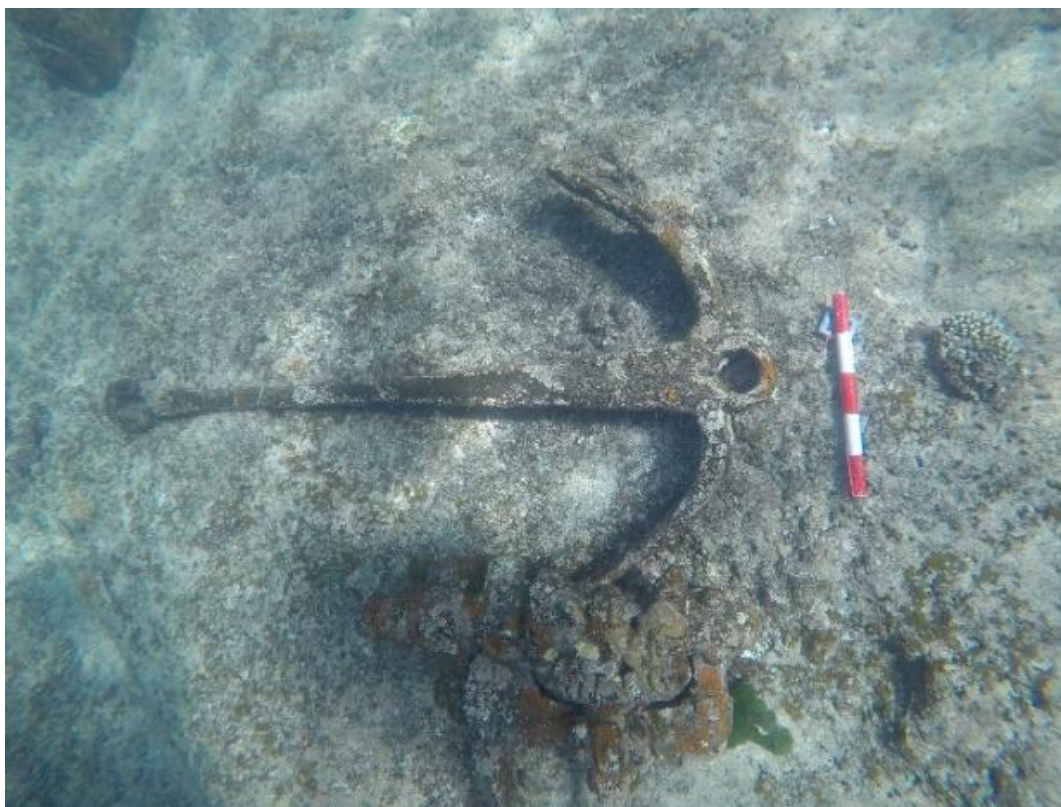
**Figure 3-58     Anchor on Target 26 (Photo by AECOM)**

Target 26 was located near Offshore Mooring (Survey Area 1) in approximately 10 feet (3 meters) of water along the edge of a reef. Target 26 was denoted as kml\_77 in the NOAA ENC shipwreck database as a visible shipwreck, always dry. Target 26 rests along the outer edge of the reef and, while investigating the target, archaeologists noted that during low tide sections of the wreck became exposed. Divers spent 34 minutes investigating Target 26 and identified the source as having elements consistent with late-19th-century to early-20th-century ships with construction features including large machinery, such as an engine and a large windlass (Figure 3-56). Target 26 also consisted of two partially buried propellers, the blades each measuring 2 feet (0.5 meters) long and 1 foot (0.4 meters) wide, and prop shafts (Figure 3-57). Two Rodger- or kedge-Admiralty-style anchors, typical of the 19th century, were located near the propellers (Figure 3-58). Archaeologists observed a large gouge in the seabed that led up to the shipwreck, implying the ship ran into the reef during the wrecking event (Figure 3-59). Observed construction elements such as engine and prop shafts appear to reflect its historic design prior to the wrecking event. Due to heavy amounts of surge and shallow water, the entirety of Target 26 was not observed during diver investigation. Strong surge and waves, as well as tropical weather, may have dispersed the site onto the reef. Based on the observed construction elements, Target 26 is likely a late-19th-century to early-20th-century vessel. Based on observed characteristics and available data, Target 26 may retain the potential to yield significant information about late-19th-century to early-20th-century shipping and site formation processes. It is recommended treating Target 26 as eligible for listing in the NRHP with an avoidance buffer of 328 feet (100 meters) from the defined site extents, pending additional information.

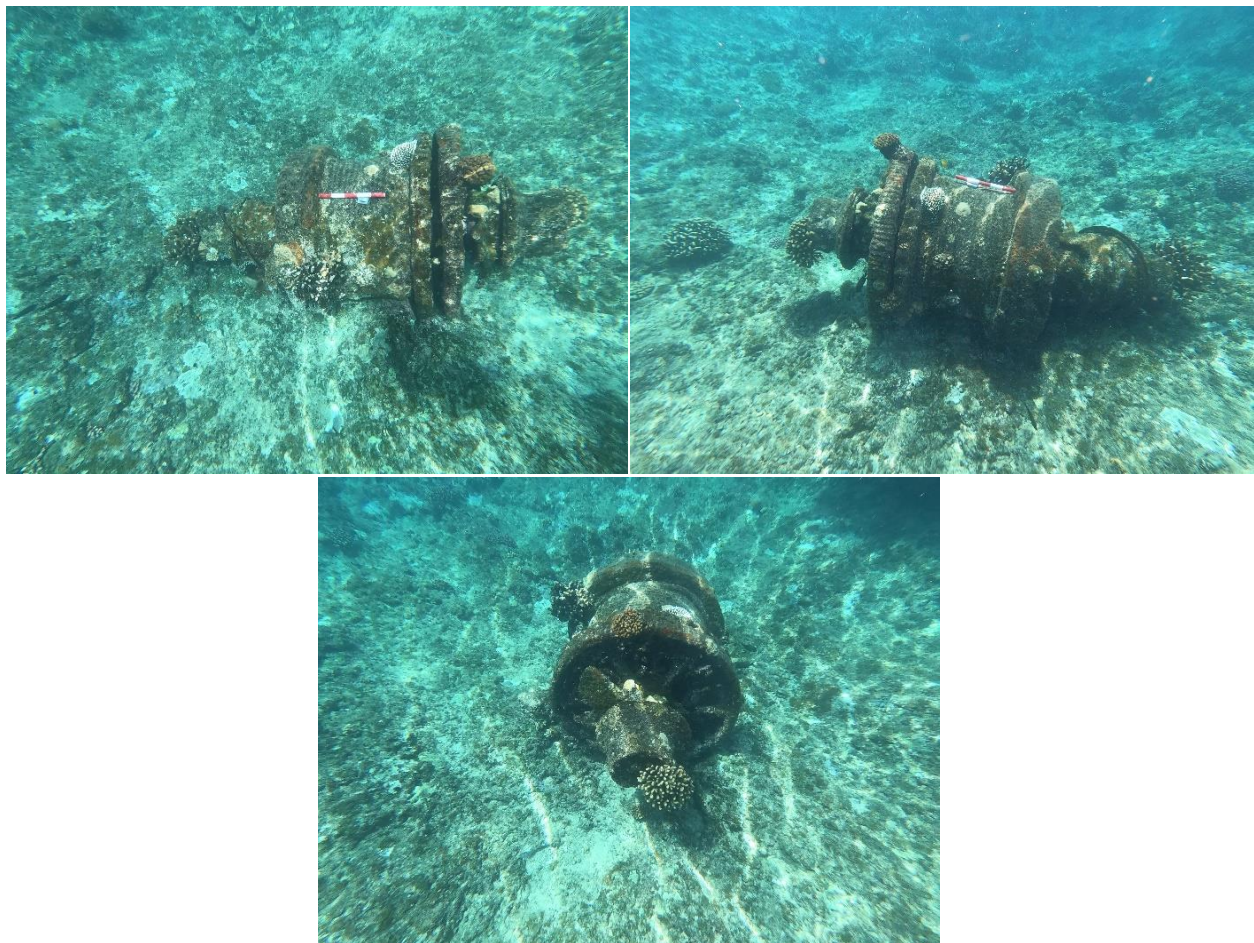
**Figure 3-60 Target 27 (Photos by AECOM)**

Target 27 was located near Tamil Channel Entrance (West) (Survey Area 3) in approximately 10 feet (3 meters) of water near Target 23. Target 27 is an isolated object, measuring 10 feet (3 meters) long and 5 feet (1.5 meters) wide, that resembles a section of a windlass or cargo winch (Figure 3-60). The lack of context and lack of anchor chain suggest that it is not an anchor windlass but could be a windlass or winch used for hauling yards or cargo. The make of the windlass/winch was reminiscent of an early- to mid-20th-century windlass. Target 27 was a probable early- to mid-20th century windlass and may be related to Target 23. It is possible that Target 27 had associated buried material. Based on observed characteristics and available data, Target 27 may be related to Target 23 and, as such, may retain the potential to yield important information regarding maritime shipping and industry practices significant to Yap and the FSM's history. Due to its potential association with Target 23, it is recommended treating Target 27 as eligible for listing in the NRHP pending additional information. Target 27 was encompassed within the recommended avoidance zone of Target 23 and may be related; therefore, an additional avoidance buffer for Target 27 is not currently recommended.

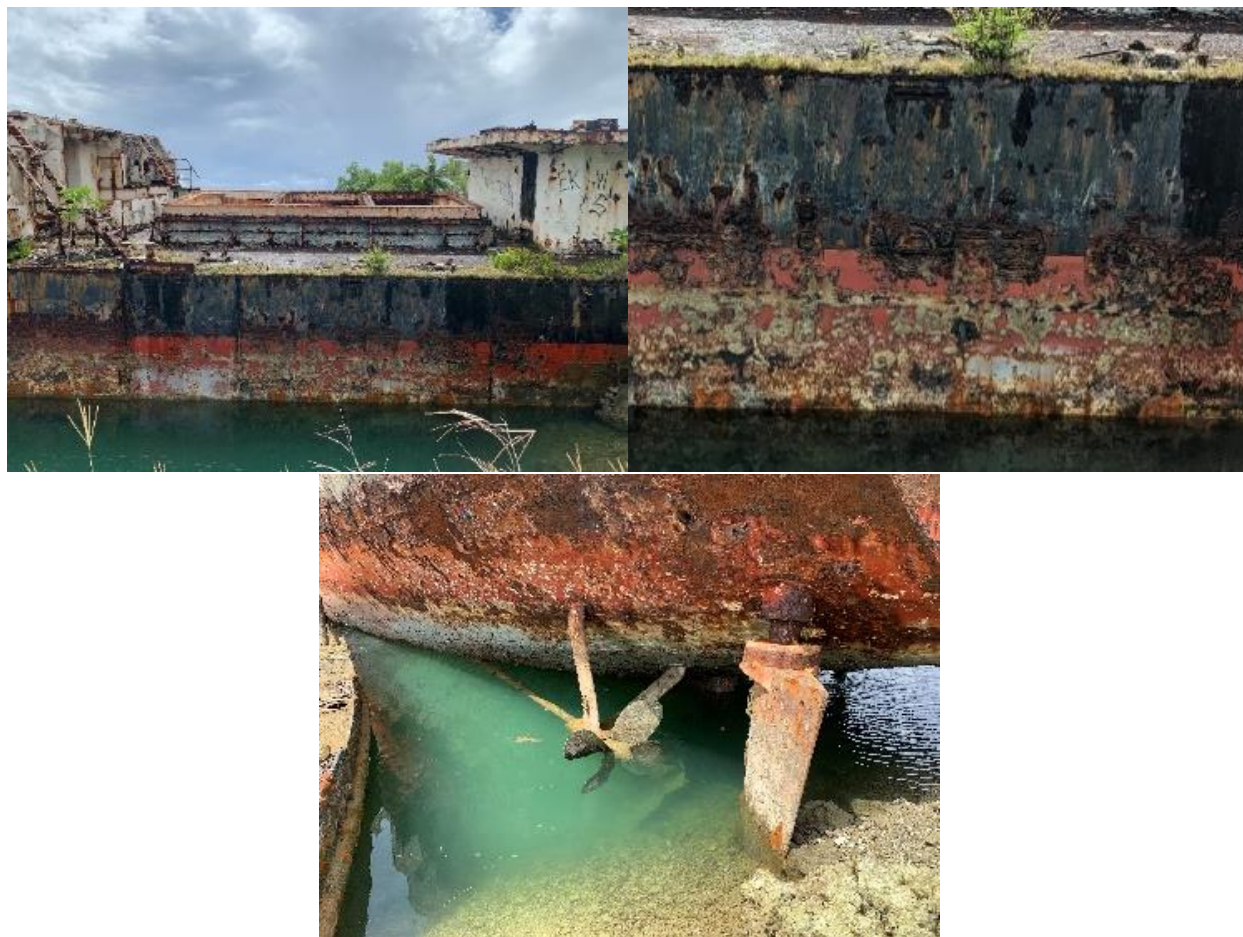
**Figure 3-64** Welded Deck Plating, Plimsoll Mark, Fixed Skeg, and Rudders on Target 01  
(Photo by AECOM)

Target 01 was located in Yap Port (Survey Area 4). Target 01 was first identified via aerial imagery as an unknown contact measuring 184 feet (56 meters) long and 43 feet (10 meters) wide (Figure 3-62). Target 01 first appeared in aerial imagery in 2013, with its upper decks and superstructure intact, but was not visible in 2008 imagery. Archaeologists conducted a pedestrian survey at low tide and with access around a majority of the target. Archaeologist identified Target 01 as a general cargo ship and observed the name *Micro Spirit* and “Yap” across the stern (Figure 3-63). Target 01 contained multiple ship construction elements, including welded deck plating, Plimsoll mark, fixed skeg, and rudders (Figure 3-64). The superstructure was salvaged along with the bulwark, leaving the weather deck and two hatchways (Figure 3-65). The *Micro Spirit* was a general cargo ship built in 1978 by Hashimoto Shipbuilding in Kobe, Japan (ShipSpotting 2010) (Figure 3-66). Owned by the Micronesian Government, *Micro Spirit* served as a cargo and passenger ship for the islands of Micronesia until the late 2000s, when it was abandoned near the Yap Recycling Center and partially salvaged. Figure 3-67 shows the state of the target in 2014 compared to what archaeologists examined in 2023. Based on observed construction elements and research into *Micro Spirit*, Target 01 is a late-20th-century general cargo ship. Based on observed characteristics and available data, Target 01 has been substantially altered and no longer retains integrity as it relates to its original use. Additionally, Hashimoto Shipbuilding built other similar vessels, such as the *Micro Chief*, some of which are still afloat (BalticShipping.com 2023). It is recommended that Target 01 is not eligible for listing in the NRHP.

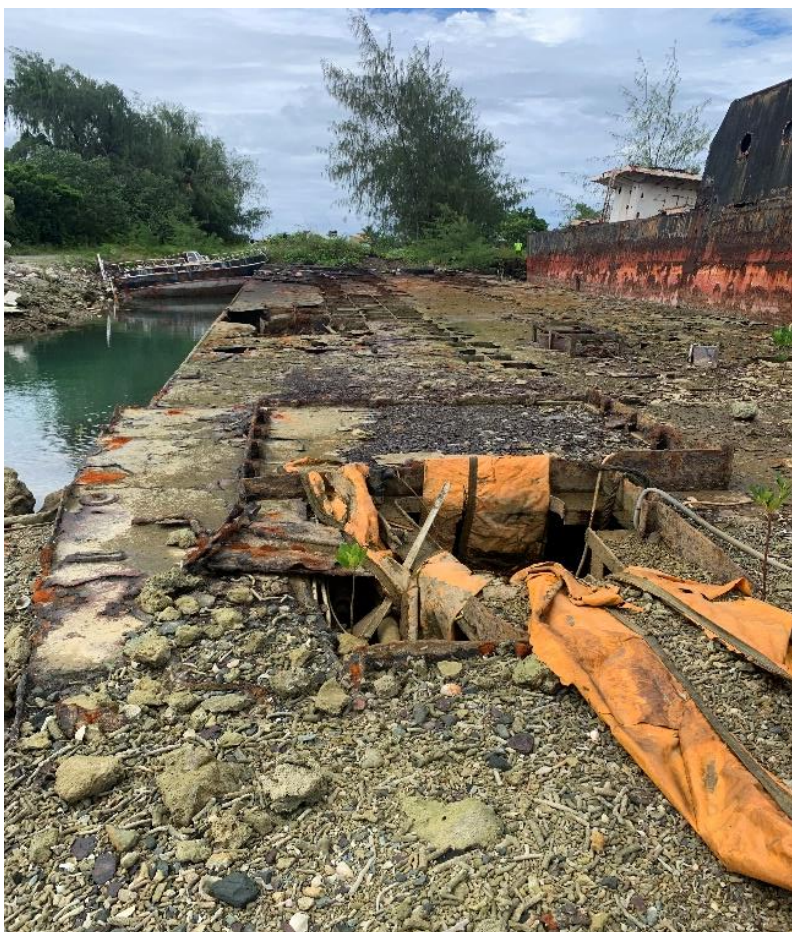
**Figure 3-70 Evidence of Superstructure and Construction Elements of Target 02 (Photo by AECOM)**

Target 02 was located in Yap Port (Survey Area 4). Target 02 was first identified partially exposed in aerial imagery as an unknown contact measuring 175 feet (53 meters) long and 37 feet (11 meters) wide (Figure 3-68). Target 02 first appeared on aerial imagery in 2013 but is not visible in 2008 aerial imagery (Figure 3-69). Archaeologists conducted a pedestrian survey at low tide and with access around a majority of the target. Archaeologists identified Target 02 as a rectangular barge and observed multiple ship construction elements, including welded deck plating, Plimsoll mark, rub rails, and iron I-beam support/framing (Figure 3-70). Target 02 was partially salvaged, with evidence that a superstructure in the aft section once existed. A partial nameplate remained visible on the stern with, “ANIL\_A\_” legible (Figure 3-71). Attempts to identify the vessel in ship registries were unsuccessful; however, observed construction elements are consistent with late-20th-century, open-ocean barge construction methodologies. Large structural cracks observed along the hull and its location near other identified vessels imply Target 02 was likely pulled ashore to facilitate the salvage/scrapping process. Based on observed construction elements and vessel size, Target 02 was likely an ocean-going barge. Based on observed characteristics and available data, Target 02 has been substantially salvaged and no longer retains integrity as it relates to its original use. Additionally, the presence of construction materials such as PVC piping and rubberized electrical coating suggest a recent construction date. Target 02 is recommended as not eligible for listing in the NRHP.

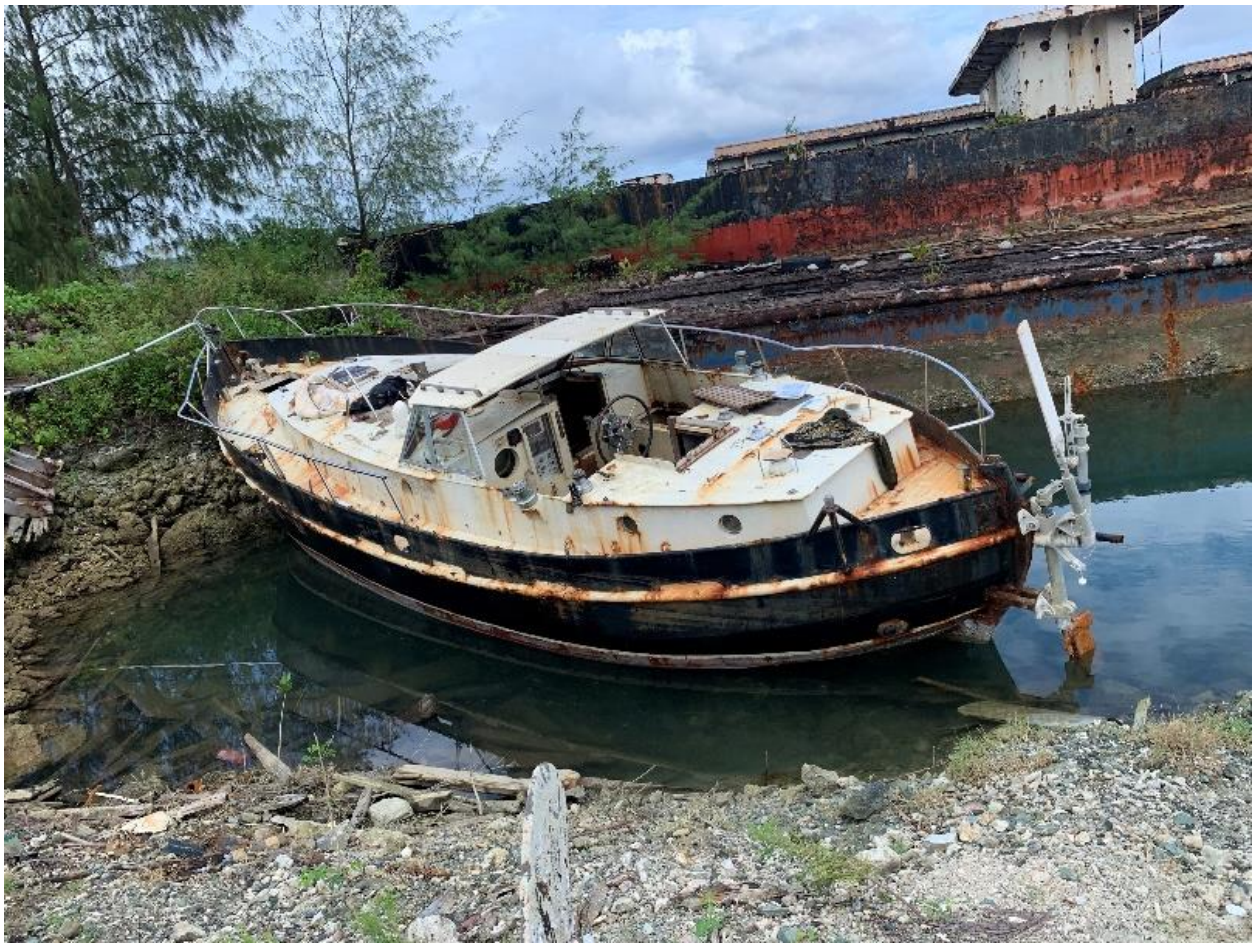
**Figure 3-72 Target 03 (Photo by AECOM)**

Target 03 was located in Yap Port (Survey Area 4) (Figure 3-72). Target 03 did not appear in the aerial imagery from 2022 (Figure 3-73). Archaeologists conducted a pedestrian survey at low tide and with access around a majority of the target. Archaeologists identified Target 03 as a small metal sailing yacht, relatively intact with a tiller and rudder mounted to the stern, electronics, aluminum railing, and rubber gasketing and scuppers. While the target appeared relatively intact, it is unclear whether the target is afloat at high tide or permanently rests on the ground. Target 03 was partially salvaged with evidence that a mast once existed. No evidence of a name or make and model of Target 03 could be discerned. Attempts to identify the vessel in ship registries were unsuccessful; however, the observed construction elements are consistent with late-20th-century recreational sailboat construction methodologies and contains electronics likely dating to the early 2000s. Based on observed characteristics and available data, Target 03 is a personal watercraft of recent construction, of which numerous examples are still afloat. Target 03 is recommended as not eligible for listing in the NRHP.

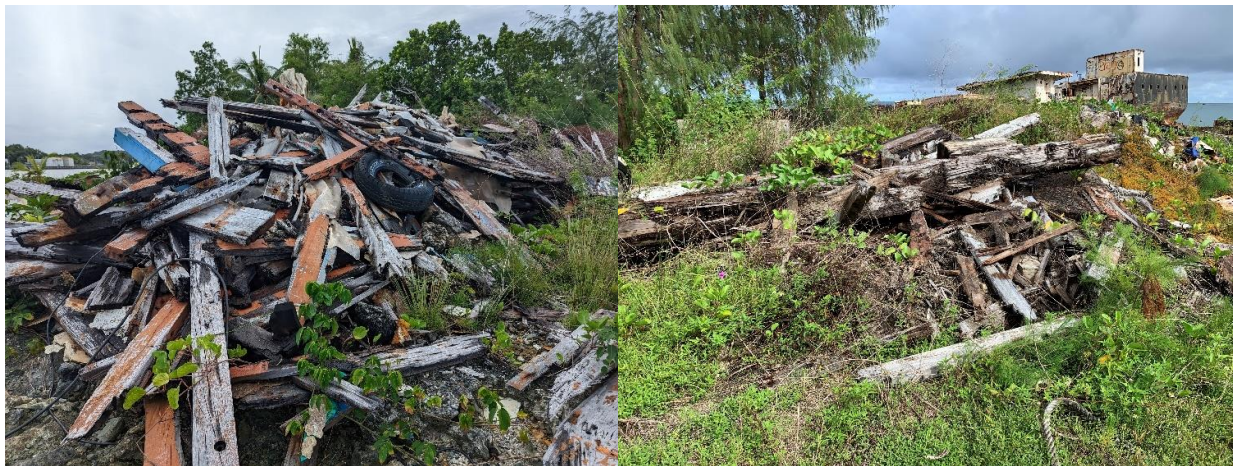
**Figure 3-74 Target 04 (Photos by AECOM)**

Target 04 was located in Yap Port (Survey Area 4) (Figure 3-74). Target 04 was scattered in approximately four locations and was visible in aerial imagery as an unknown contact encompassing an area of about 130 feet by 50 feet (40 meters by 15 meters). Target 04 first appeared on aerial imagery in 2022 but was not visible in 2019 aerial imagery; however, in the 2019 aerals, within the vicinity of the Target 04 remains are two beached vessels (Figure 3-75 and Figure 3-76). These vessels first appeared in the aerial imagery from 2018 but not in 2017. It is possible these two vessels may be the intact vessels for Targets 04 and 05. Archaeologists conducted a pedestrian survey at low tide and with access around a majority of the target. Archaeologists identified Target 04 as the disarticulated remains of a wooden vessel. Target 04 is single-framed, with 2-inch (5-centimeter) outer hull planking. The frames were 3.5 inches (9 centimeters) wide and between 10 inches and 10.5 inches (25 centimeters and 26.7 centimeters) apart (Figure 3-77). Target 04 also has evidence of heavy fastening using both wooden treenails and iron bolts (Figure 3-78). Archaeologists identified a distinguishable keelson and rudder-like timbers in the largest pile. Archaeologists also identified an engine, prop shaft, and propeller with cloth or fibrous matting or pay between the wood timbers (Figure 3-79). An additional engine, prop shaft, and propeller sits at the edge the adjacent forest. Archaeologists could not confirm a relationship between the engine/propeller and the main timber piles during the investigation. Observed construction elements are consistent with early-20th-century shipbuilding techniques; however, due to Micronesia's remoteness and a potential lack of access to large iron bolts, the use of treenails as a common material may be more commonplace in more recent ship construction activities. The modern engine, prop, and shaft suggested that Target 04 may have been retrofitted to update the propulsion capabilities of the vessel. Based on observed construction elements, Target 04 was possibly a mid- to late-20th-century wooden vessel retrofitted with a modern engine, propeller, prop, and shaft. Although identified ship elements can be seen within the disarticulated remains, the site lacks integrity for design, setting, workmanship, feeling, and association and, therefore, is not likely to yield important information. Target 04 is recommended as not eligible for listing in the NRHP.

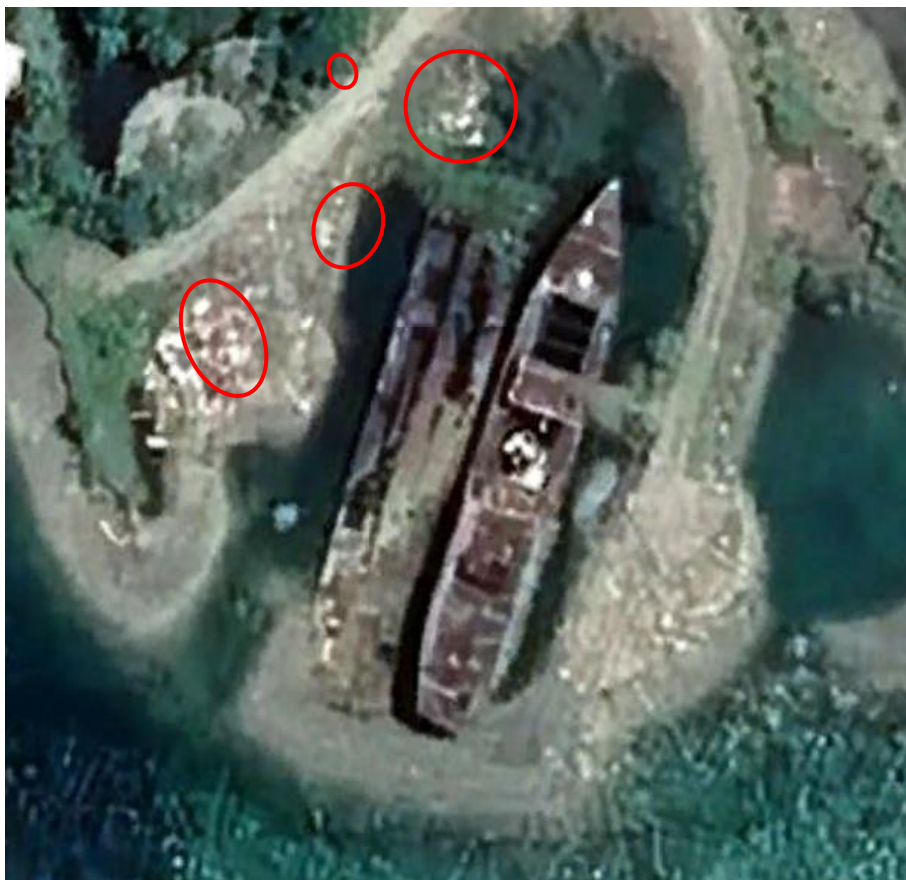
**Figure 3-75     Aerial Imagery of Target 04 (Google Earth)**
