# Final Field Report for Baseline Cultural Resources Surveys for the Sea Port in Yap, Federated States of Micronesia

Naval Facilities Engineering Systems Command, Pacific

Cardno GS – AECOM Pacific Joint Venture

October 2023

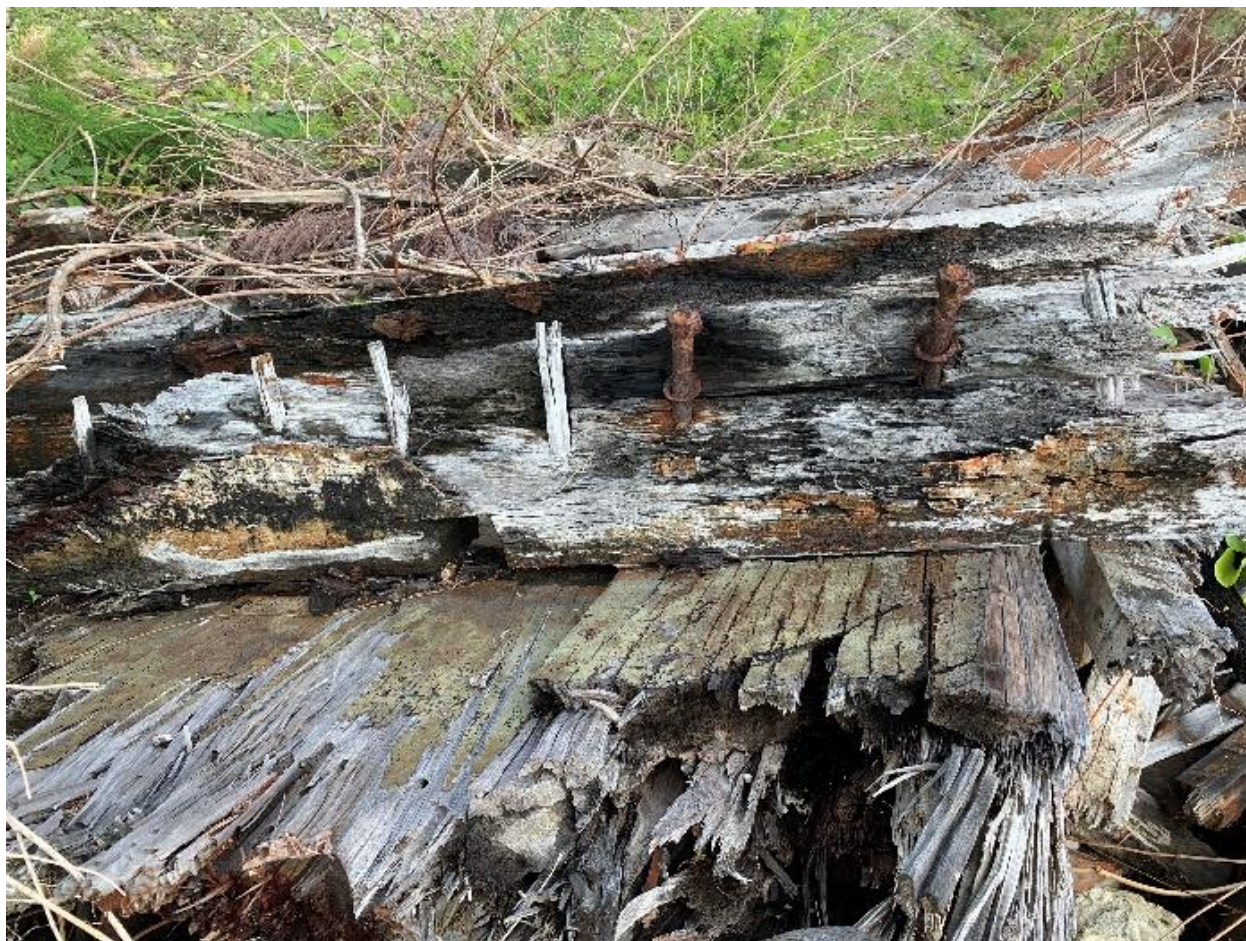
**Figure 3-78    Treenails and Iron Bolts (Photo by AECOM)**

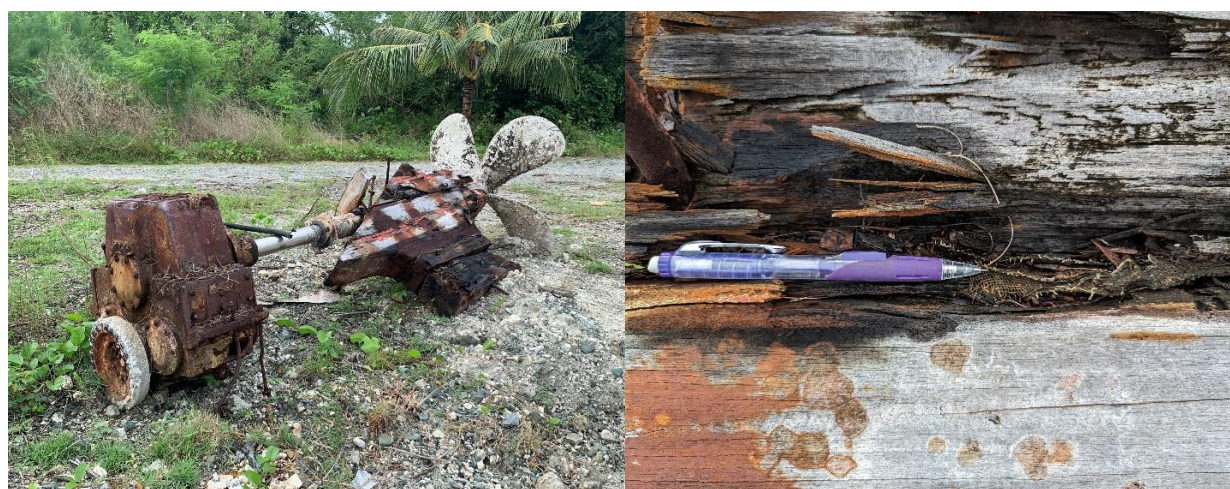
**Figure 3-79    Engine, Propeller, Prop and Shaft, and Fiber Insulation on Target 04  
(Photos by AECOM)**

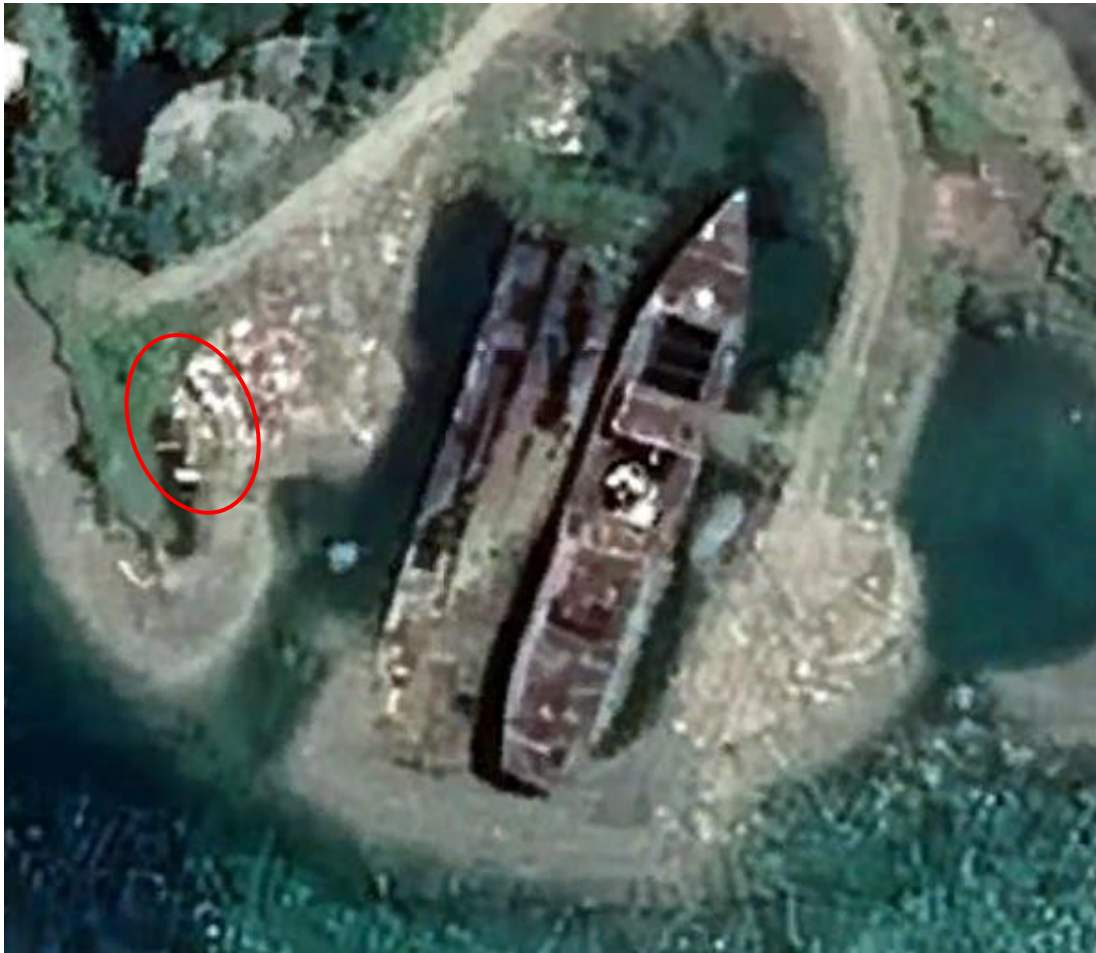
Target 05 was located in Yap Port (Survey Area 4) (Figure 3-80). Target 05 was identified as exposed in aerial imagery as an unknown contact measuring roughly 35 feet (10 meters) long and 3 feet (9 meters) wide. Target 05 first appeared on aerial imagery in 2022 but was not visible in 2019 aerial imagery; however, in the 2019 aerals, within the vicinity of the Target 05 remains are two beached vessels (Figure 3-80). These vessels first appeared in the aerals from 2018 but not in 2017. It is possible these two vessels are the intact vessels for Targets 04 and 05. Archaeologists conducted a pedestrian survey at low tide and with access around a majority of the target. Archaeologists identified Target 05 as the disarticulated remnants of a fiberglass boat in pieces within the same scrap pile as the main structure of Target 04 (Figure 3-81). A potential relationship with Target 04 was not established during the investigation; however, observed construction elements are consistent with features of a late-20th-century fiberglass boat. Based on observed construction materials, Target 05 was likely the remains of a modern fiberglass boat with an unknown relationship to Target 04. Target 05 is a modern fiberglass vessel that lacks integrity and, therefore, is not likely to yield important information. Target 05 is recommended as not eligible for listing in the NRHP.

**Figure 3-80     Aerial Imagery of Target 05 (Google Earth)**

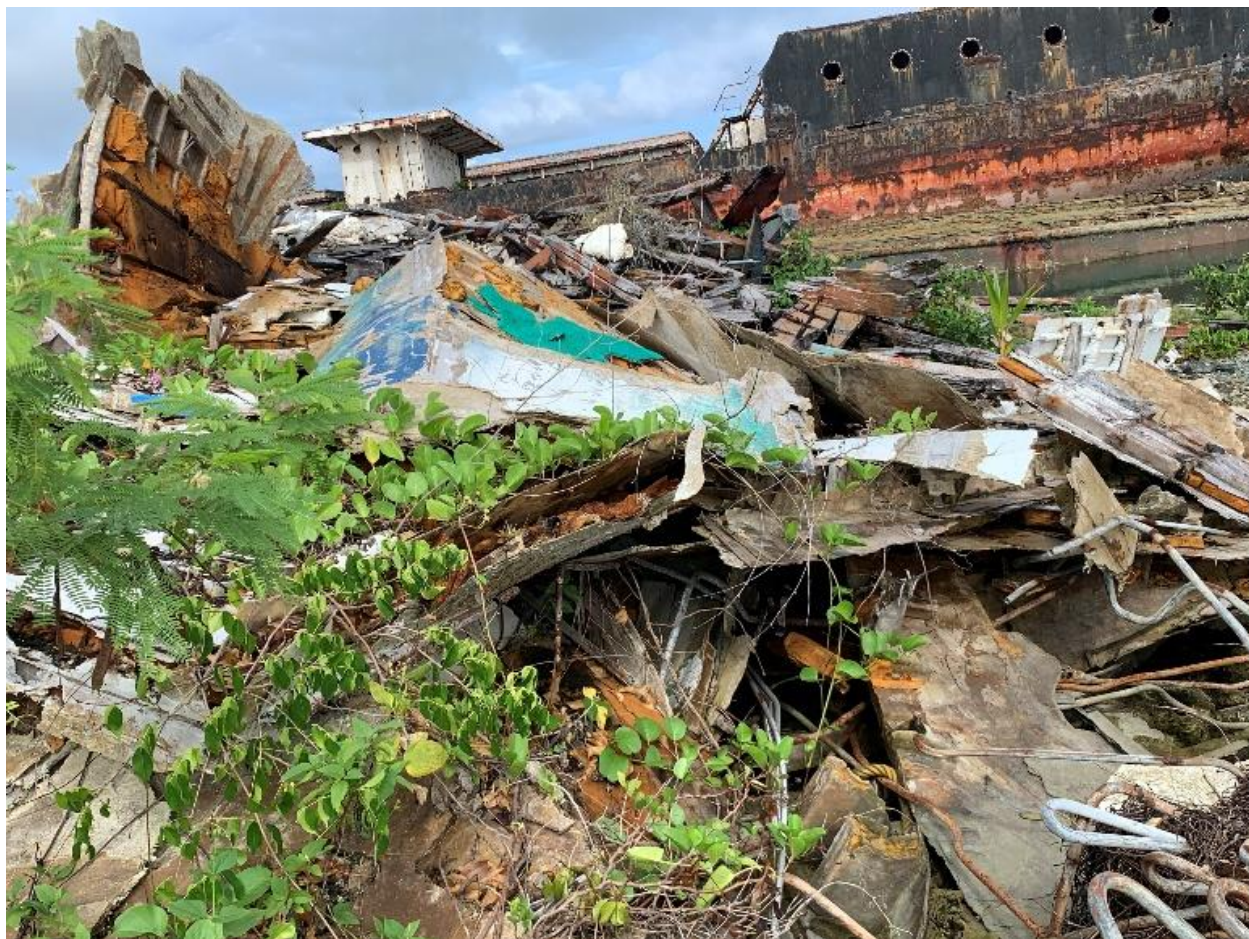
**Figure 3-81     Target 05 (Photo by AECOM)**

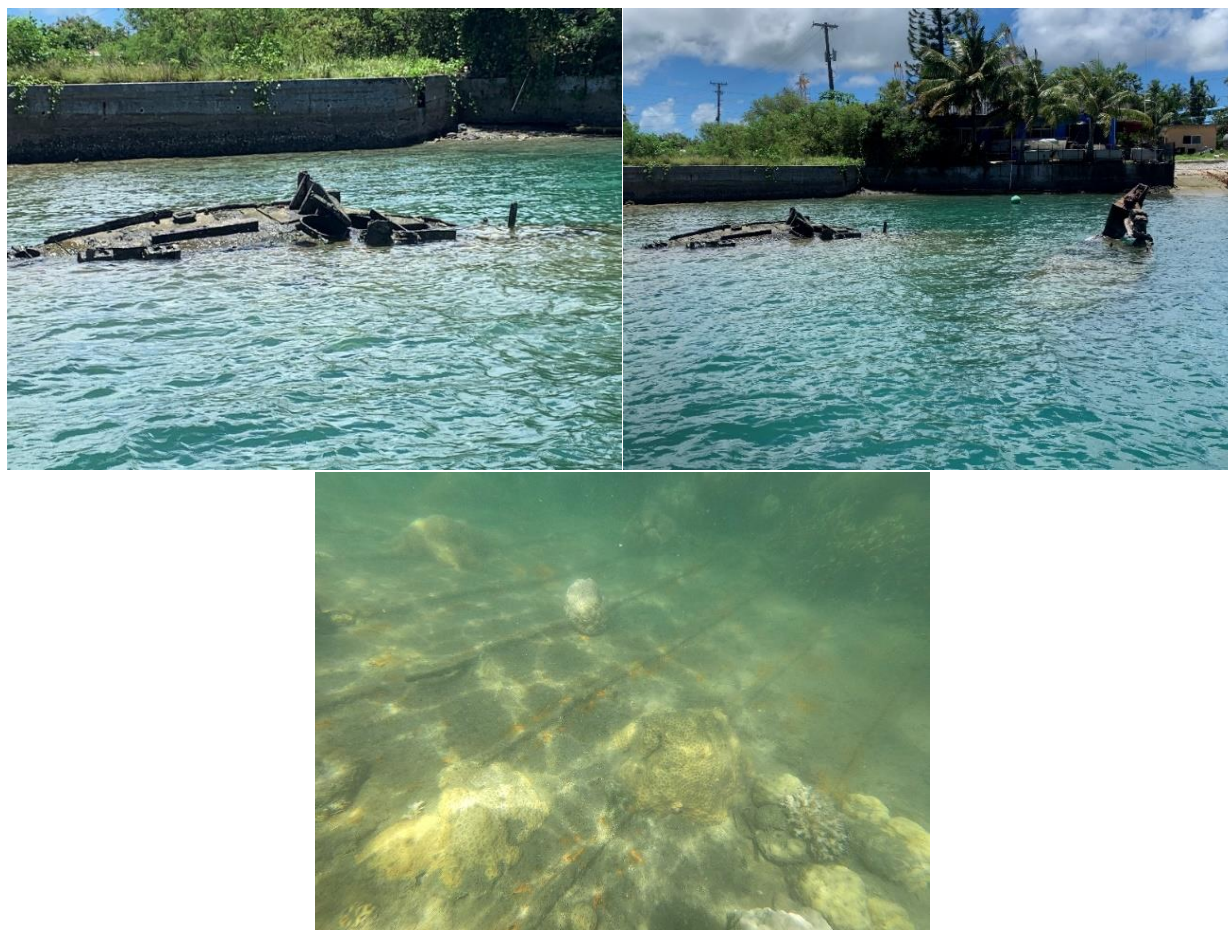
Target 07 consisted of Acoustic Contact S020, which was located in Yap Port (Survey Area 4) in approximately 15 feet (4.6 meters) of water. Target 07, which was 105 feet (32 meters) long and 26 feet (8 meters) wide, was situated just north and adjacent to a boat ramp, lying parallel against the sea wall (Figure 3-84). While investigating Target 07, archaeologists noted that the target was completely submerged during high tide but became substantially exposed during low tide (Figure 3-85). Divers spent 34 minutes investigating Target 07 and identified the source as a cargo shipwreck with mid- to late-20th-century features such as an anchoring system, iron deck plating, hatches, and welded metal deck planking (Figure 3-85). Substantial marine growth obscured details including names or other potential identification markers; however, observed construction elements are consistent with mid- to late-20th-century ship construction methodologies. Based on observed construction elements and vessel size, Target 07 was likely a cargo ship. Based on observed characteristics and available data, Target 07 may retain the potential to yield important information regarding maritime shipping and industry practices significant to Yap and the FSM's history. It is recommended treating Target 07 as eligible for listing in the NRHP with an avoidance buffer of 164 feet (50 meters) from the defined site extents, pending additional information.

**Figure 3-85      Target 07 Ship Construction Elements (Photos by AECOM)**

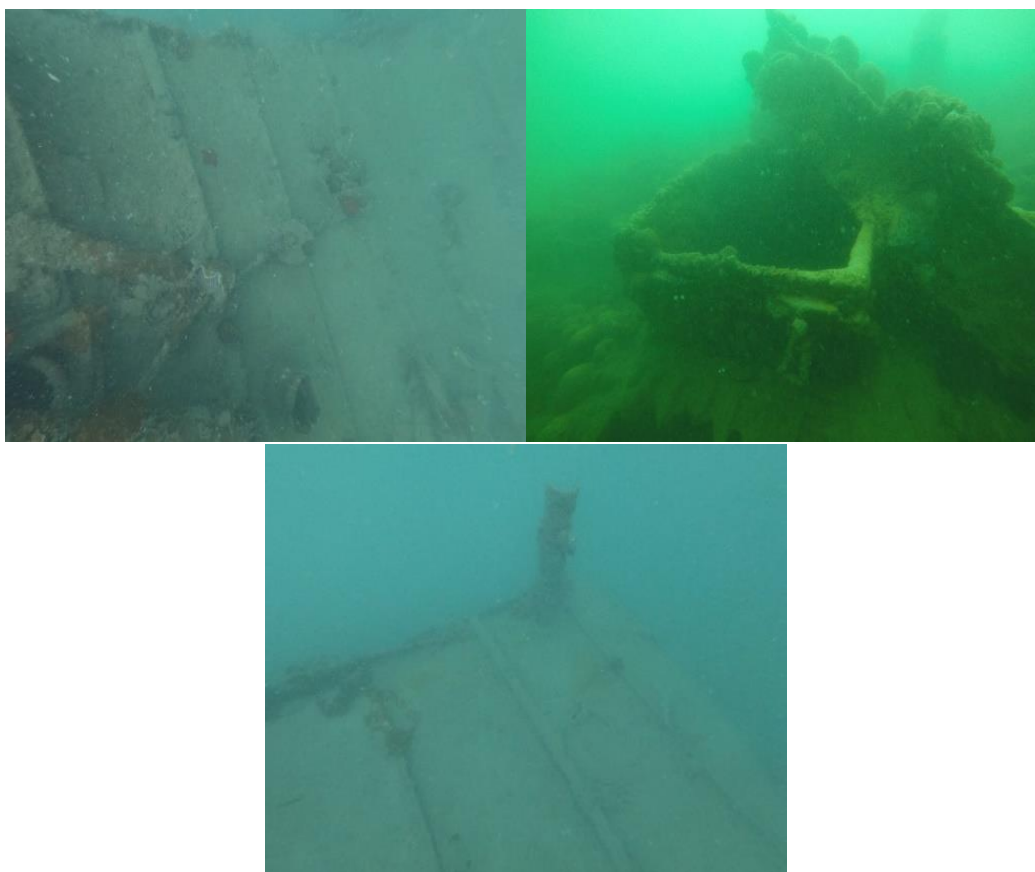
Target 13 consisted of Acoustic Contact S023 and was located in Yap Port (Survey Area 4) in approximately 45 feet (14 meters) of water (Figure 3-89). Navy Seabee MBES data denotes Target 13 as a wreck, measuring 79 feet (24 meters) long and 20 feet (6 meters) wide (Figure 3-90). Divers spent 34 minutes investigating Target 13 and identified the source as a barge or work craft, observing multiple ship construction elements including welded deck plating, open hatches, mooring bitts, and a 55-gallon drum (Figure 3-91 and Figure 3-92). Archaeologists also noted an unidentified anchor, similar to a kedge Admiralty-style anchor, hanging off the vessel (Figure 3-93). Substantial marine growth obscured details including names or other potential identification markers; however, observed construction elements are consistent with mid- to late-20th-century shipbuilding techniques. Based on observed construction elements and vessel size, Target 13 is likely a barge or work craft. Based on observed characteristics and available data, Target 13 may retain the potential to yield important information regarding maritime shipping and industry practices significant to Yap and the FSM's history. It is recommended treating Target 13 as eligible for listing in the NRHP with an avoidance buffer of 164 feet (50 meters) from the defined site extents, pending additional information.

**Figure 3-91 Welded Decking and Open Hatch of Target 13 (Photos by AECOM)**

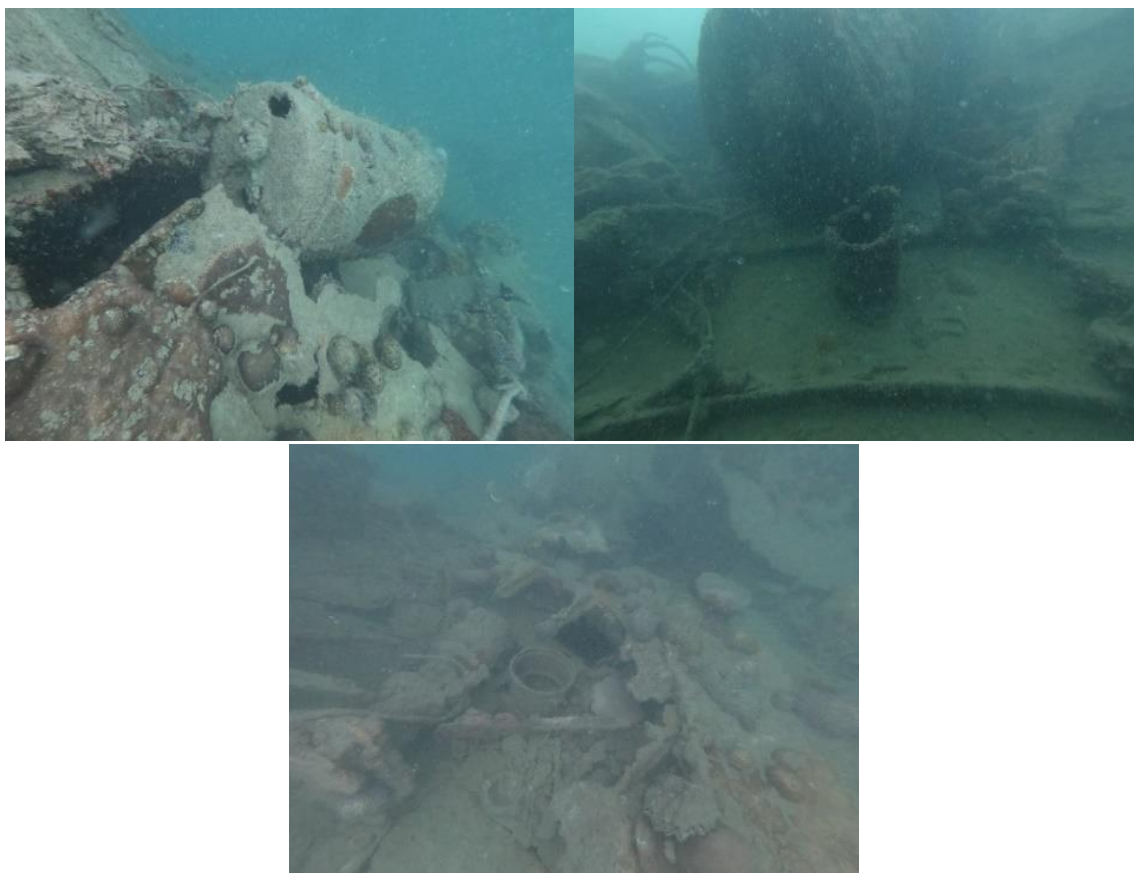
**Figure 3-92** 55-Gallon Drum and Other Features of Target 13 (Photos by AECOM)

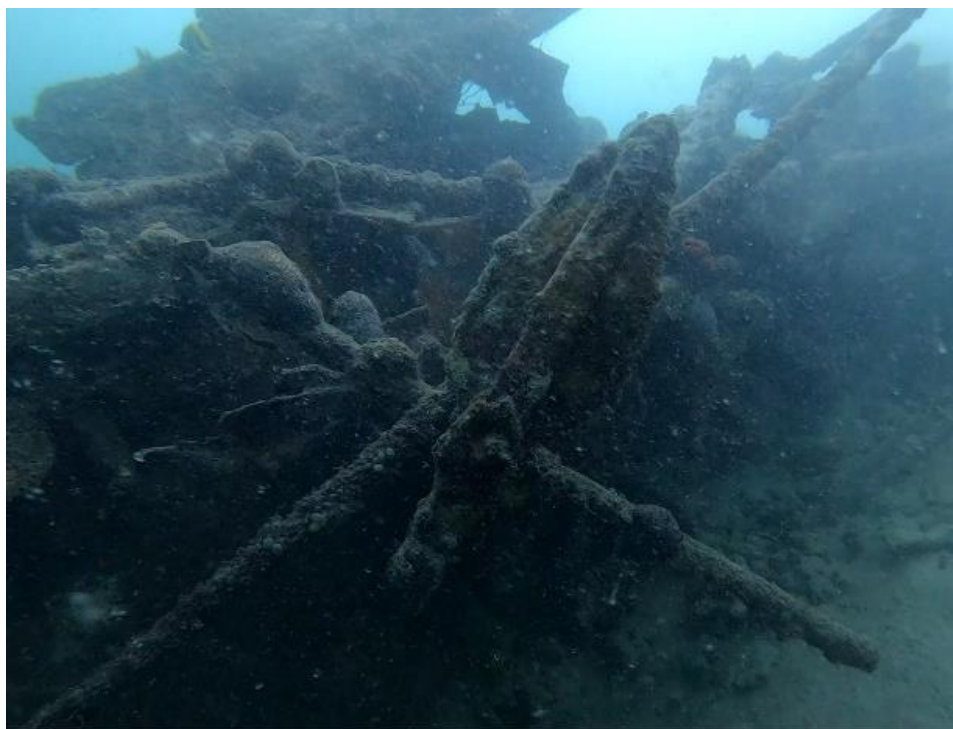
**Figure 3-93** Unidentified Anchor on Target 13 (Photo by AECOM)

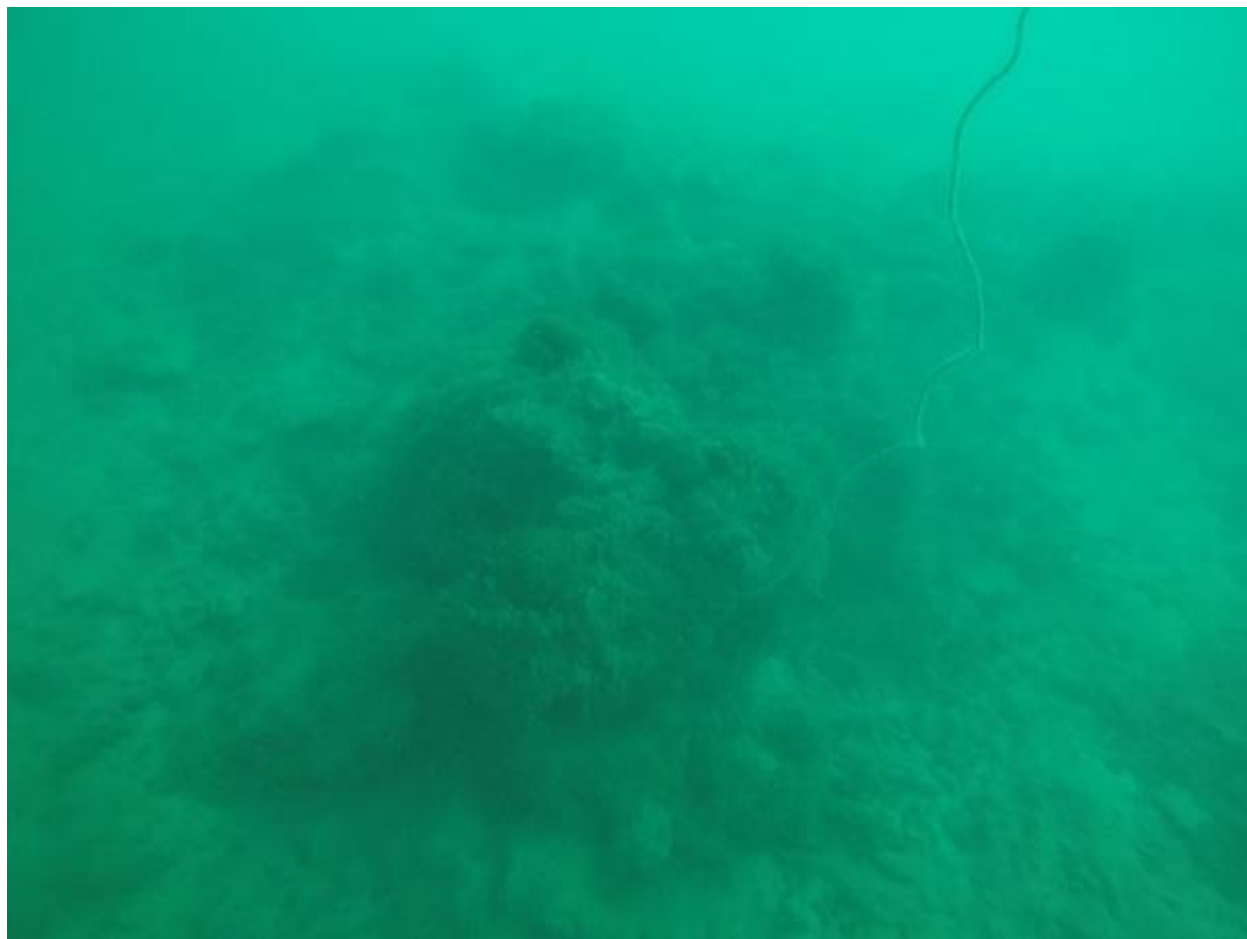
Target 18 consisted of Acoustic Contact S025 and was located in Yap Port (Survey Area 4) in approximately 40 feet (12 meters) of water (Figure 3-94). Contact S025 was an unknown contact measuring 35 feet (10 meters) long and 16 feet (5 meters) wide. Divers spent 20 minutes investigating Target 18 and identified the source as a ridge of rocks/coral reef with substantial relief (Figure 3-95). The rock/coral reef was long and linear, which is consistent with recorded sonar imagery. The source of Target 18 was a natural rock/coral ridge, a non-anthropogenic object.

**Figure 3-95    Target 18 (Photo by AECOM)**

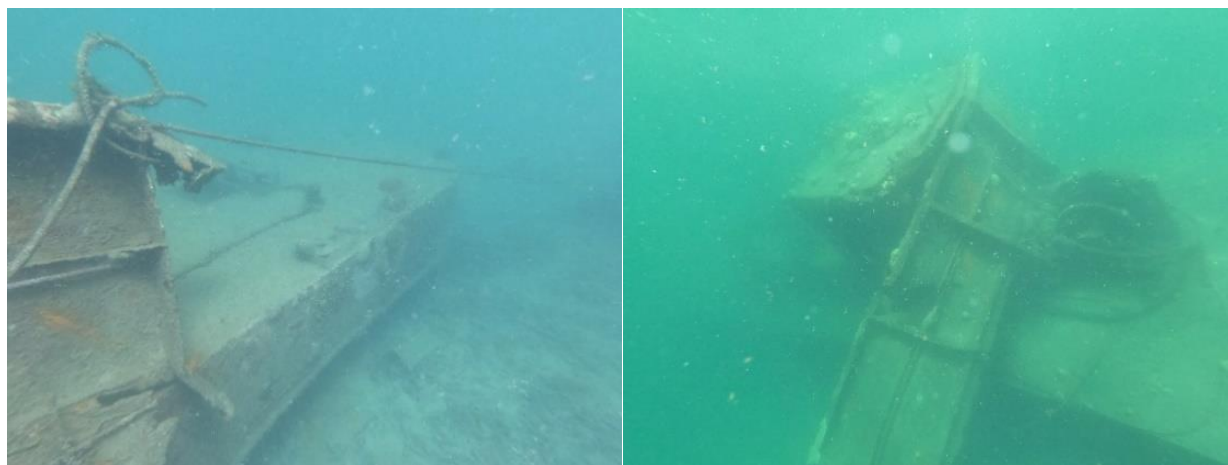
Target 25 consisted of Acoustic Contact S002 and was located near Yap Port (Survey Area 4) in approximately 47 feet (14 meters) of water. Navy Seabee MBES data designates the target as a wreck, measuring 43 feet (13 meters) long and 16 feet (5 meters) wide (Figure 3-97). Divers spent 139 minutes investigating Target 25 and identified the source as a towboat or work boat, with a portion of an old sea wall wrapped around the cabin and still attached to shore via a line (Figure 3-98). Archaeologists observed a large bollard or mooring bitt that was uprooted from the aft metal deck plating (Figure 3-99). The mooring bitt was pointed toward a large towing winch (Figure 3-100). It is probable that the uprooted mooring bitt was caused by what the winch was towing. Other construction elements observed included several hatches, an engine room, machinery in the cabin, access holes, H-bits, and rub rails off the stern and stern (Figure 3-101). Several cables and dock lines were tied and strewn about the target. Roughly 30 feet (10 meters) from Target 25 was a section of metal sheeting that may have also been associated with a nearby seawall. Based on the observed construction elements, Target 25 was likely a mid- to late-20th-century towboat or similar work boat. Based on observed characteristics and available data, Target 25 may retain the potential to yield important information regarding maritime shipping and industry practices significant to Yap and the FSM's history. It is recommended treating Target 25 as eligible for listing in the NRHP with an avoidance buffer of 164 feet (50 meters) from the defined site extents, pending additional information.

**Figure 3-98 Target 25 with Sea Wall Wrapped Around and Attached to Shore by a Mooring Line (Photo by AECOM)**

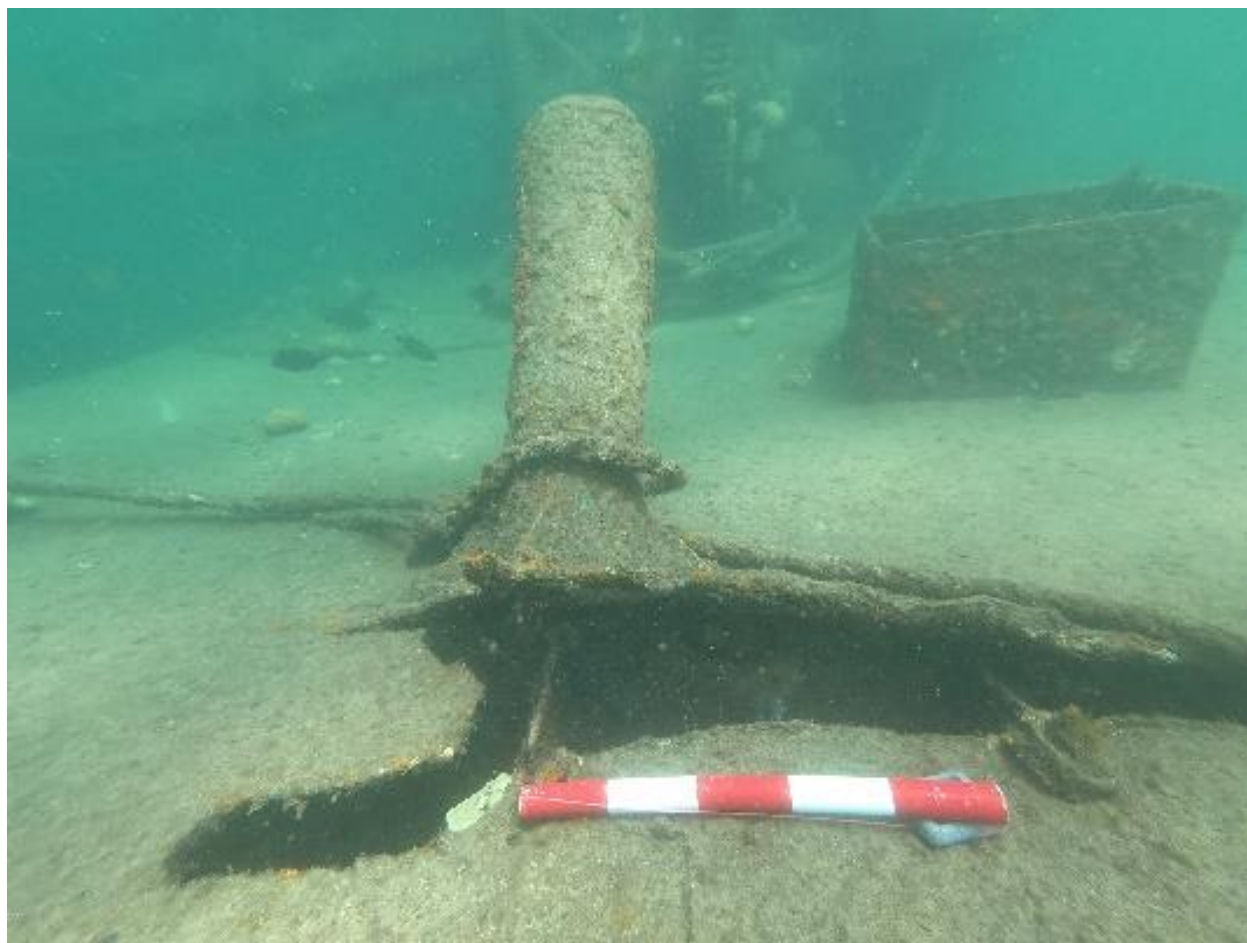
**Figure 3-99 Mooring Bitt Unrooted Towards Towing Winch (Photo by AECOM)**

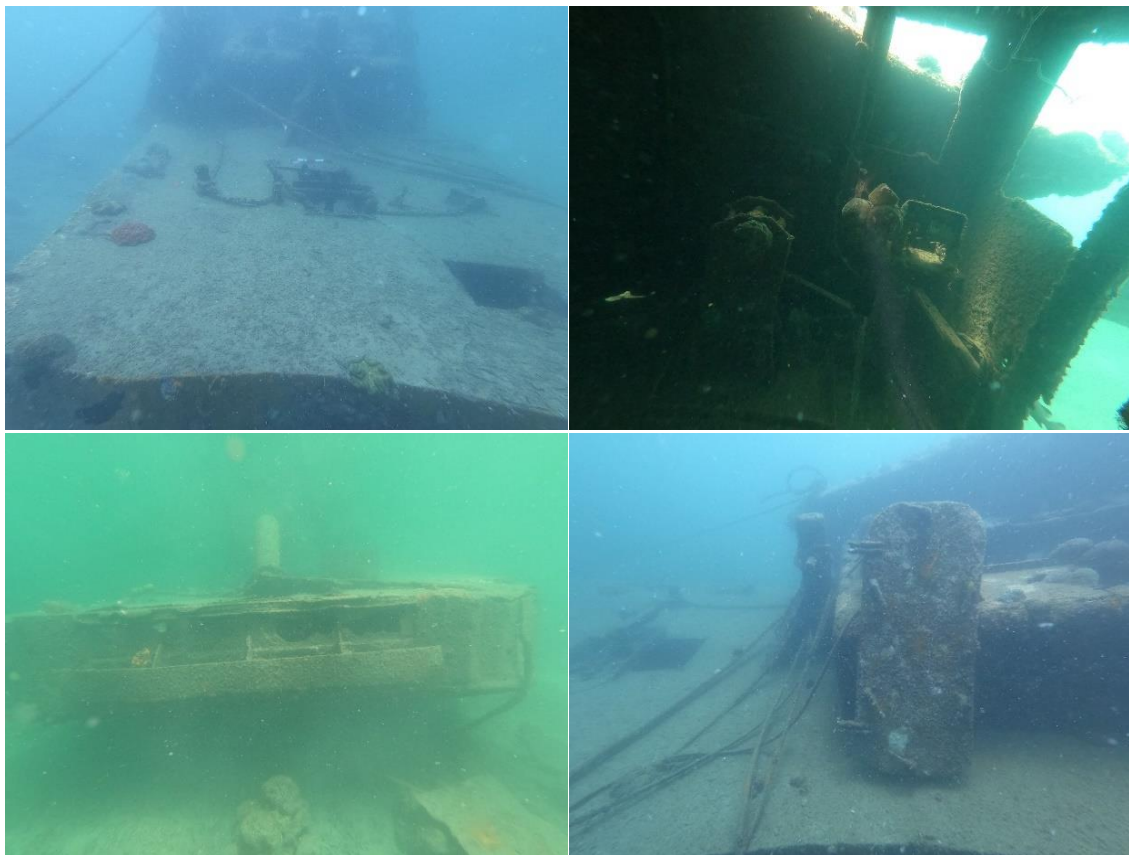
**Figure 3-101 Hatch (Top Left), Machinery in Cabin (Top Right), Rub Rail (Bottom Left), and Dock Line (Bottom Right) on Target 25 (Photos by AECOM)**

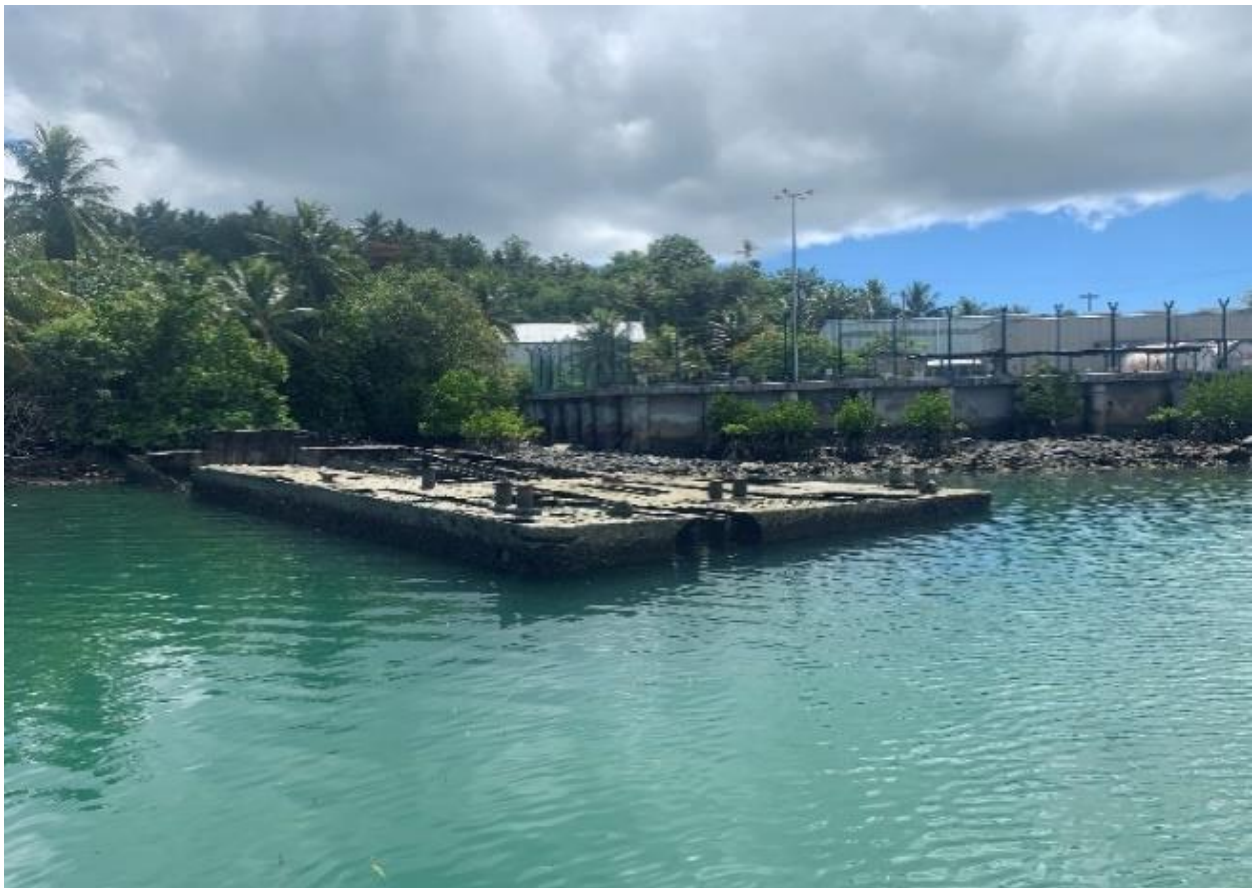
Target 15 was located in Yap Port–Southwest (Survey Area 5) (Figure 3-103). Divers identified Target 15 partially exposed in aerial imagery as an unknown contact measuring 130 feet (40 meters) long and 35 feet (10 meters) wide (Figure 3-104). Aerial imagery from 2005 depicted Target 15 and corresponded with shipwreck locations identified on a 1981 U.S. Geological Survey (USGS 1981). Archaeologists identified Target 15 as a rectangular barge and observed multiple ship construction elements, including welded deck plating, iron transverse hold frames, and iron I-beam support/framing (Figure 3-105). Other notable construction elements included mooring bitts, large cleats, and two toeing pad eyes. A name or other identifying markings were not observed; however, observed construction elements were consistent with those of mid- to late-20th-century barges. Based on observed construction elements and vessel size, Target 15 was likely an ocean-going barge. Based on observed characteristics and available data, Target 15 may retain the potential to yield important information regarding maritime shipping and industry practices significant to Yap and the FSM's history. It is recommended treating Target 15 as eligible for listing in the NRHP with an avoidance buffer of 164 feet (50 meters) from the defined site extents, pending additional information.

**Figure 3-103 Target 15 (Photo by AECOM)**

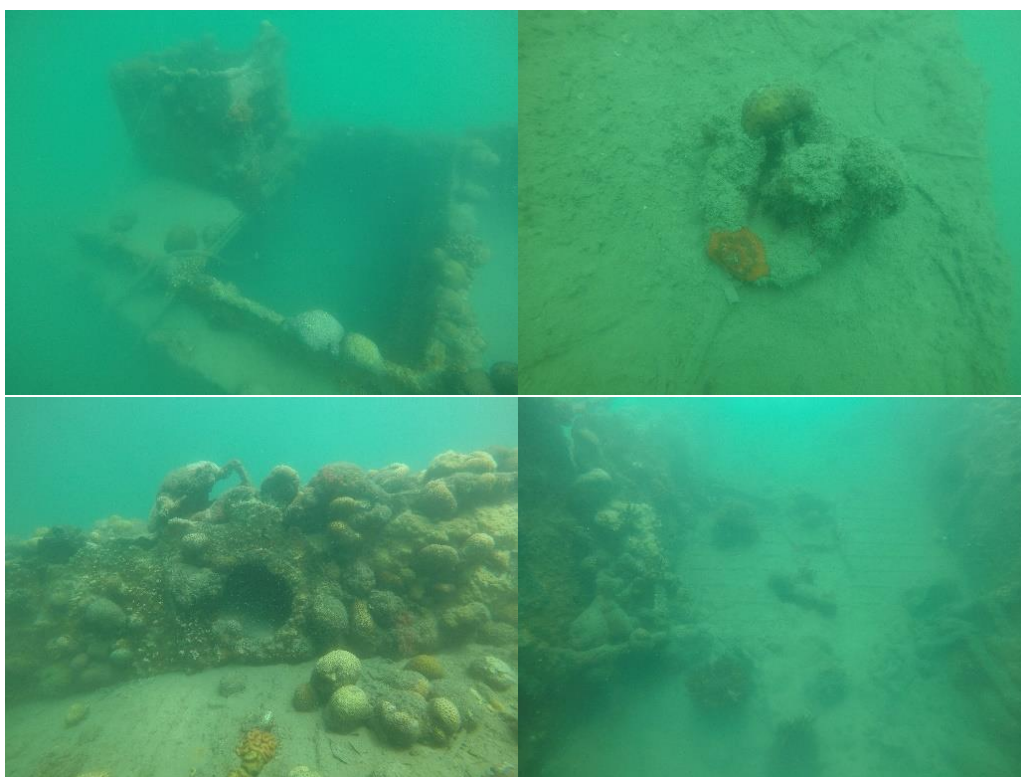
Target 16 consisted of Acoustic Contact S028 and was located in Yap Port–Southwest (Survey Area 5) in approximately 33 feet (10 meters) of water (Figure 3-106). Navy Seabee MBES data designated Target 16 as a wreck, measuring 46 feet (14 meters) long and 20 feet (6 meters) wide (Figure 3-107). Target 16 sat parallel to a seawall in the harbor. Divers spent 92 minutes investigating Target 16 and identified the source as a landing craft or similarly styled cargo transport. Archaeologists observed several features including the pilot house, cargo tie rings, access holes to wing tanks, and corrugated flooring (Figure 3-108). The deck plating near the pilot house was missing, exposing the engine room and engine parts (Figure 3-109). The ramp was detached and laying on the sea bottom, partially buried (Figure 3-110). Substantial marine growth obscured details along the interior and exterior sides of the landing craft. Based on observed construction features, Target 16 was likely a landing craft. Based on observed characteristics and available data, Target 16 may have the potential to yield significant information about World War II activities on Yap. It is recommended treating Target 16 as eligible for listing in the NRHP with an avoidance buffer of 164 feet (50 meters) from the defined site extents, pending additional information.

**Figure 3-108 Pilot House (Top Left), Cargo Tie Rings (Top Right), Access Holes to Wing Tanks (Bottom Left), and Corrugated Flooring (Bottom Right) on Target 16 (Photos by AECOM)**

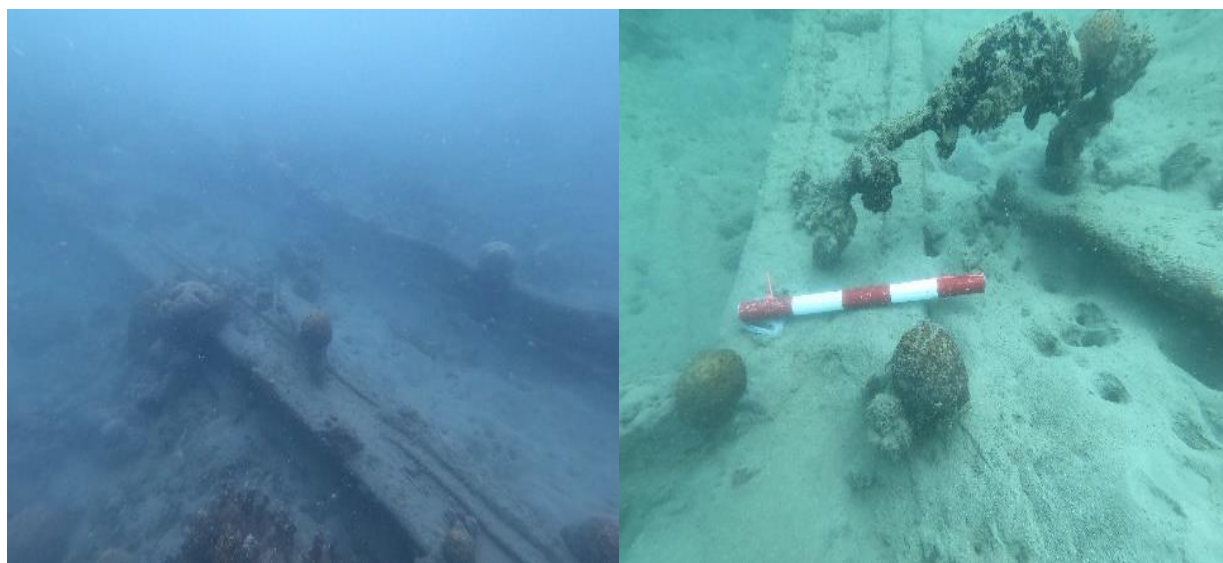
Target 17 consisted of Acoustic Contact S007 and was located in Yap Port–Southwest (Survey Area 5) in approximately 15 feet (4.5 meters) of water (Figure 3-111). Target 17 was located off the Vital FSM Petrocorp petroleum plant in Tamil Harbor. Divers spent 112 minutes investigating Target 17 and identified the source as consistent with pier remnants. The main features observed at Target 17 consisted of five partially buried parallel metal beams each measuring 33 feet (10 meters) long and 1.3 feet (0.4 meters) wide (Figure 3-112). Throughout the site, archaeologists noted several vertical metal supports existing parallel to the beams. Some of the supports were connected by a crossbar, while others were freestanding. Archaeologists also noted triangular support brackets (Figure 3-112). Historical charts from Japanese surveys dated 1917–1921 depicted a pier in the location of Target 17 (U.S. Navy Hydrographic Office 1924). Photographs from 1945 depict the pier as a raised stretch of dirt without visible structure (Figure 3-113) (MissingAirCrew.com, n.d.). By 1976, this location consisted of the current petrol facility with substantial shoreline improvements and stabilization efforts, including a spit extending southward. Based on the historical charts, Target 17 may be the disarticulated remains of a pier dating to the Japanese administration. Based on observed characteristics and available data, Target 17 is a disarticulated pier structure that lacks integrity for design, setting, workmanship, feeling, and association and, therefore, is not likely to yield important information. Target 17 is recommended as not eligible for listing in the NRHP.

**Figure 3-112 Large Metal Beams on Target 17 (Photos by AECOM)**

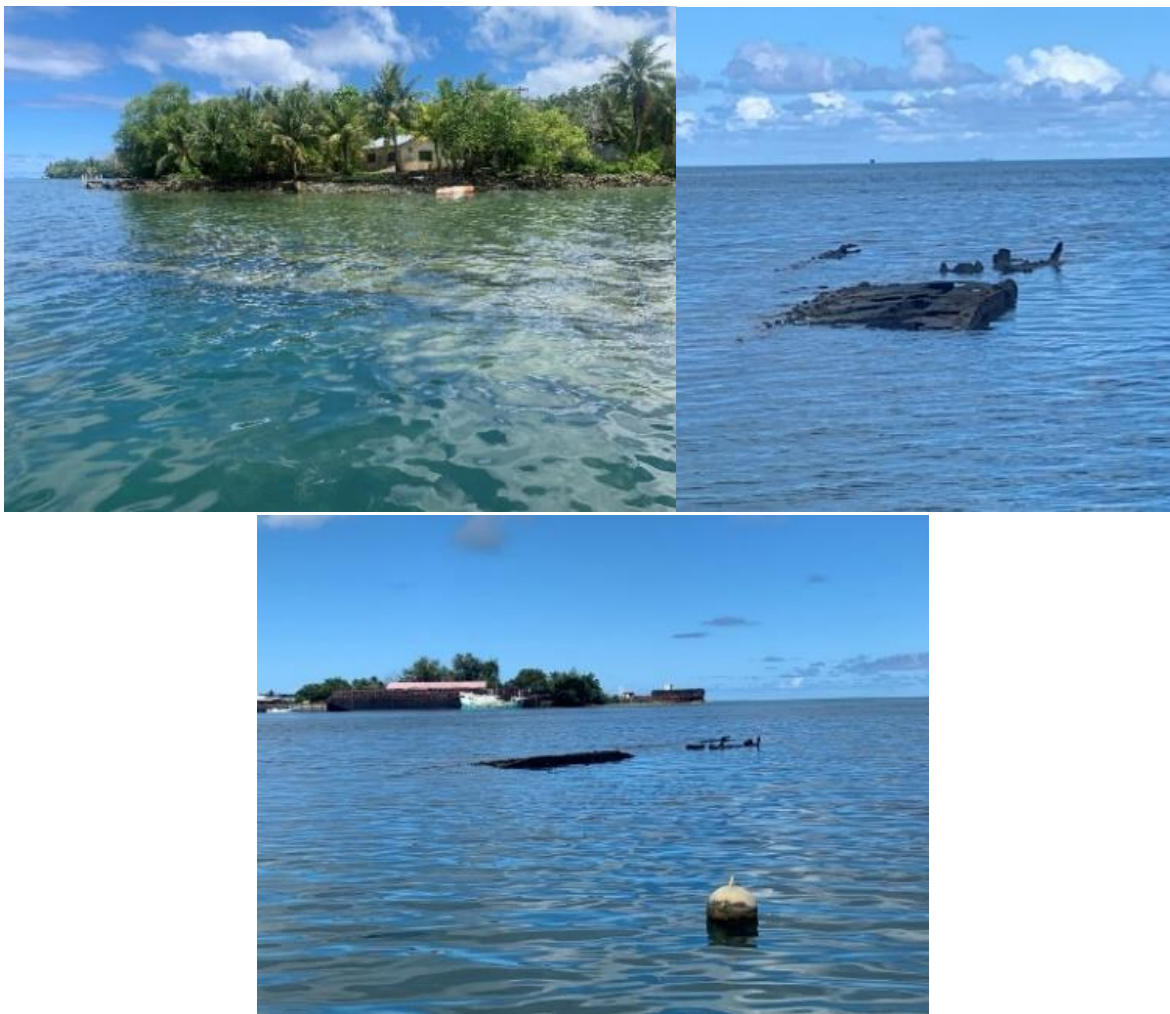
Target 21 was located in Yap Port–Southwest (Survey Area 5) and is denoted as kml\_79 in the NOAA ENC shipwrecks database as a visible shipwreck, always dry. Target 21 was partially exposed and first appeared on aerial imagery in 2013, but was not visible in 2008 aerial imagery. Target 21 may correspond with a shipwreck identified on a 1981 U.S. Geological Survey map (USGS 1981) (Figure 3-114). While investigating Target 21, archaeologists noted that the target was completely submerged during high tide but became substantially exposed during low tide (Figure 3-114). Divers spent 42 minutes investigating Target 21 and identified the source as a rectangular barge, observing multiple ship construction elements including iron deck frames that support deck plating and are secured by a series of single riveting butt straps. The rivets measured 4 inches (10 centimeters) across (Figure 3-115). Divers measured Target 21 at 75 feet (23 meters) long and 16 feet (5 meters) wide. Target 21 contained other features such as 10-inch (25-centimeter) cleats and heavy-duty U-bolts (Figure 3-116). Observed construction elements were consistent with mid- to late-20th-century barge construction methodologies. Based on observed construction elements and vessel size, Target 21 was likely a barge. Based on observed characteristics and available data, Target 21 may retain the potential to yield important information regarding maritime shipping and industry practices significant to Yap and the FSM's history. It is recommended treating Target 21 as eligible for listing in the NRHP with an avoidance buffer of 164 feet (50 meters) from the defined site extents, pending additional information.

**Figure 3-115 Target 21 at High and Low Tides (Photos by AECOM)**

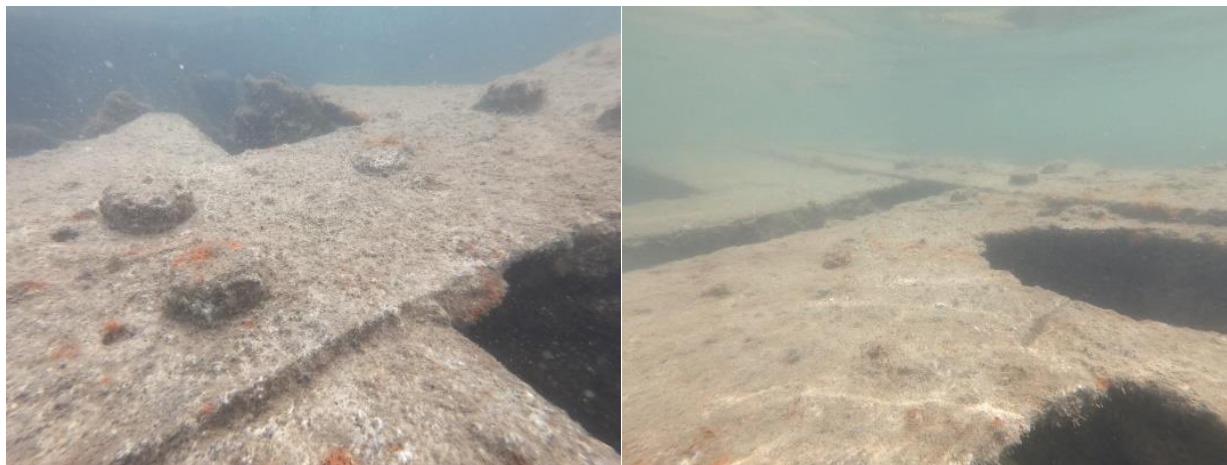
**Figure 3-116 Single Riveting Butt Straps and Deck Plating (Photos by AECOM)**

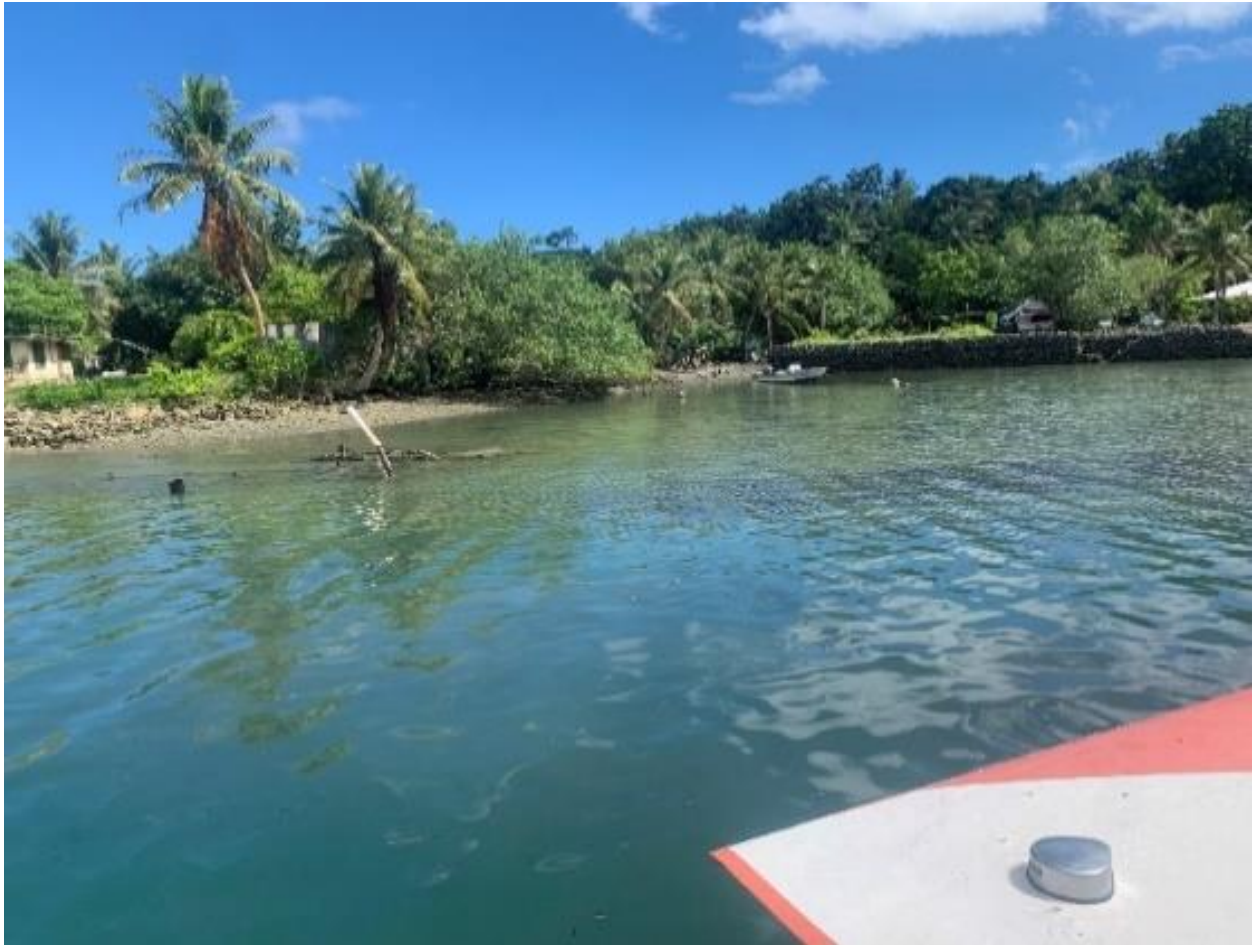
Target 22 was located in Yap Port–Southwest (Survey Area 5) and was partially exposed at low tide (Figure 3-118). Target 22 was denoted as kml\_75 in the NOAA ENC shipwrecks database as a visible shipwreck, always dry. Target 22 was partially exposed and first appears on aerial imagery in 2013, but was not visible in 2008 aerial imagery, and may correspond with shipwreck location identified on a 1981 U.S. Geological Survey map (USGS 1981) (Figure 3-119). Divers spent 40 minutes investigating Target 22 and identified the source as likely to be a rectangular barge split in two, with a section of structure exposed during low tide. Divers measured Target 22 at an overall length of 43 feet (13 meters) and 23 feet (7 meters) wide. Archaeologists observed ship construction elements such as welded deck plating and iron deck frames (Figure 3-120). A white polyvinyl chloride pipe was mounted to a portion of the structure that was exposed to mark the wreck as an obstruction, but likely not contemporaneous with Target 22. Observed construction elements are consistent with mid- to late-20th-century construction methodologies. Based on observed construction elements and vessel size, Target 22 was likely a barge. Based on observed characteristics and available data, Target 22 may retain the potential to yield important information regarding maritime shipping and industry practices significant to Yap and the FSM's history. It is recommended treating Target 22 as eligible for listing in the NRHP with an avoidance buffer of 164 feet (50 meters) from the defined site extents, pending additional information.

**Figure 3-118 Target 22 (Photo by AECOM)**

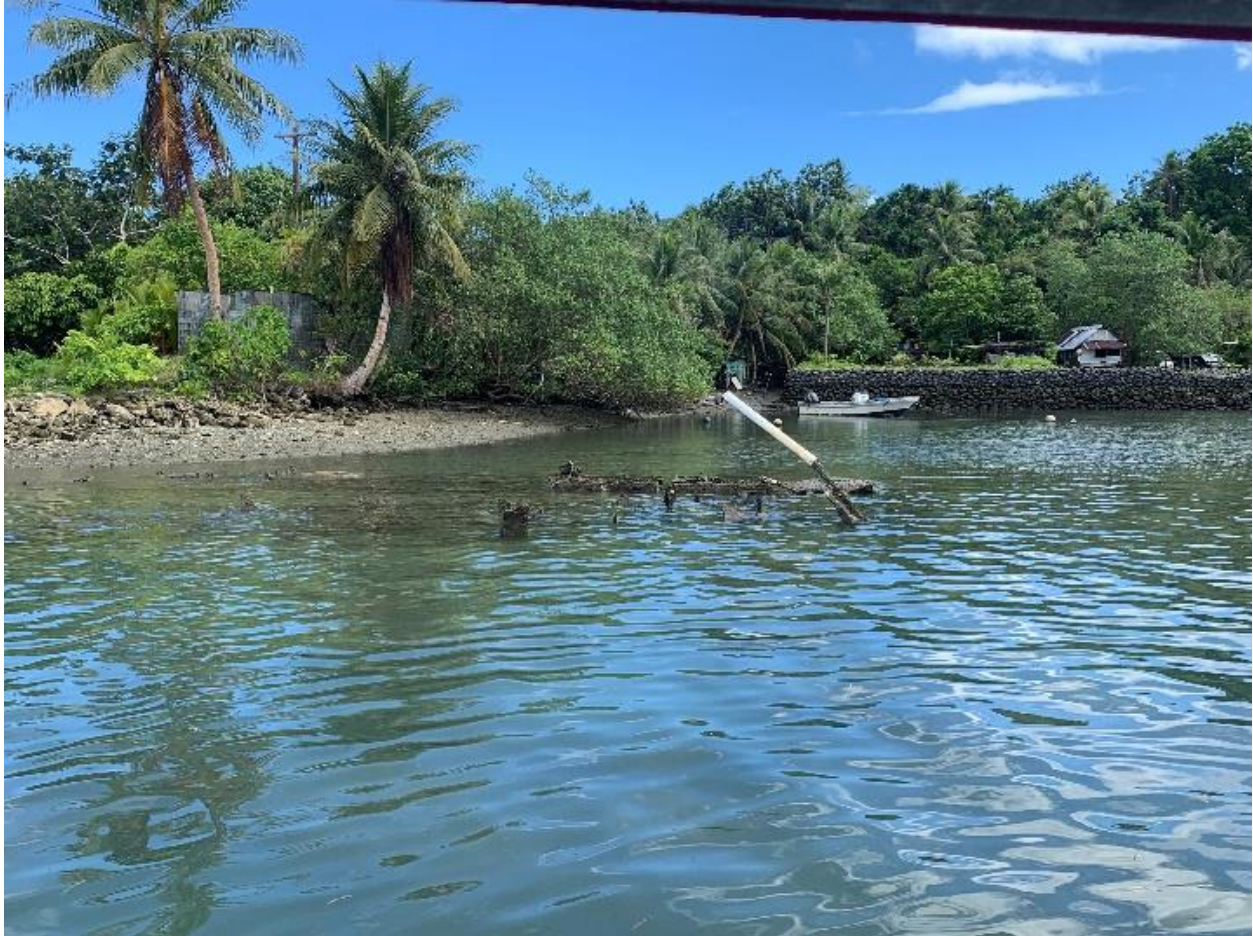
**Figure 3-120 Framing Elements of Target 22 (Photo by AECOM)**
