# Final Field Report for Baseline Cultural Resources Surveys for the Sea Port in Yap, Federated States of Micronesia

Naval Facilities Engineering Systems Command, Pacific

Cardno GS – AECOM Pacific Joint Venture

October 2023

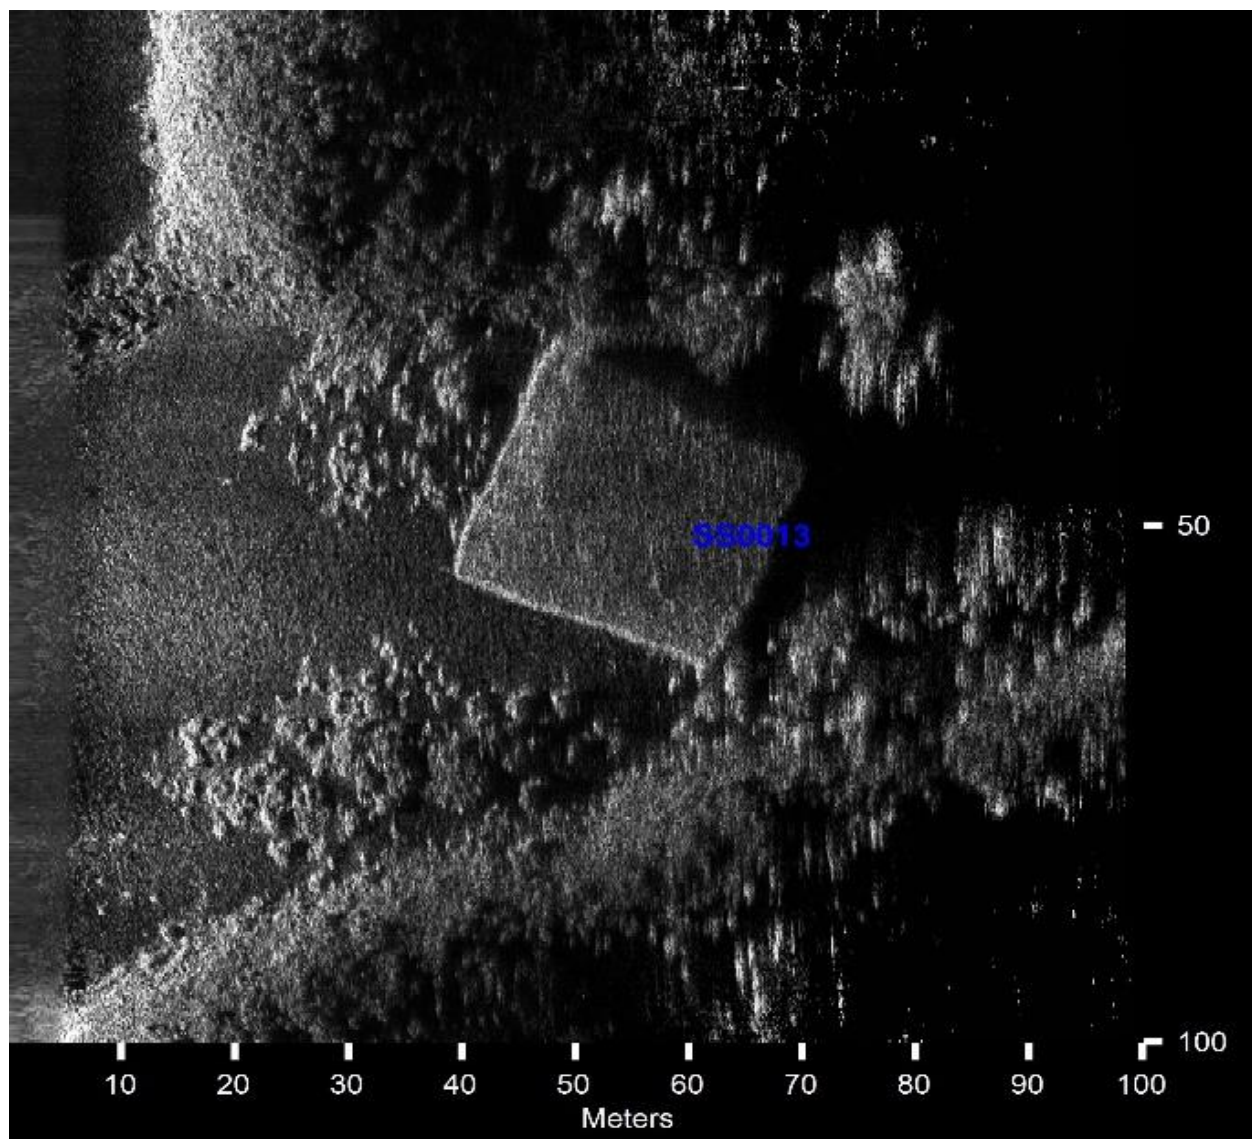
Target 08 was recorded as Acoustic Contact S013 and located in Yap Port–North (Survey Area 7) in approximately 41 feet (12.5 meters) of water (Figure 3-122). Target 21 was listed as kml\_73 in the NOAA ENC shipwreck database as a submerged shipwreck. The Navy Seabee MBES data designated Target 08 as a wreck and corresponded in size and shape with the acoustic image, measuring 66 feet (20 meters) long and 79 feet (24 meters) wide (Figure 3-123). Local diving operators informed archaeologists that Target 08 was a sunken barge that was previously used as a floating pier. Divers spent 64 minutes investigating Target 08 and identified the source as a mid- to late-20th-century barge with evidence of mooring bits, rub rails, and an open hatch (Figure 3-124). Substantial marine growth obscured details including names or other potential identification markers. The source of Target 08 was a mid- to late-20th-century barge. Based on observed characteristics and available data, Target 08 may retain the potential to yield important information regarding maritime shipping and industry practices significant to Yap and the FSM's history. It is recommended treating Target 08 as eligible for listing in the NRHP with an avoidance buffer of 164 feet (50 meters) from the defined site extents, pending additional information.

**Figure 3-122 Target 08 (Acoustic Contact S013)**

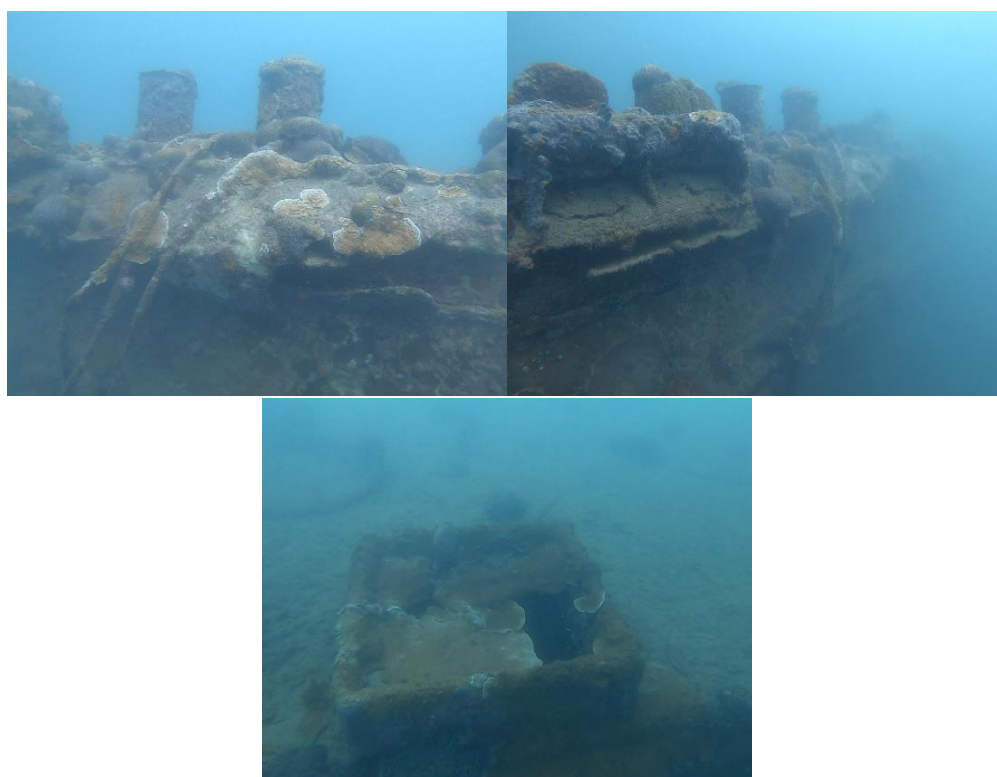
**Figure 3-124 Mooring Bitts (Top Left), Rub Rails (Top Right), and an Open Hatch (Bottom) on Target 08 (Photos by AECOM)**

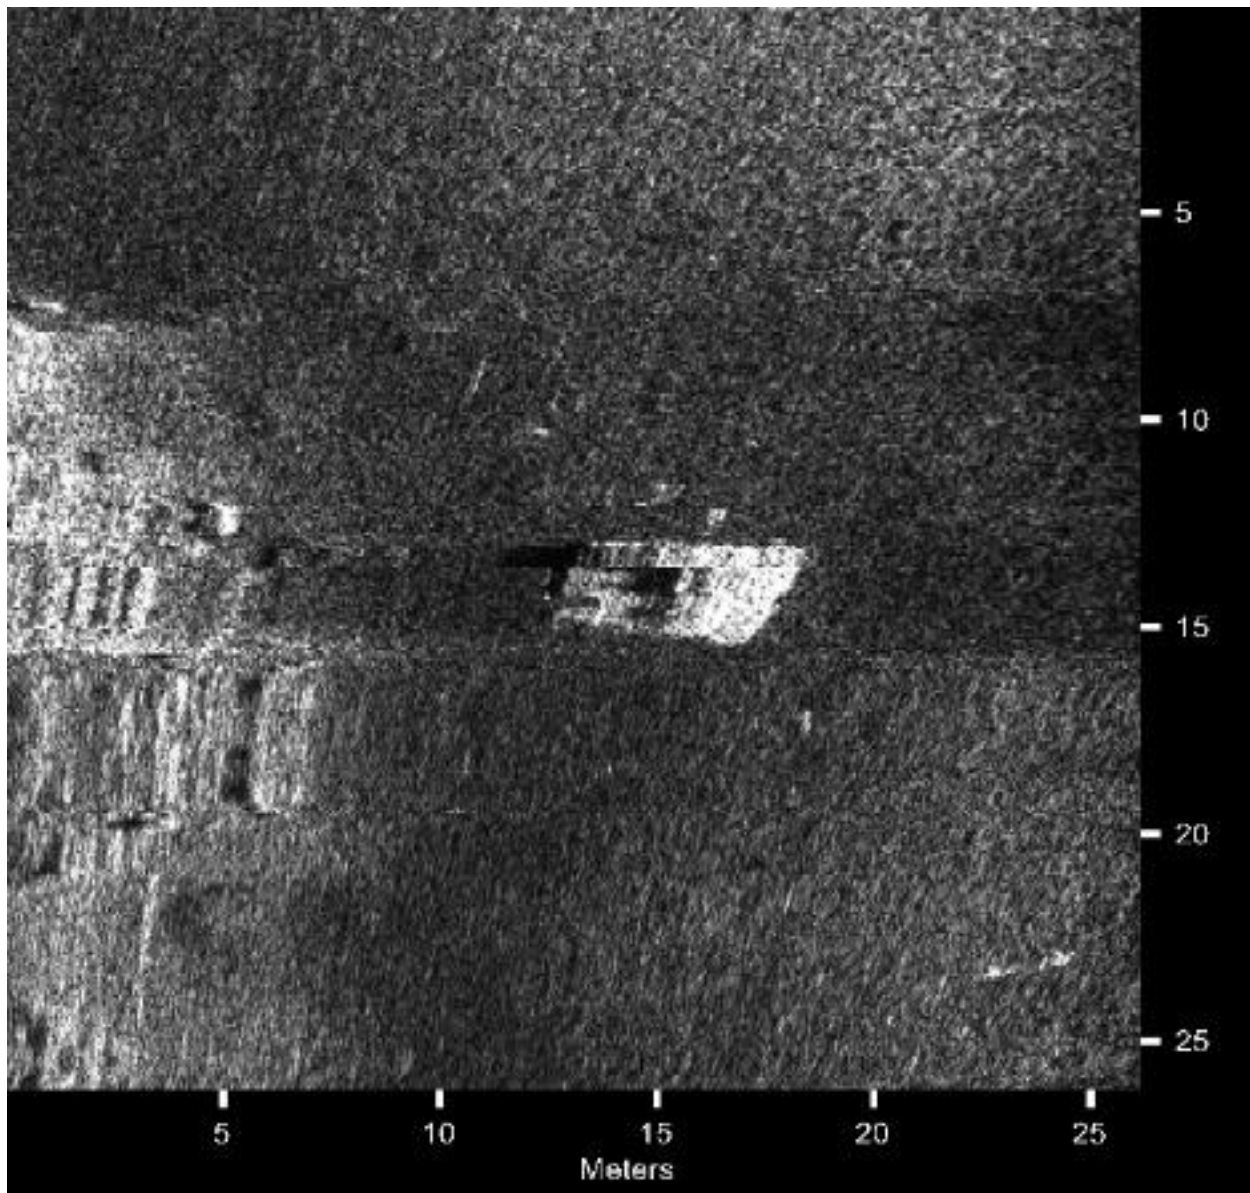
Target 14 consisted of Acoustic Contact S001 which was located in Yap Port–North (Survey Area 7) in approximately 47 feet (14 meters) of water (Figure 3-125). Target 14 is an unknown contact measuring 16 feet (5 meters) long and 16 feet (5 meters) wide. Divers spent 22 minutes investigating Target 14 and identified the source as a probable track crane or crawler crane (Figure 3-126). The track crane was rectangular and compact, which was consistent with recorded sonar imagery. Target 14 also consisted of tracks, a cabin, a boom and track controls/seat, and evidence of a removed boom (Figure 3-127). The source of Target 14 is a modern track crane; it is recommended as not eligible for listing in the NRHP.

**Figure 3-125 Target 14 (Acoustic Contact S001)**

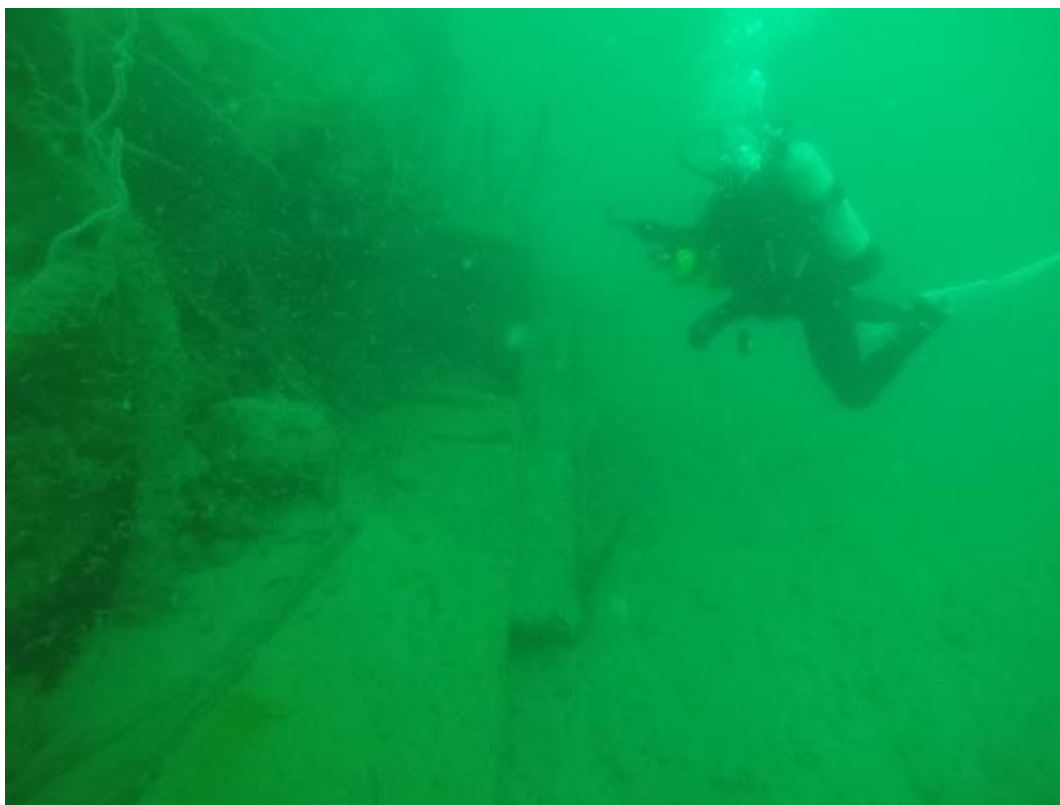
**Figure 3-126 Target 14, Probably Track Crane (Photo by AECOM)**

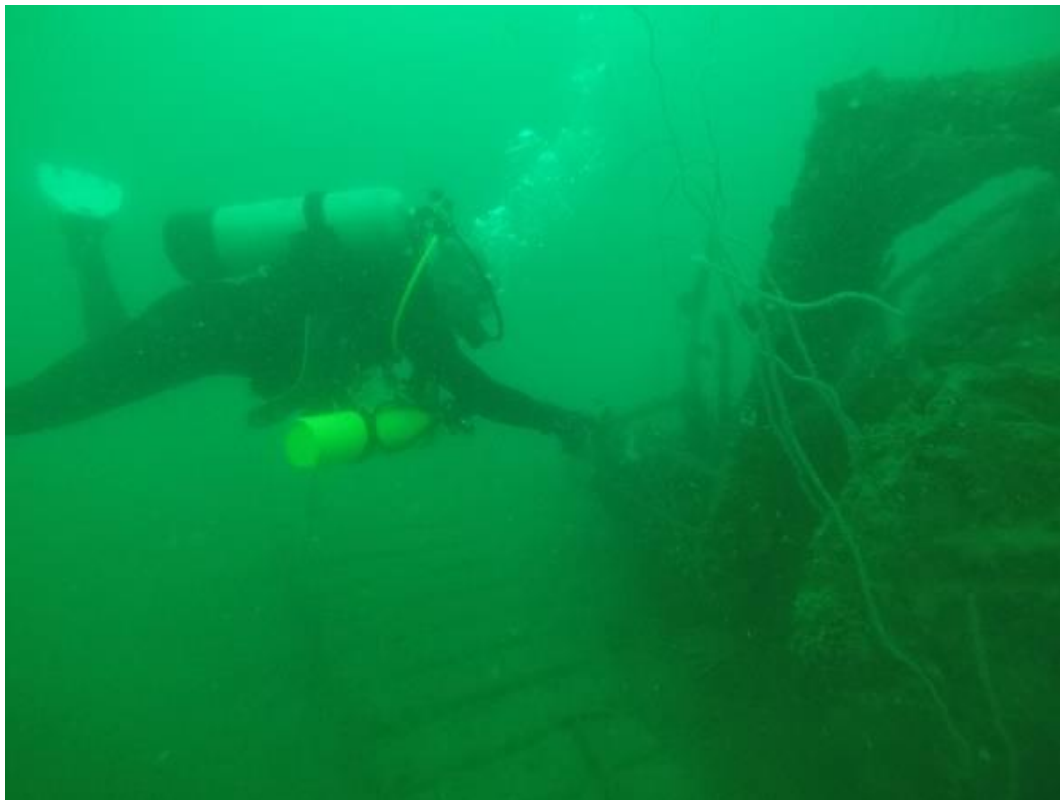
**Figure 3-127 Tracks on Target 14 (Photo by AECOM)**

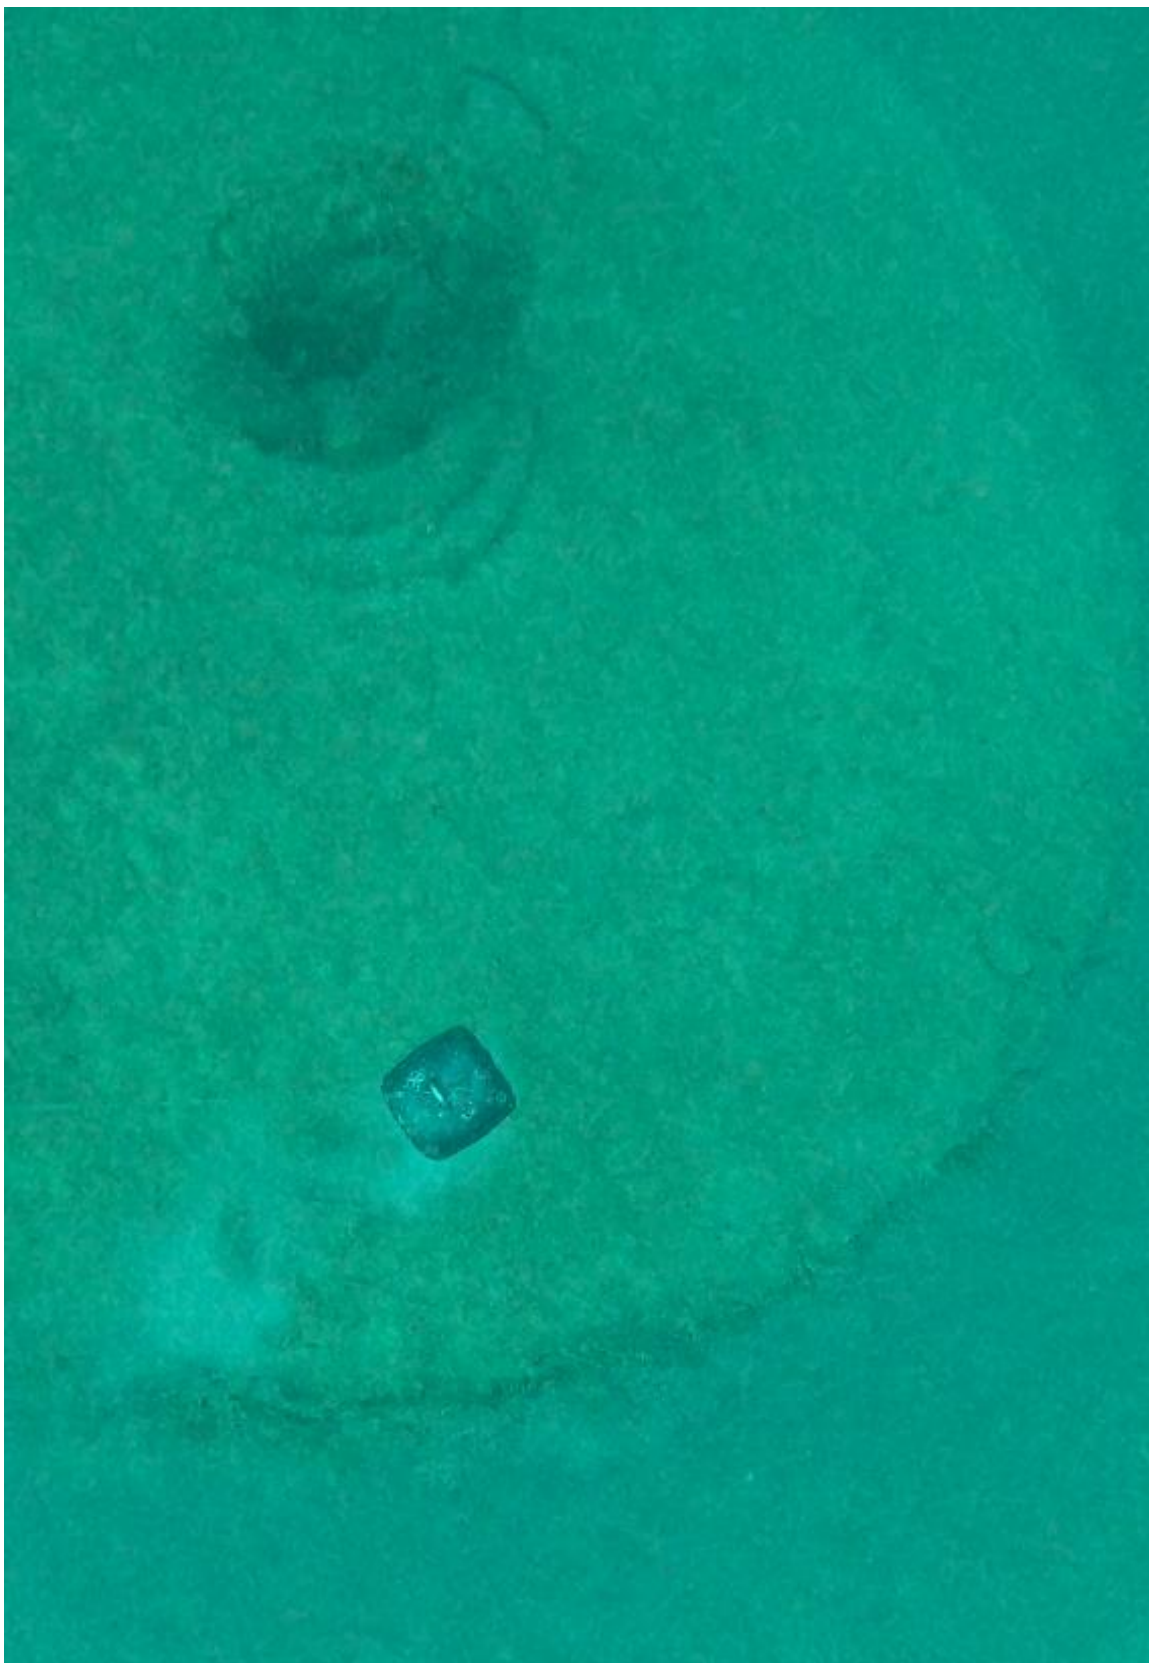
- Within MBES data, F-7\_obstruction was listed as a submerged linear object. Drop camera footage revealed a large cylinder object, similar to an outflow pipe (Figure 3-129).
- Within MBES data, F-9\_obstruction was also listed as a sunken buoy and anchor blocks. Drop camera footage revealed a cylindrical mooring block with an exposed eye bolt (Figure 3-130).
- Within MBES data, F-12\_obstruction was also listed as a sunken buoy. Drop camera footage revealed an unknown anthropogenic object (Figure 3-131). Captured video depicts an angular piece of likely iron or steel, with a single linear protrusion. F-12\_obstruction is likely a piece of anthropogenic debris.
- Drop camera footage depicts multiple pieces of shipwreck debris in the middle of the channel and is discussed in greater detail within Section 3.2.1.4, subsection Target 24 (Figure 3-42).

**Figure 3-130** Drop Camera Footage of F-9\_obstruction

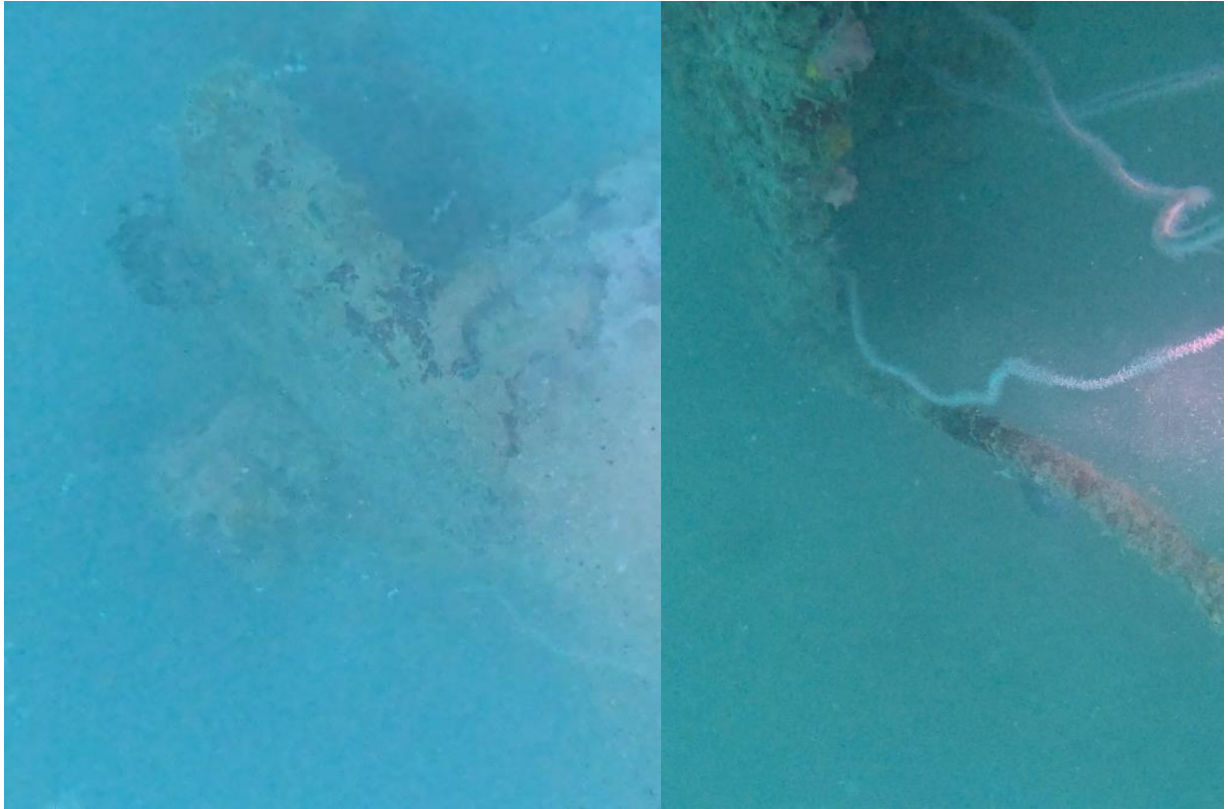
**Figure 3-131 Drop Camera Footage of F-12\_obstruction**

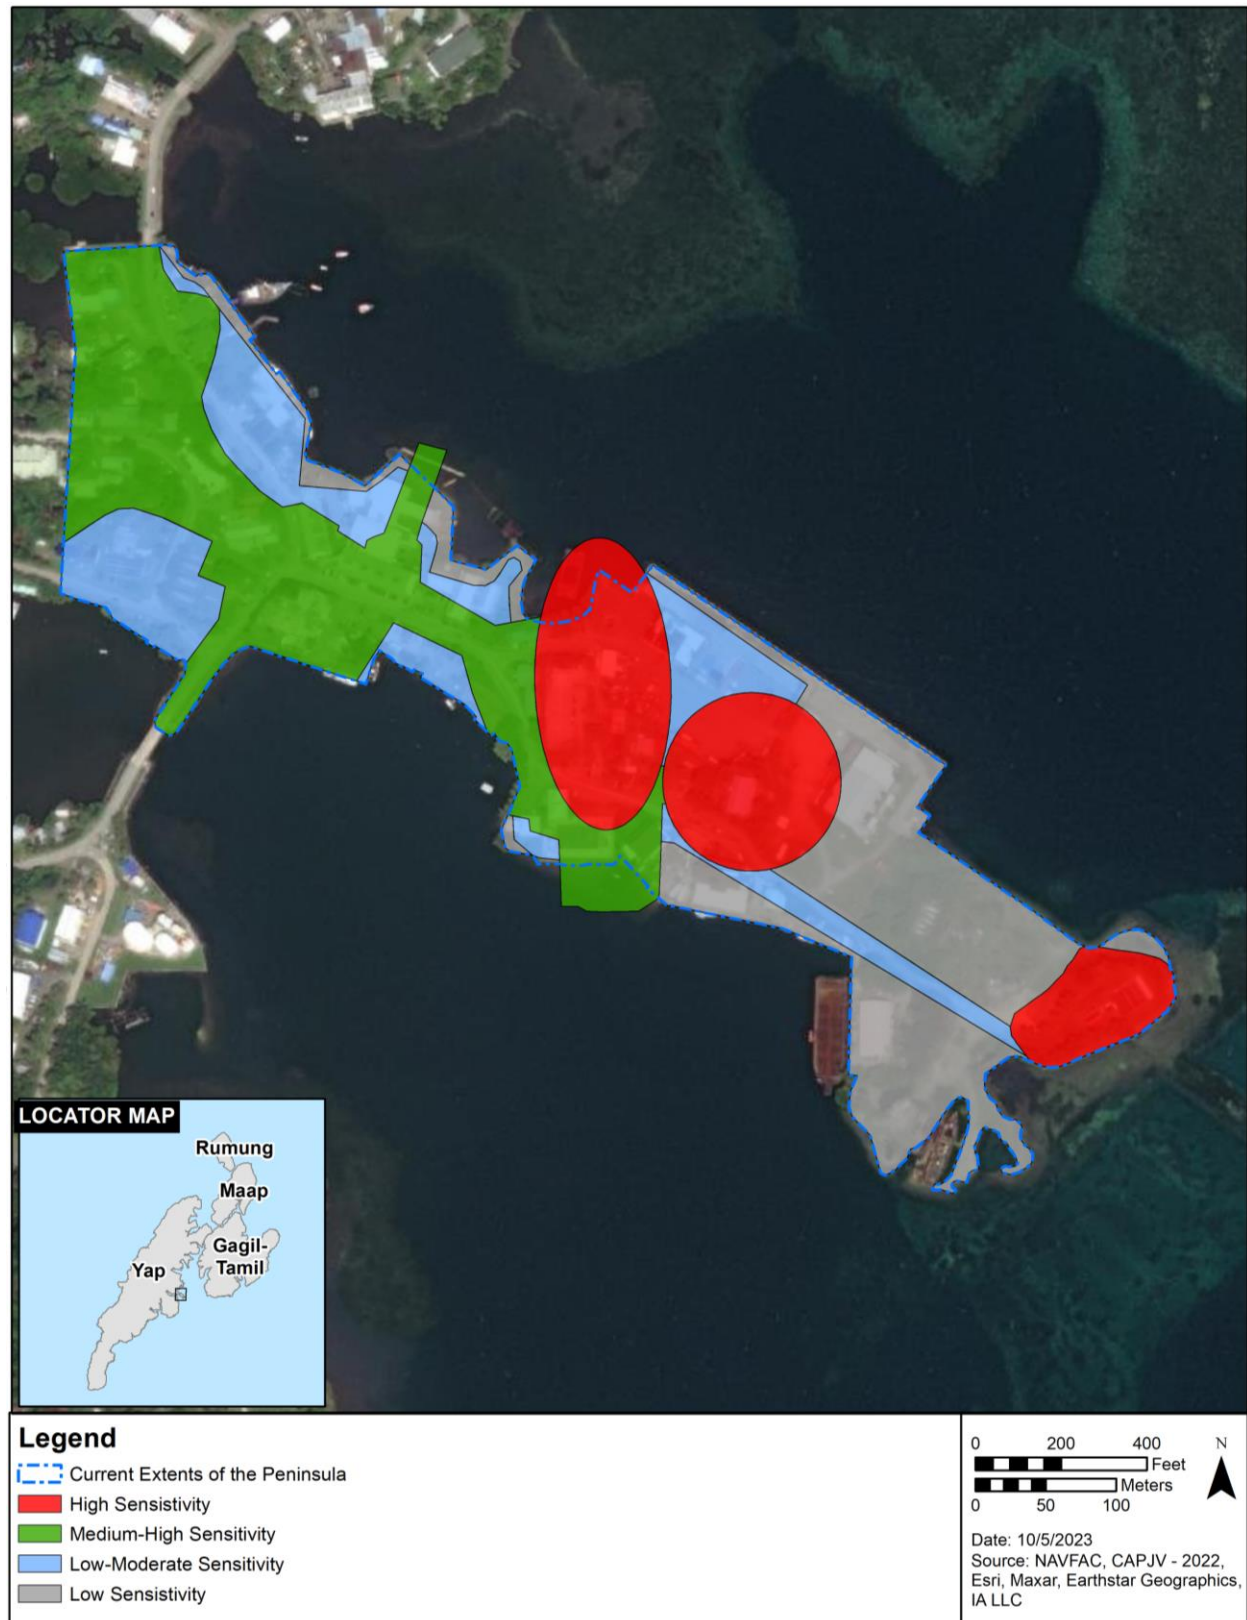
Figure 4-5 Archaeological Sensitivity Map for the Yap Port Peninsula

Figure 4-5 presents an archaeological sensitivity map for the Yap Port designating areas of high, medium, and low sensitivity for cultural resources. The following variables were considered: (1) spatial coverage and intensities of previous investigations, (2) the distribution of known cultural resources, (3) classes of cultural resources (e.g., traditional cemetery, World War II concrete pad), (4) proximity to the coastline (for terrestrial and nearshore marine resources), and (5) soil and topographic attributes. This map was generated from fieldwork results, historical maps, and the land reclamation analysis displayed in Figure 4-4.

The three islets that were enveloped by land reclamation have the highest archaeological sensitivity. These locations may retain significant traditional Yapese deposits and deposits relating to the entire colonial sequence. At a minimum, archaeological monitoring is recommended should any ground-disturbing construction occur in these areas. Pre-construction testing may be warranted, and this should be determined based on specific construction plans.

Areas formed through late-19th- and early-20th-century land reclamation and Yap Port development are classified as medium-high archaeological sensitivity. These areas may retain deposits and features (e.g., pier remnants) relating to the initial development of Yap Port by colonial administrations. At a minimum, archaeological monitoring is recommended should ground-disturbing construction in these areas occur. Pre-construction testing may be warranted, and this should be determined based on specific construction plans.

Areas of the peninsula that formed since ca. 1980 are considered low sensitivity. No archaeological mitigation is recommended.

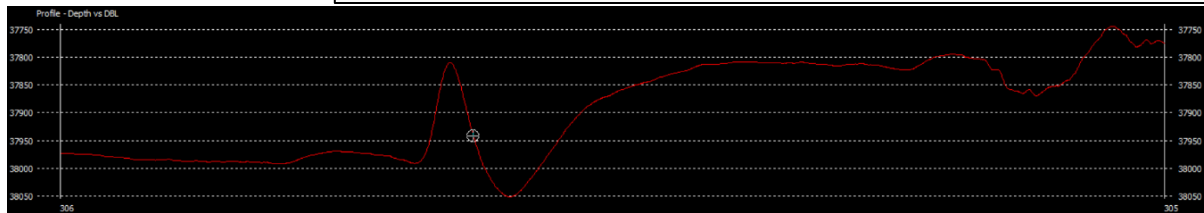
Table 3-1 lists the targets identified in the side scan and magnetometer surveys. The HYPACK survey reports for these targets are presented in Appendix B. A representative target report of target F-10 is shown Figure 3-6. This target was thought to be a shipwreck.

Figure 3-6. HYPACK report (top) and raw gamma profile (bottom) for target F-10, thought to be a shipwreck

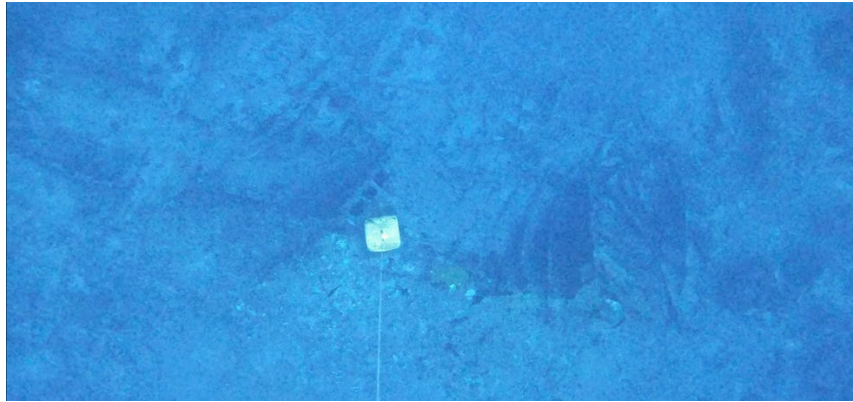
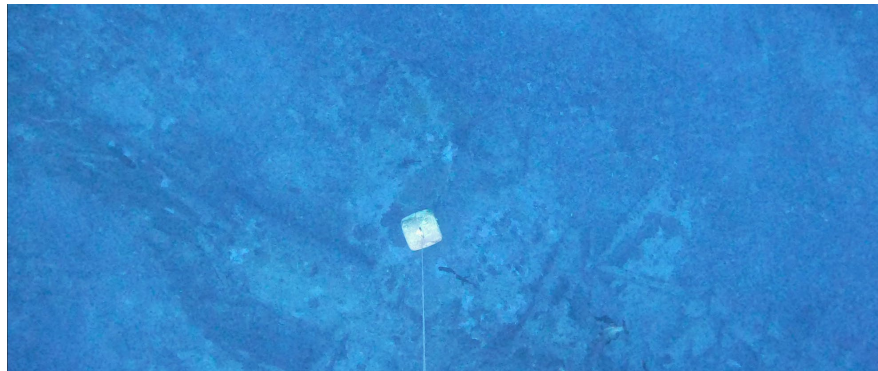
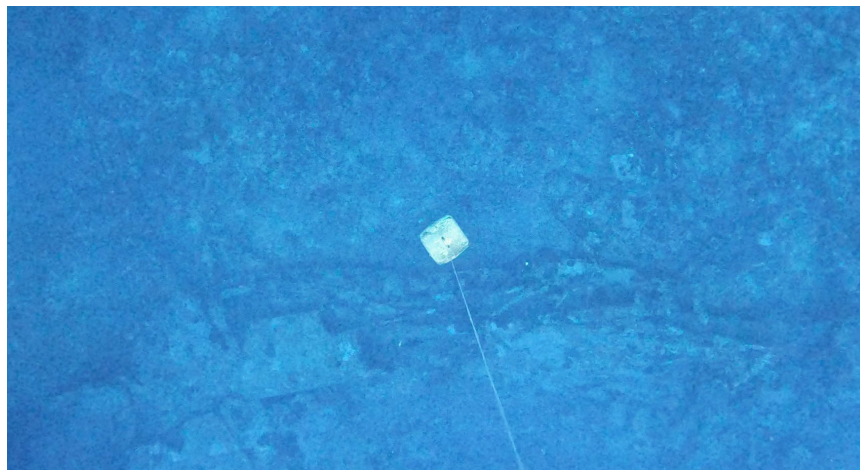
Target 1 for the focused cultural survey is shown in Figure 3-17. This target was thought to be remnants from a German vessel, dated from World War I era. The wreckage was in approximately 35 meters of water depth. Target F-7 is shown in Figure 3-18, and appeared to be a metal barrel/drum-like object. Target F-9 is shown in Figure 3-19, and was thought to be a mooring anchor. Target F-12 imagery is shown in Figure 3-20 and its object type is unknown.

**Figure 3-17. Target 1 of interest identified by the Cultural Resources Team, investigated with the deepwater drop camera setup on May 9, 2023.**

**This target is thought to be remnants of a German vessel from World War I era**

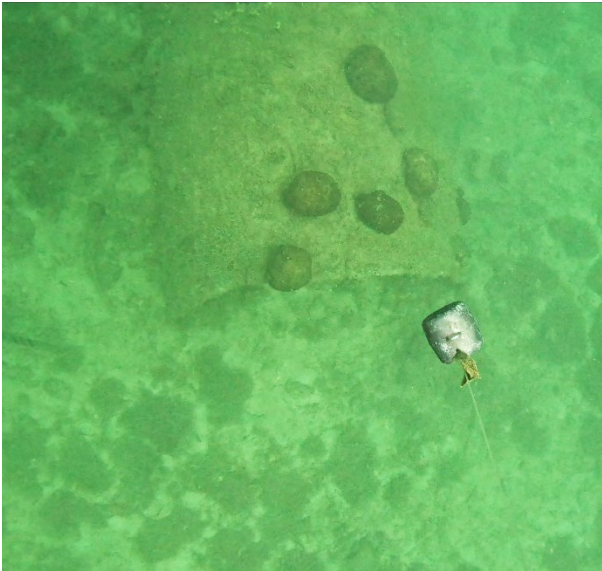
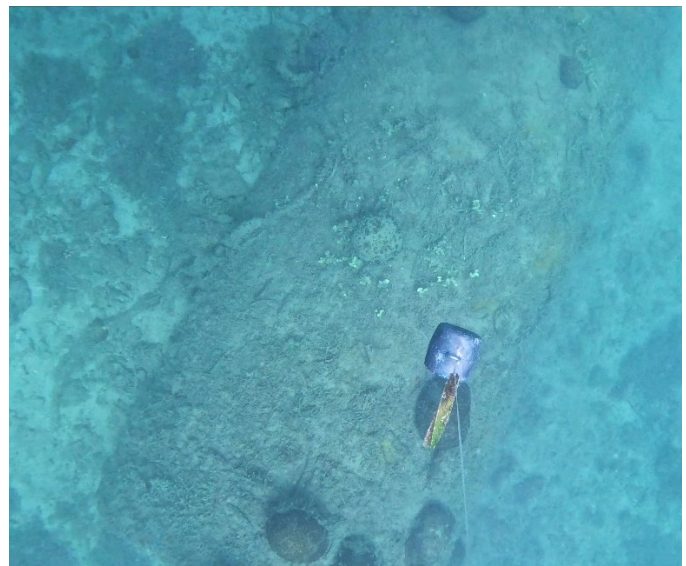
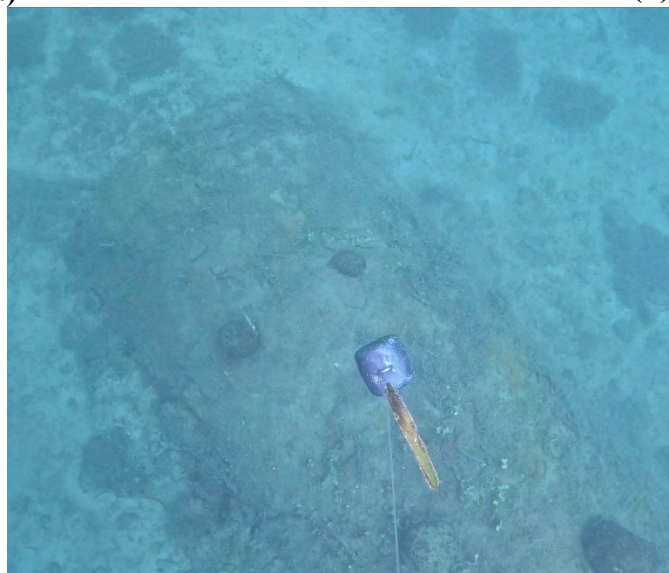
**Figure 3-18. Target 2 of interest identified by the Cultural Resources Team investigated with the deepwater drop camera setup on May 10, 2023**

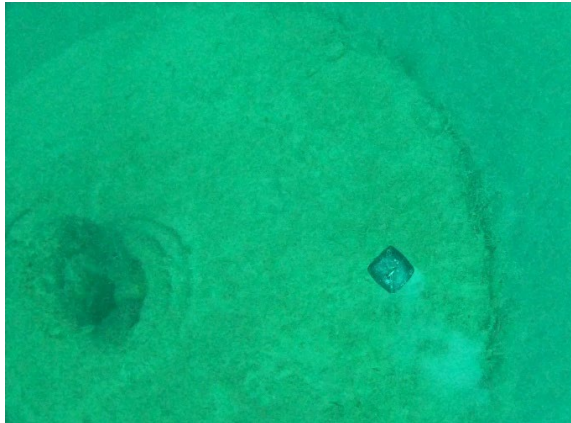
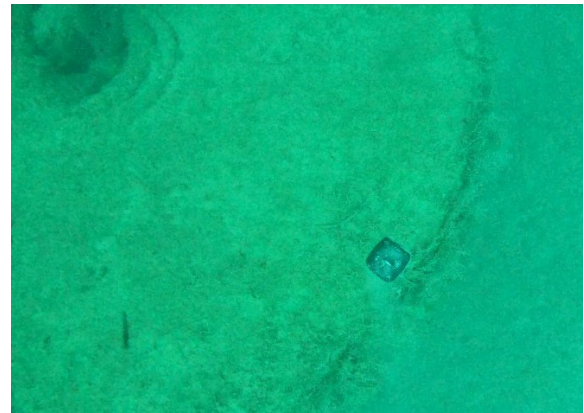
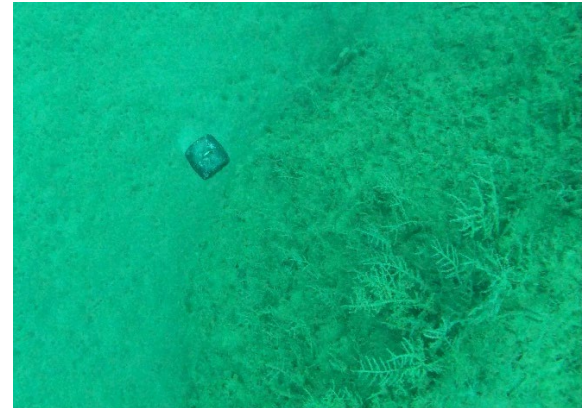
**Figure 3-19. Target 3 of interest identified by the Cultural Resources Team investigated with the deepwater drop camera setup on May 10, 2023**

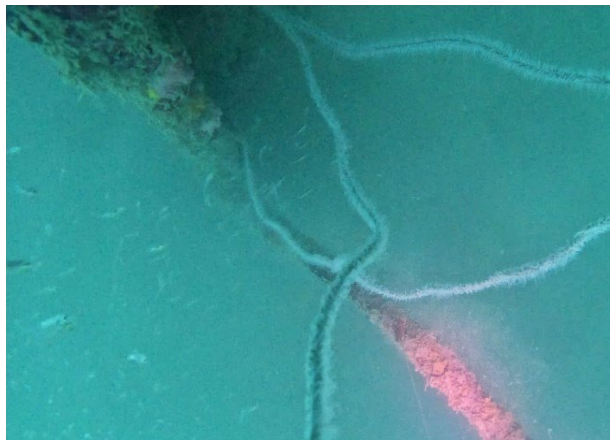
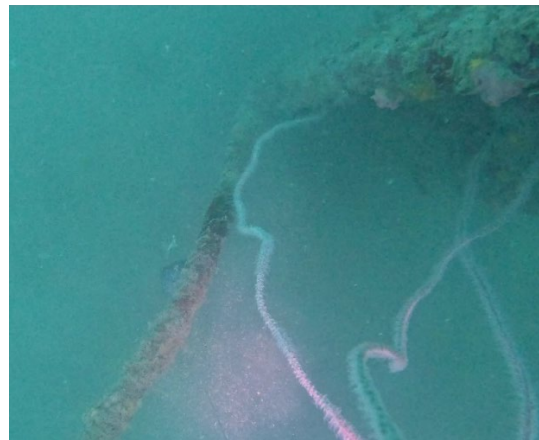
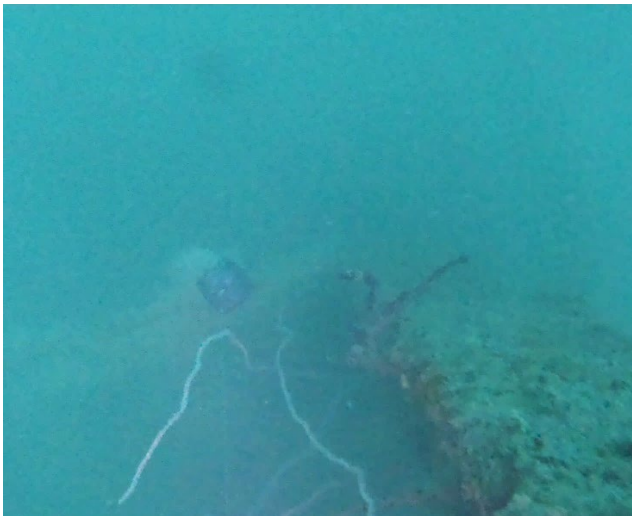
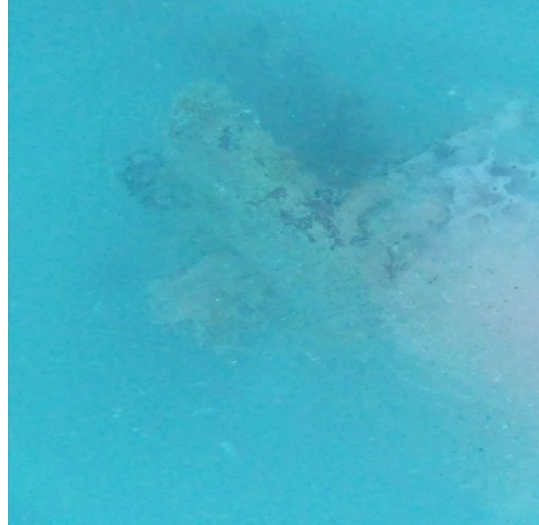
**Figure 3-20. Target 4 of interest identified by the Cultural Resources Team investigated with the deepwater drop camera setup on May 10, 2023**

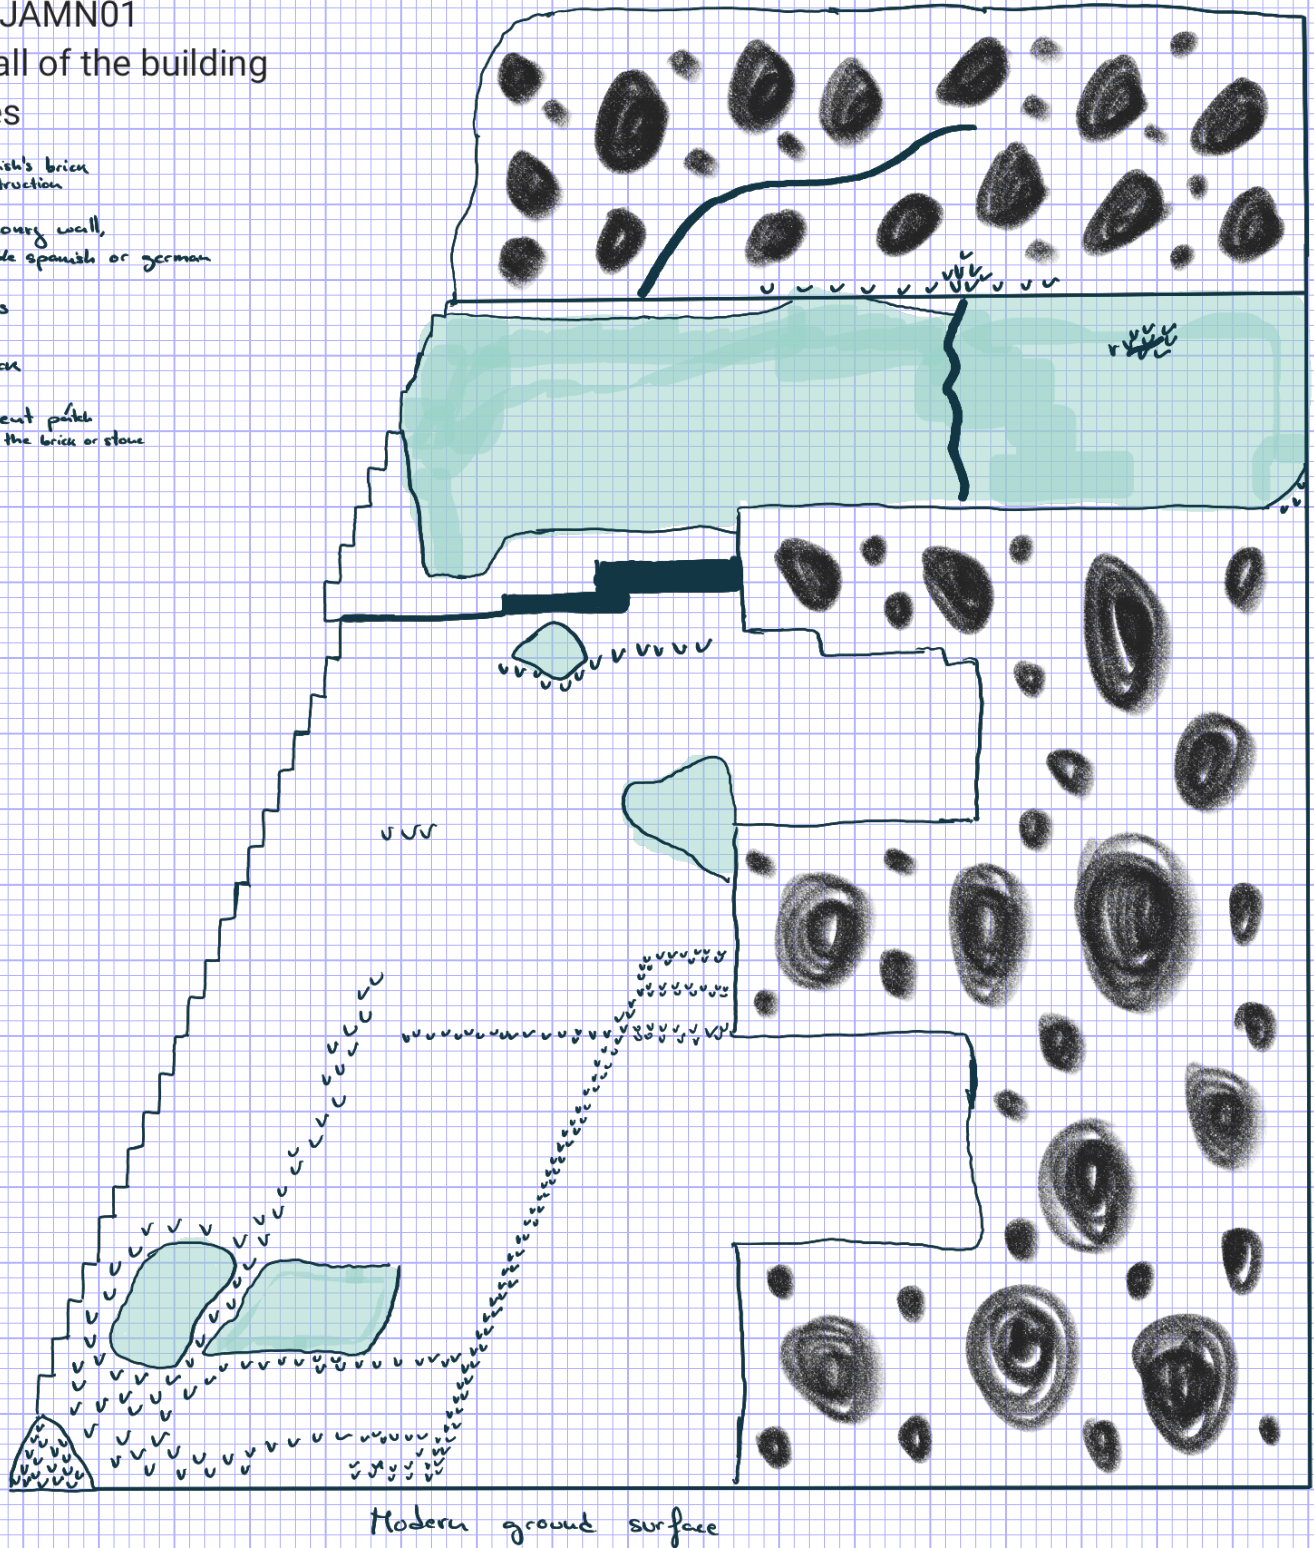
- ☐ Spanish's brick construction
- ☐ Masonry wall, probable spanish or german
- ☐ Grass
- ☐ Crack
- ☐ Cement patch over the brick or stone

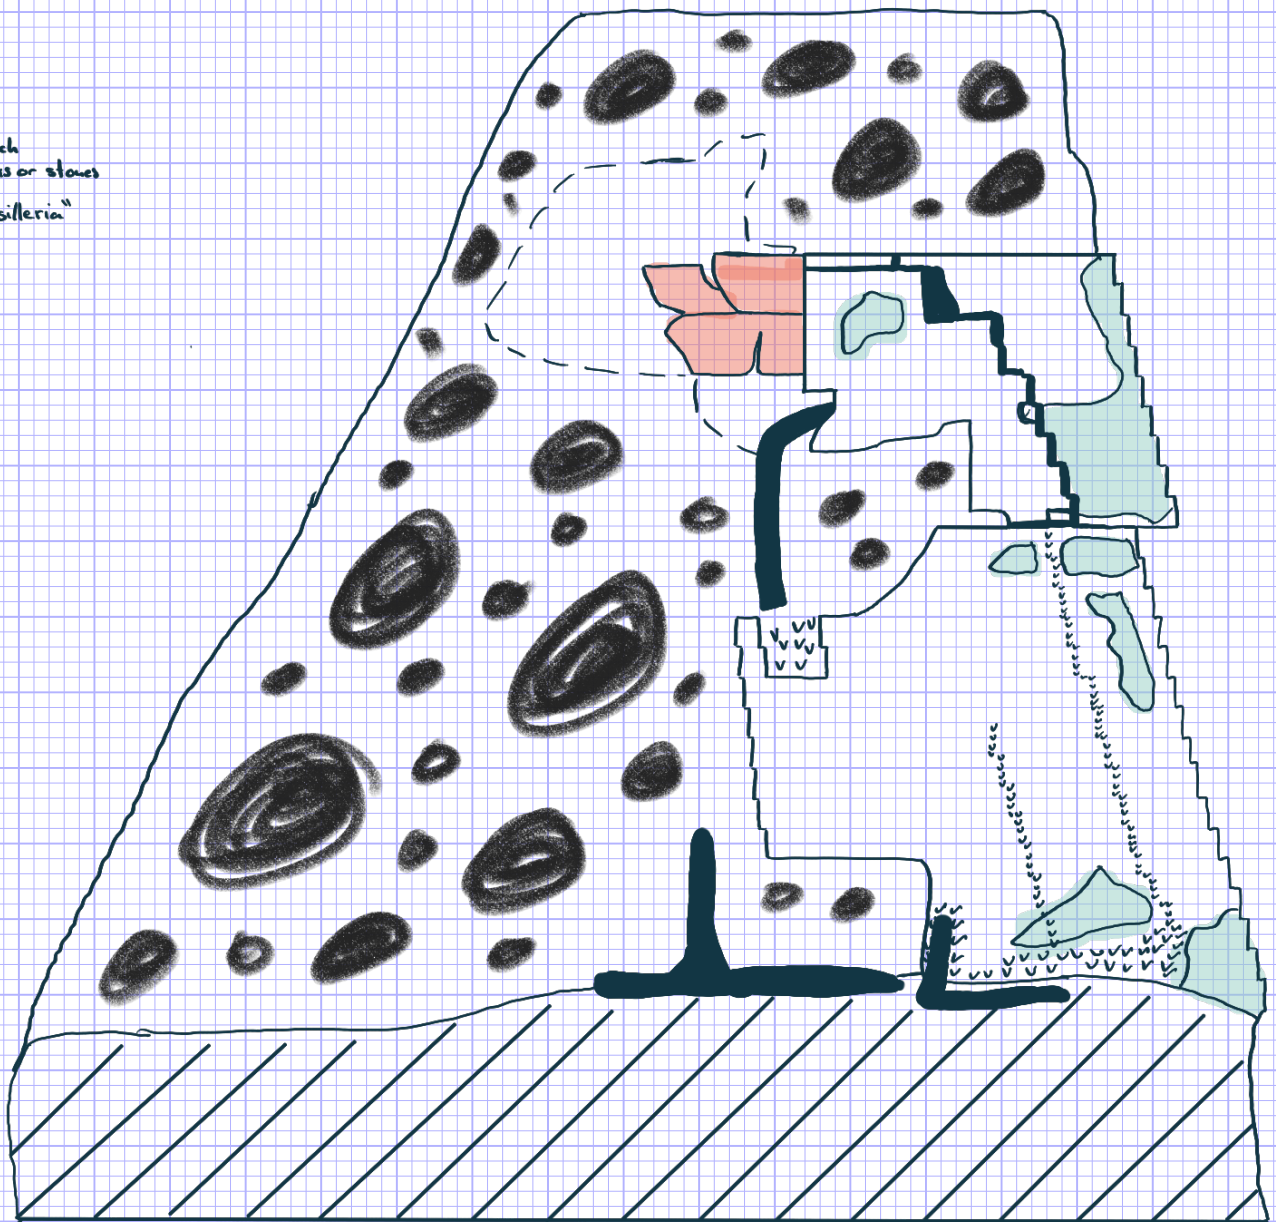
- ☐ Spanish's brick construction
- ☐ Masonry wall, probable Spanish or German
- ☐ Grass
- ☐ Root or cracks
- ☐ Cement patch over the bricks or stones
- ☐ Spanish "silleria"
- ☐ Damage in the wall
- ☐ XX century addition

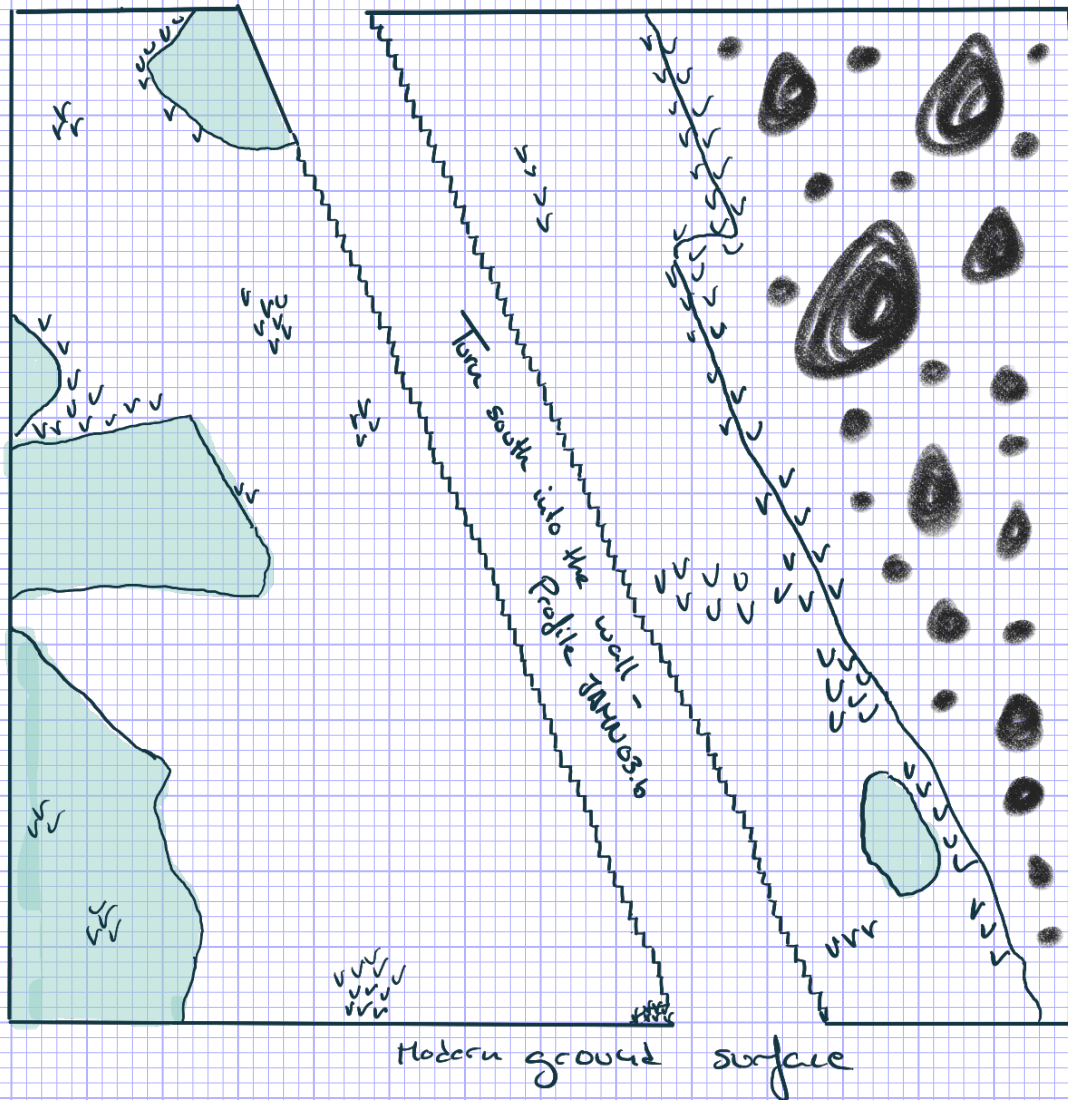
- ☐ Spanish's brick construction
- ☒ Masonry wall, probable spanish or german
- ☒ Vegetation
- ☒ Crack
- ☒ Cement patch over the brick or stone

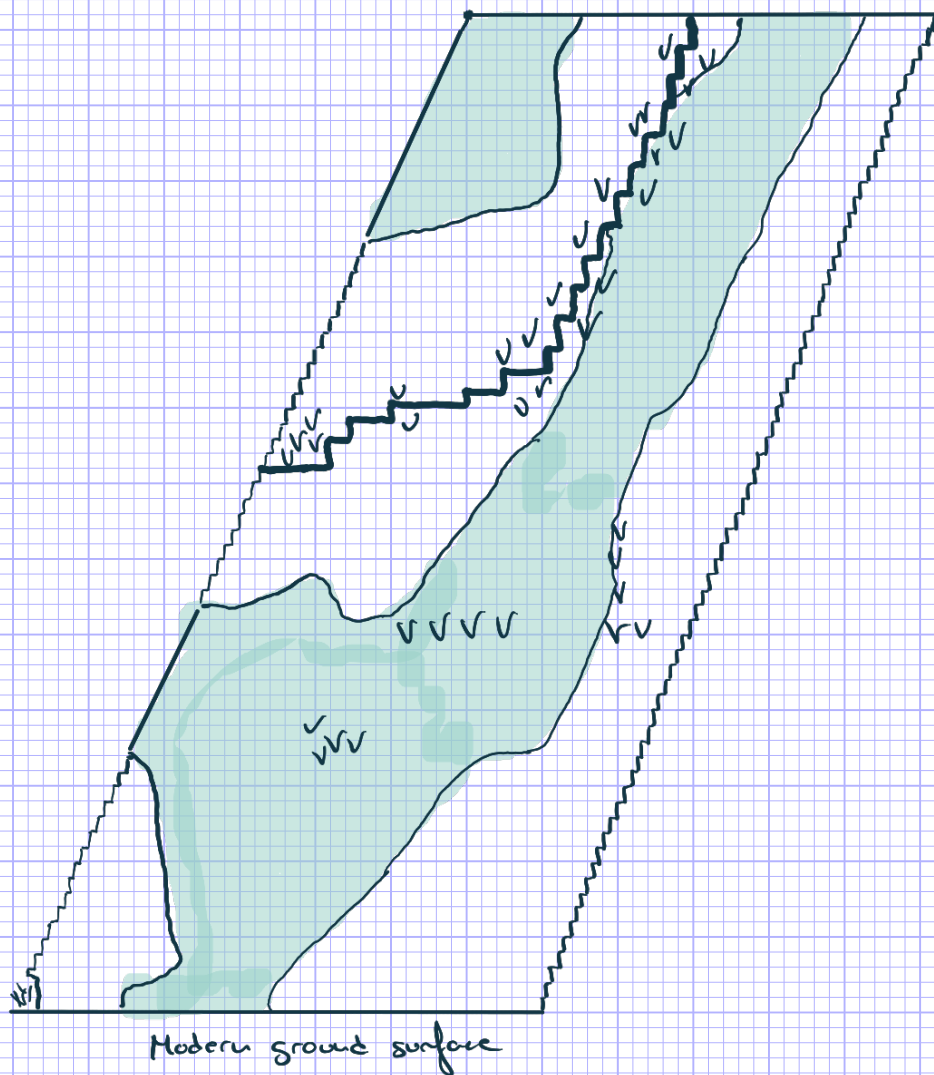
- ☐ Spanish's brick construction
- ☒ Stones w/ grass, possible german addition
- ☒ Vegetation
- ☒ Crack
- ☒ Cement patch over the brick or stone
