**Naval Facilities Engineering Systems Command Pacific
JBPHH HI**

Phase I Environmental Site Assessment

Yap Seaport

May 2024

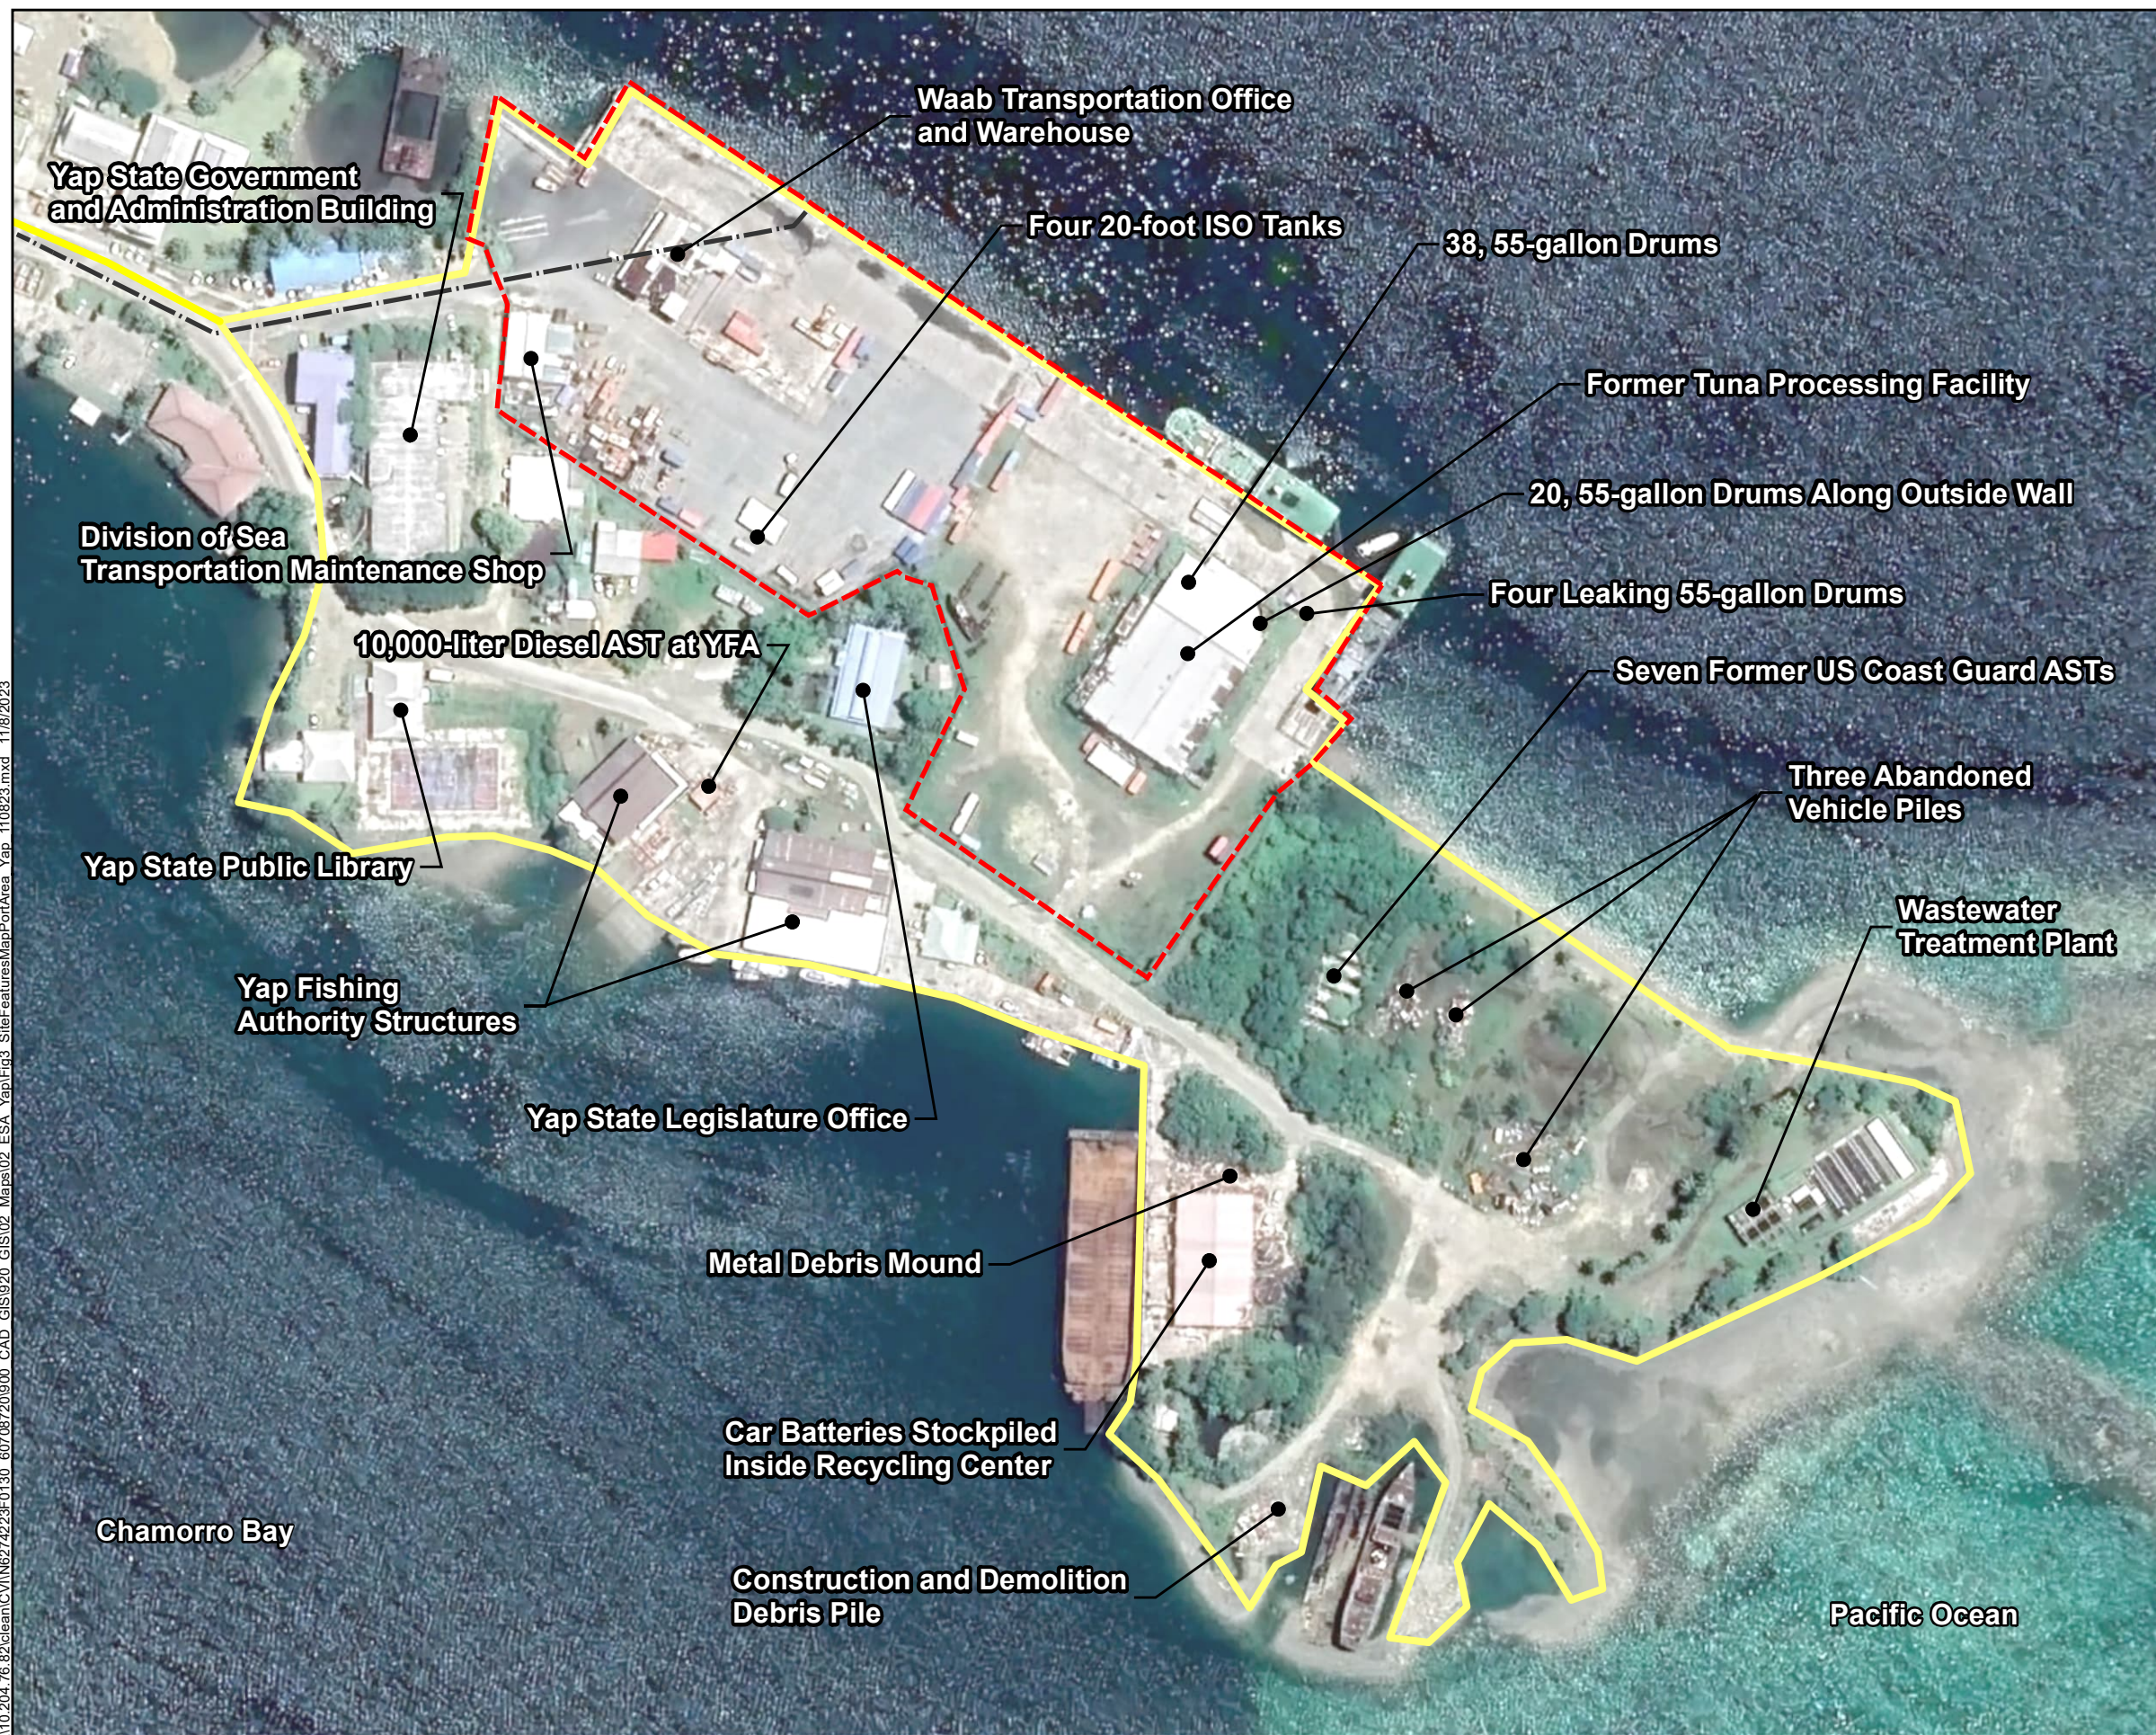
Figure 3
Site Features - Port Area
Environmental Site Assessment
Yap Port, Colonia, Yap Island,
Federated States of Micronesia

- An underground fuel pipeline is present within the port area of the subject property (Figure 3). The pipeline is used to transport mainly gasoline and diesel fuel offloaded by tanker barges at the port to the Vital PetroCorp fuel farm, located approximately 200 feet to the southeast of the Chamorro Bay road portion of the subject property. Mr. Rumwol, the officer in charge, was unaware of any releases from the pipeline. It could not be determined whether the pipeline is regularly leak tested, the leak testing methods, and testing results. Based on this lack of information, the pipeline represents a material threat of a potential future release. A monitoring well was observed in a parking lot adjacent to the fuel pipeline. Mr. Mautaman was unaware of the purpose of the monitoring well and whether it is associated with the fuel pipeline.

- Four 20-foot ISO tanks containing liquified petroleum gas were observed inside the fenced area of the port area portion of the subject property (Figure 3). The ISO ASTs are managed by the Sea Transportation Office. Mr. Siugwemal indicated the ASTs are temporarily stored at the port pending their subsequent transportation. Mr. Siugwemal was uncertain of the specific duration of time the ASTs have been in storage. During the site inspection, the tanks appeared in good condition without evidence of corrosion and no evidence of leaks or releases were observed below the tanks.

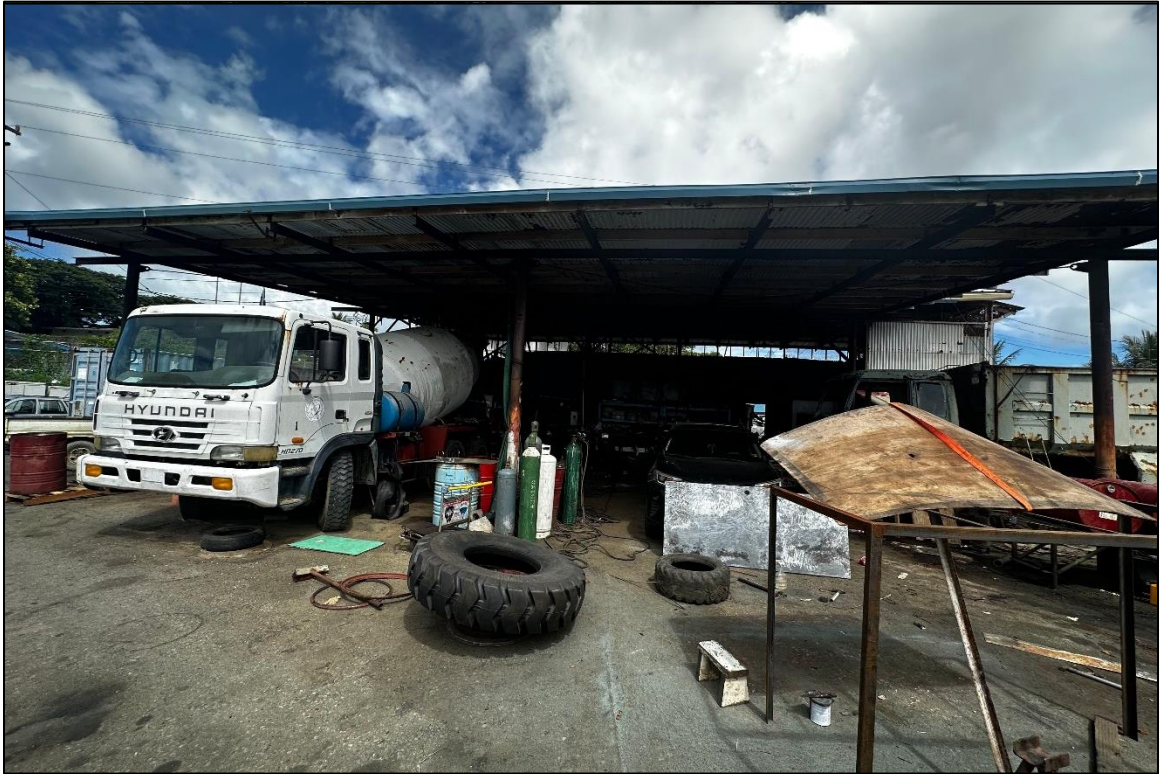
- Extensive oil staining at the Division of Sea Transportation maintenance shop, encompassing an area of approximately 200 square feet, is considered a REC, in AECOM's opinion. Petroleum hydrocarbons have likely leached to underlying soil and entered floor and trench drains.

- Twenty drums located within the Division of Sea Transportation maintenance shop (Appendix A, Photos 5–7). With the exception of six 55-gallon drums that are utilized for daily maintenance and repair activities, the drums were observed to be empty. None of the drums were labeled and all were uncovered and on concrete pavement. Extensive oil staining, estimated to be approximately 200 square feet in total area, was observed on the pavement throughout maintenance shop. Spilled fluids have likely infiltrated floor and trench drains at the shop, which discharge to the ocean (Appendix A, Photos 8 and 9).

Photo 5: Overview of the Division of Sea Transportation maintenance shop. Photo is looking west.

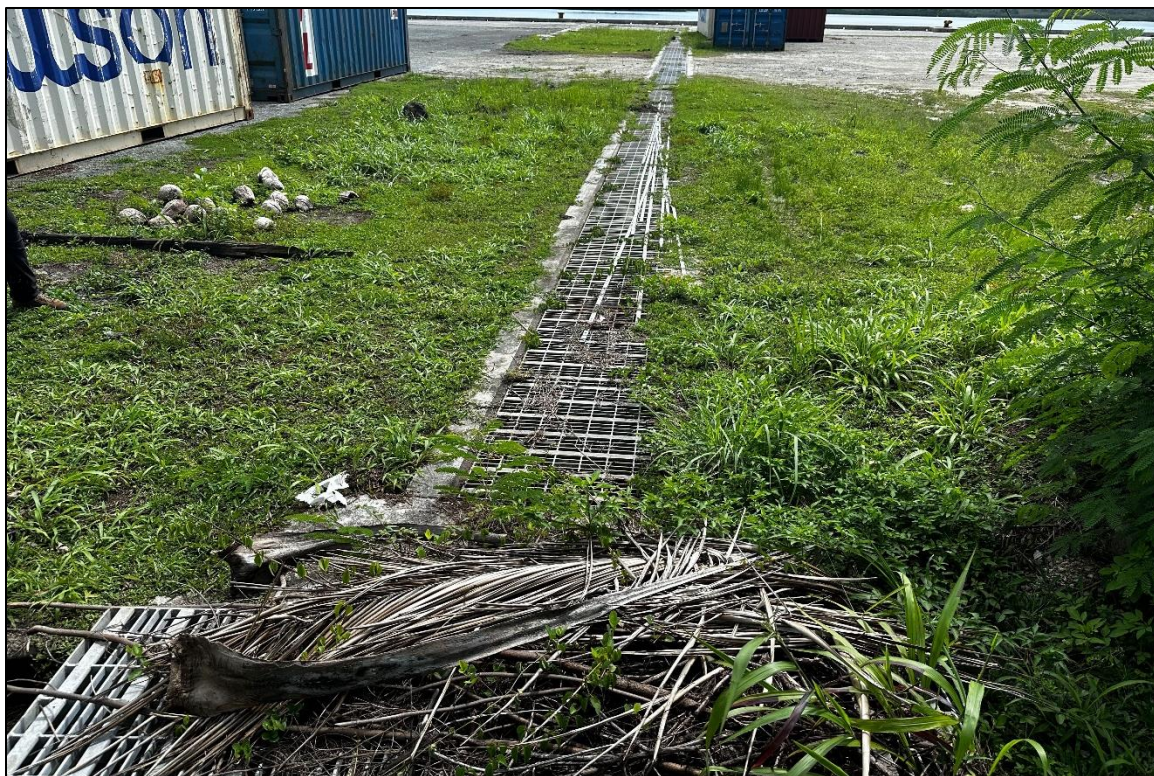
Photo 9: Drainage channel heading toward ocean. Photo is looking north.

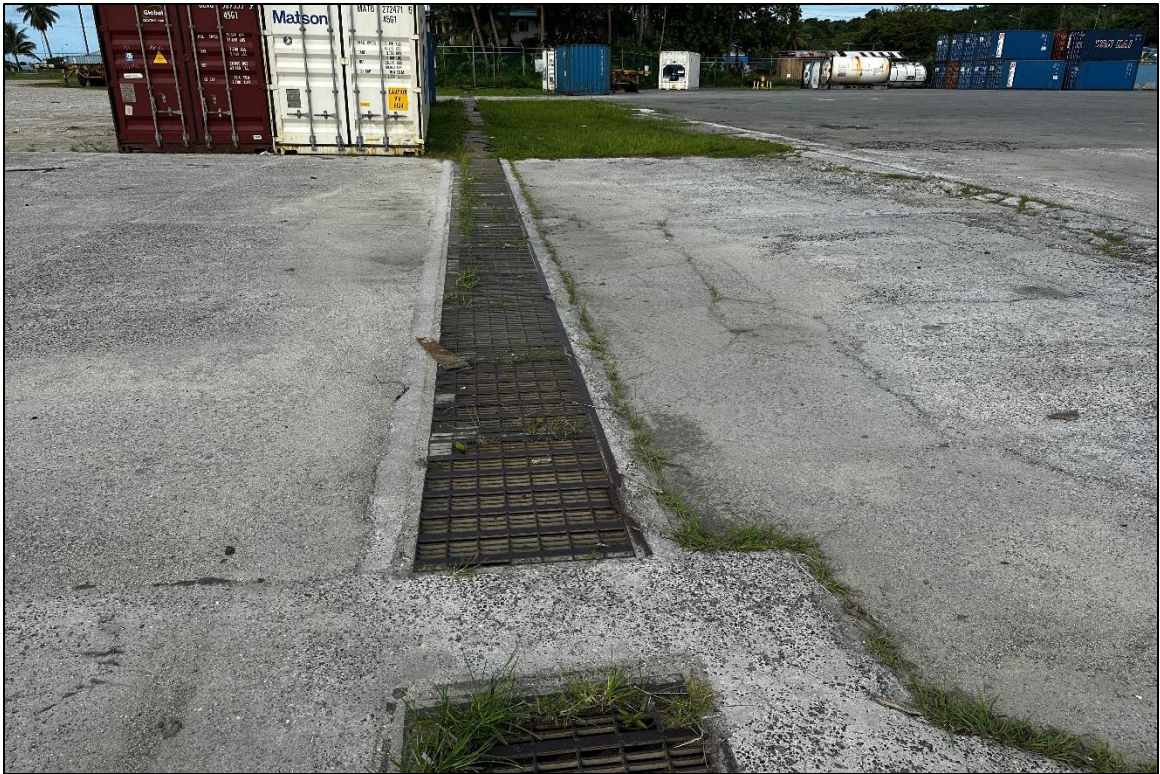
Photo 11: Storm drain channel which encircles the gated area within the port and leads toward the ocean. Photo is looking south.

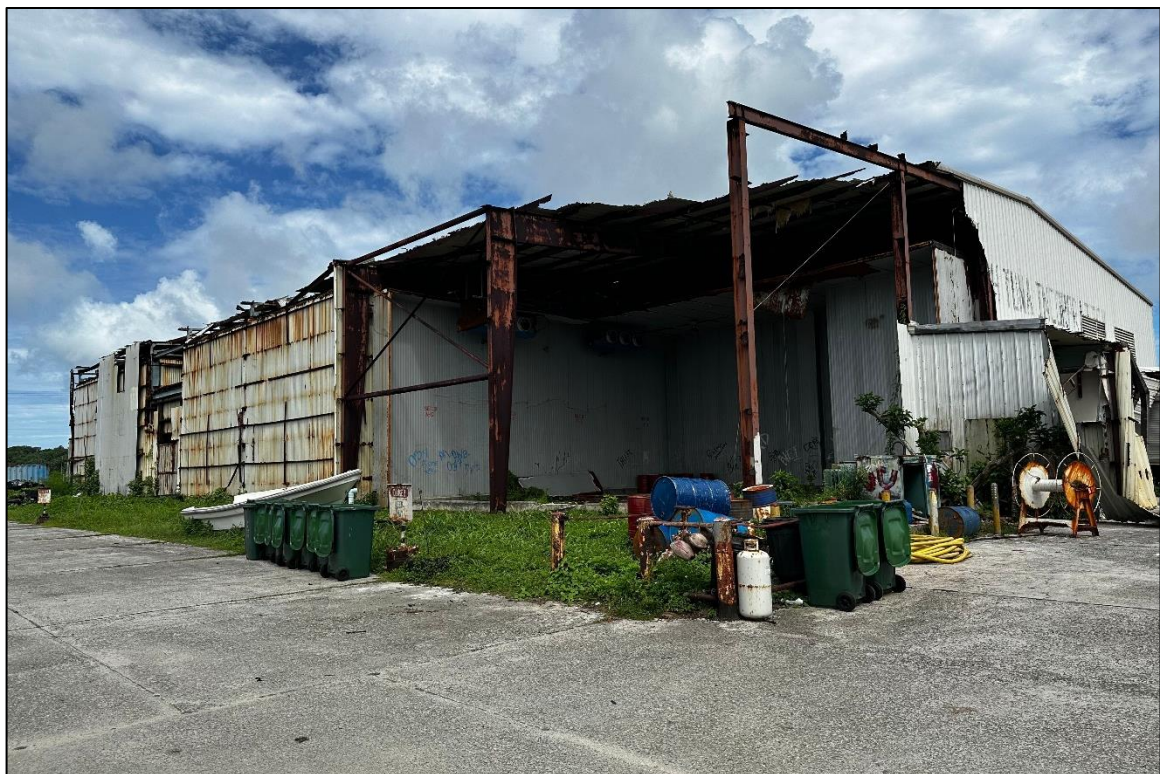
Photo 12: Overview of the former tuna canning facility's northeast corner. Photo is looking southwest.

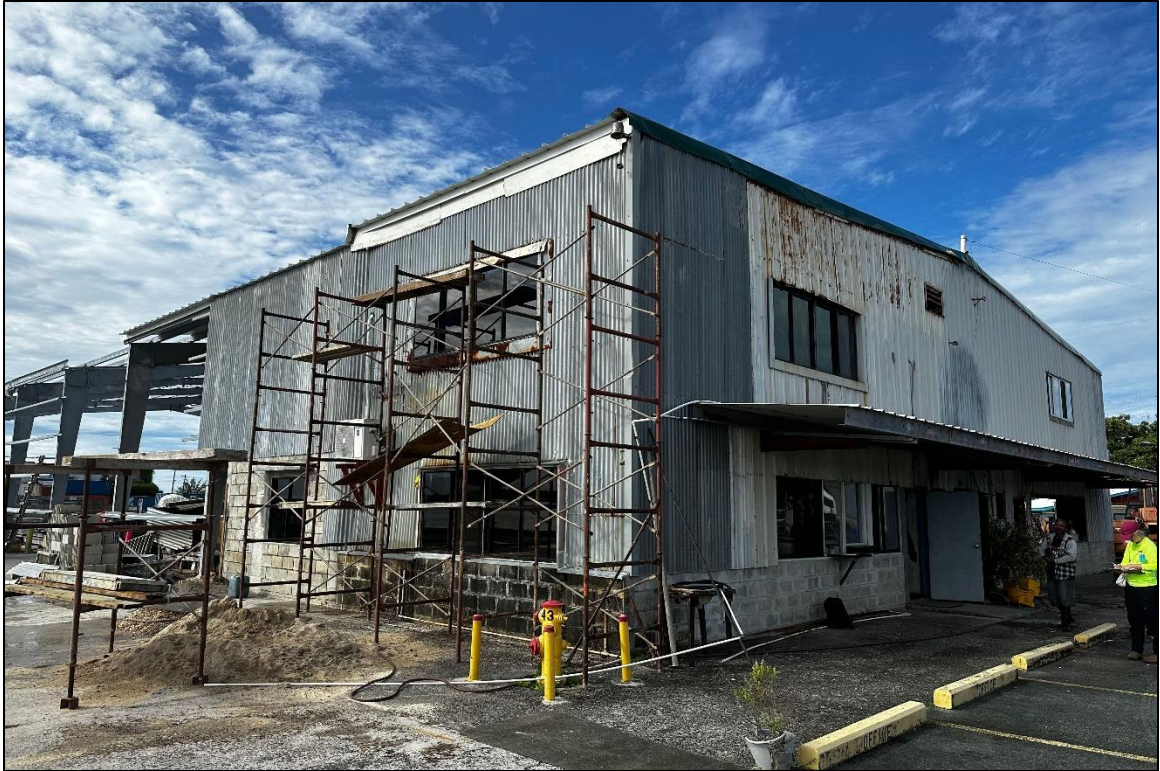
Photo 13: Overview of the front side of the Waab Transportation Company structure used as an office. The rear end is used as a warehouse. The building was under renovation during site visit. Photo is looking south.

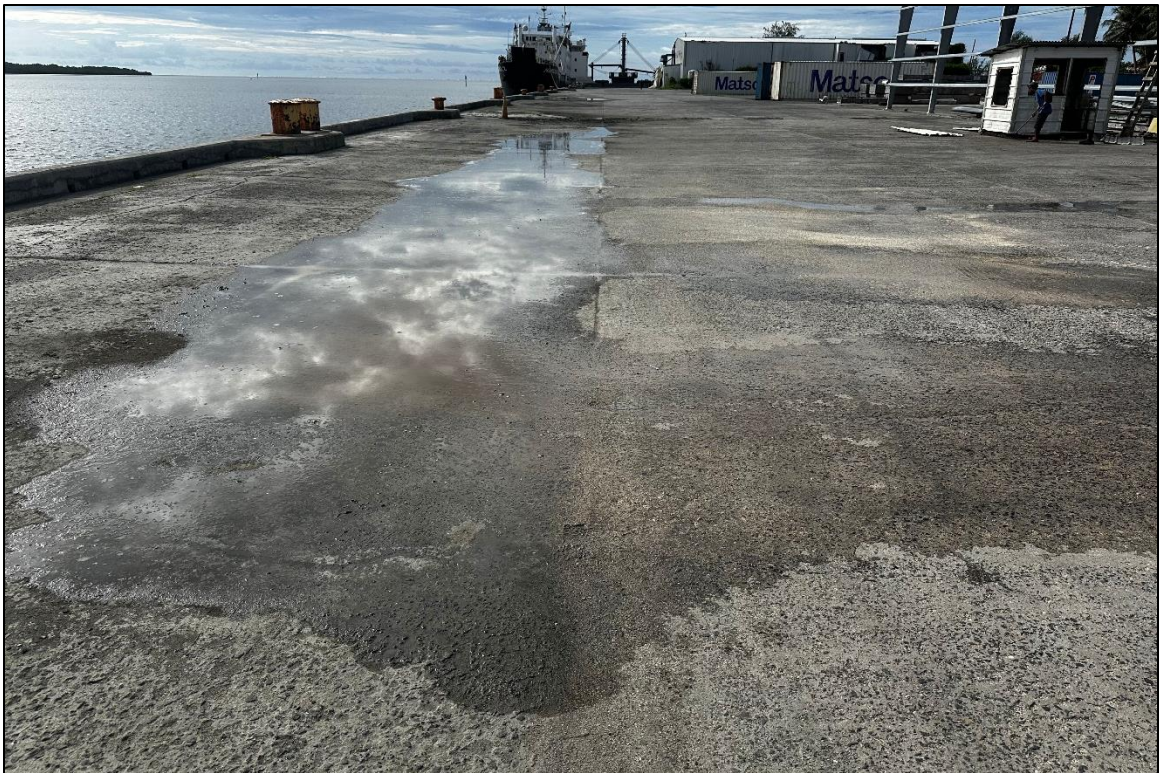
Photo 14: Overview of the main wharf at the seaport with the berths visible on the left side. Note: Natural water pooling is visible. Photo is looking southeast.

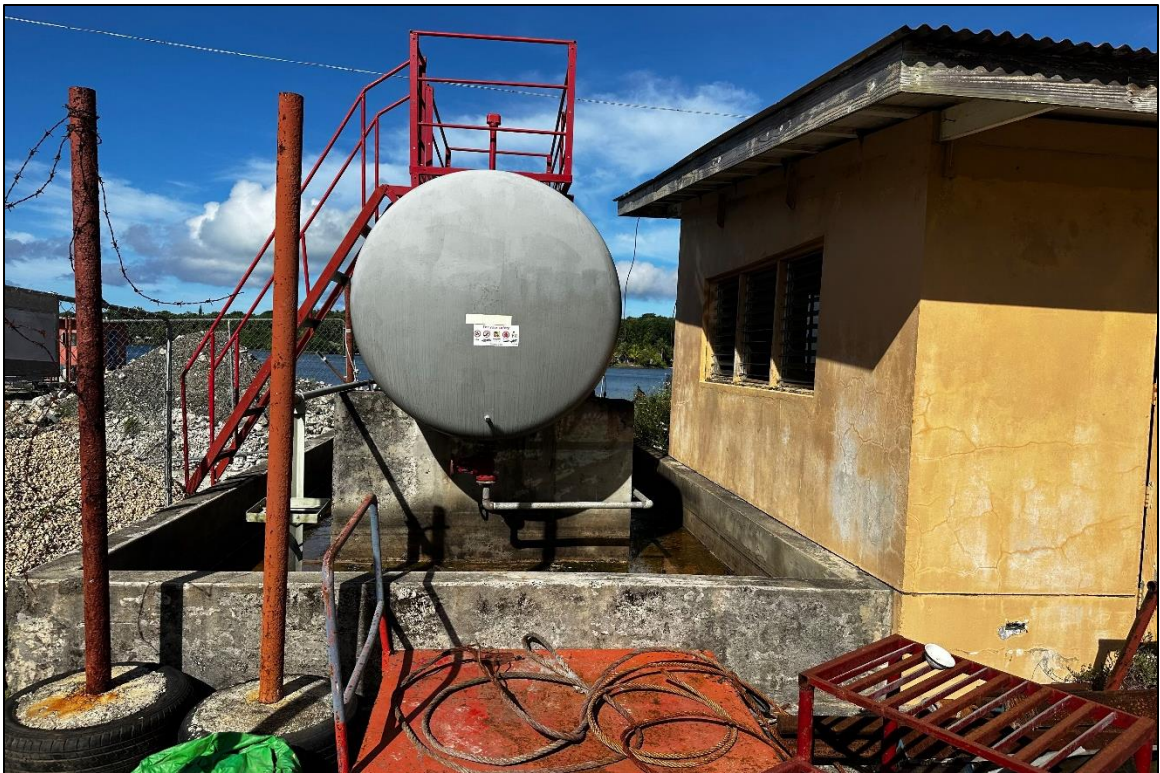
- A 10,000-liter diesel AST constructed of steel is present at the YFA facility (Appendix A, Photo 16). The AST is situated above a concrete containment basin. The installation date of the AST was unknown by YFA staff; however, the 1987 Yap Fishing Harbor Preparation Project drawings identify an “oil tank” would be installed (i.e., the AST was presumably installed after 1987). Mr. Yow and Ms. Falfen, the assistant general manager at YFA, indicated that other than a minor leak that was reported and repaired in 2022, no significant releases have been recorded from the AST. The 2022 leak was entirely contained within the concrete containment basin.

Photo 16: Overview of 10,000-liter diesel AST located at the YFA facility. Note: A concrete containment basin sits beneath the AST. Photo is looking south.

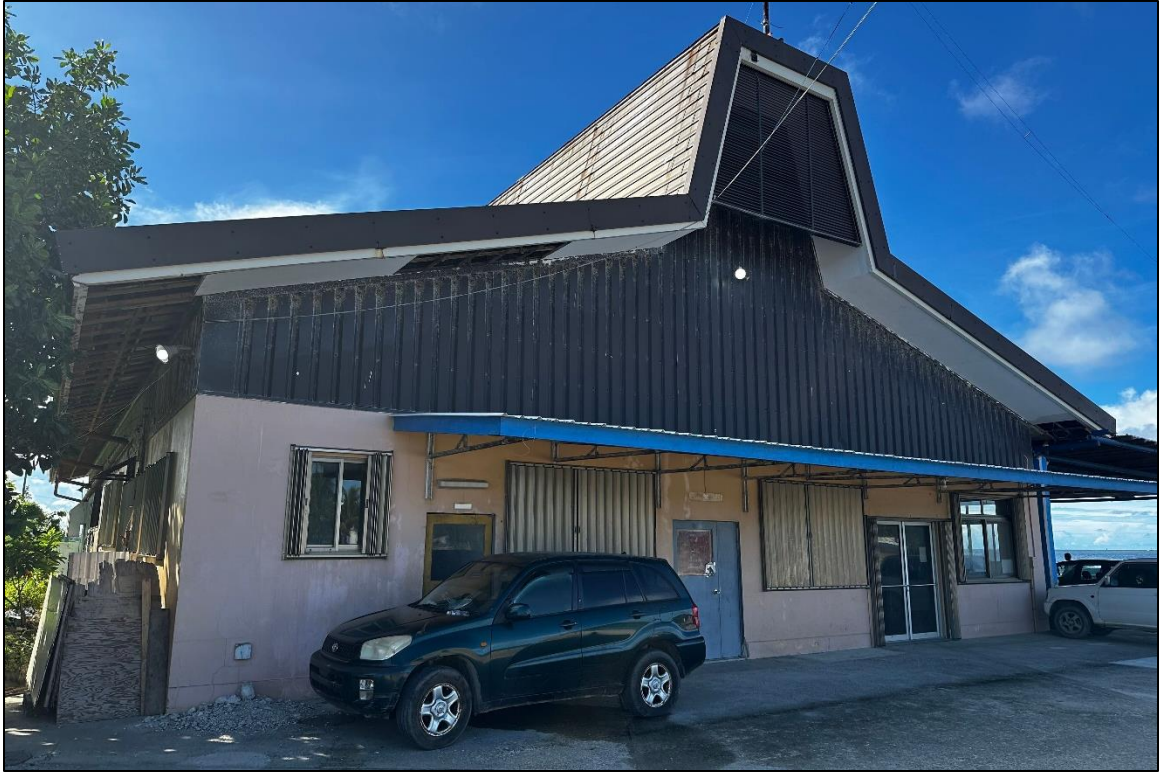
Photo 17: Overview of the office building at the YFA premises. Photo is looking east.

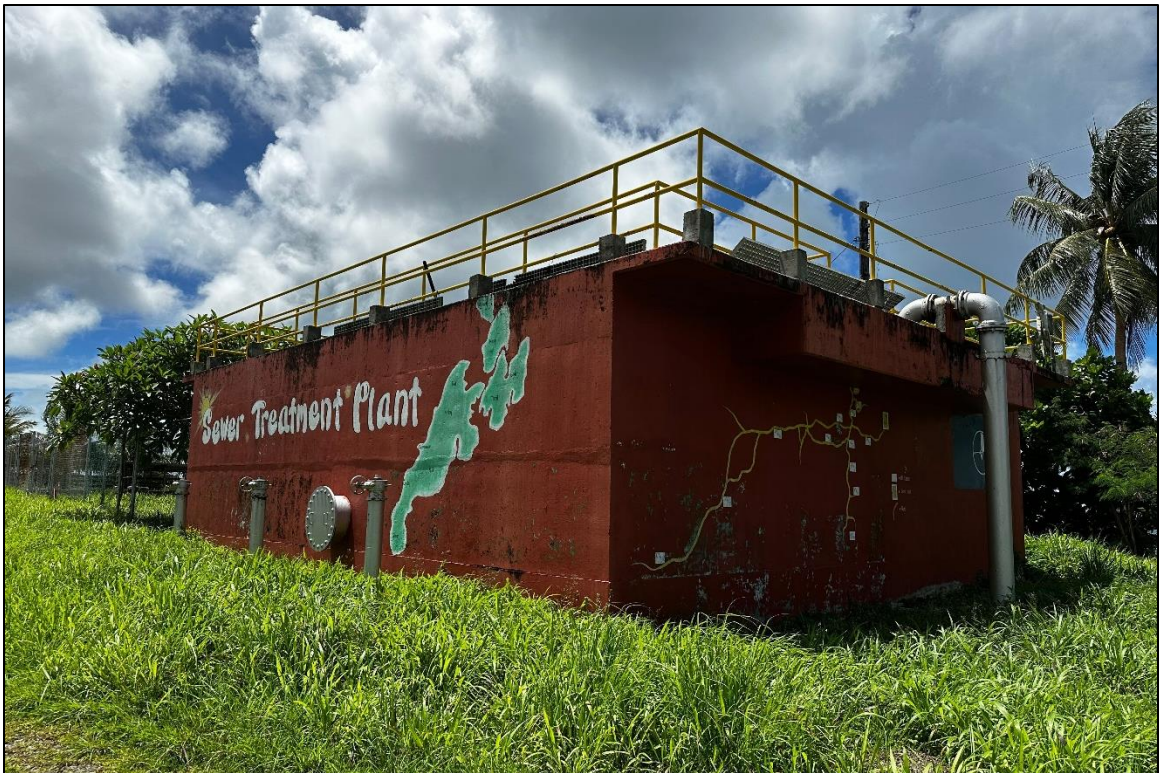
Photo 20: Overview of wastewater treatment plant located near the eastern boundary of the subject site. Photo is looking east.

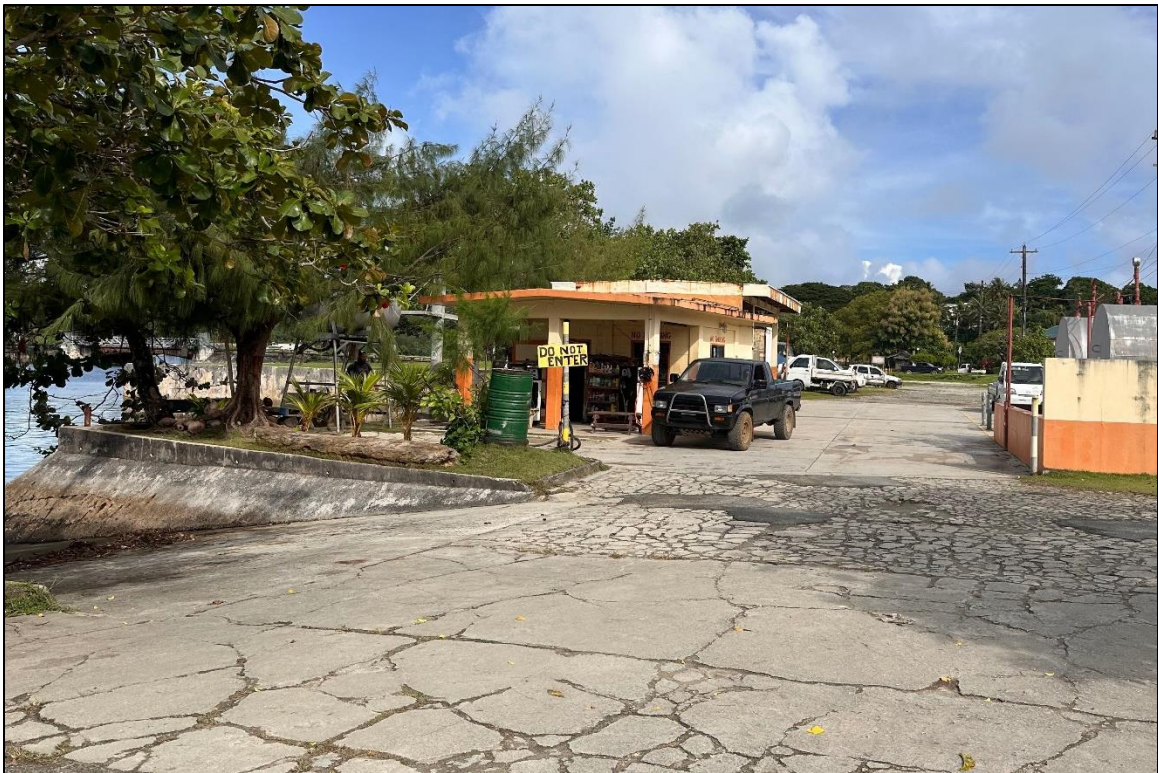
Photo 26: Overview of YCA Rufan Gas Station and its proximity to the ocean. Photo is looking southwest.

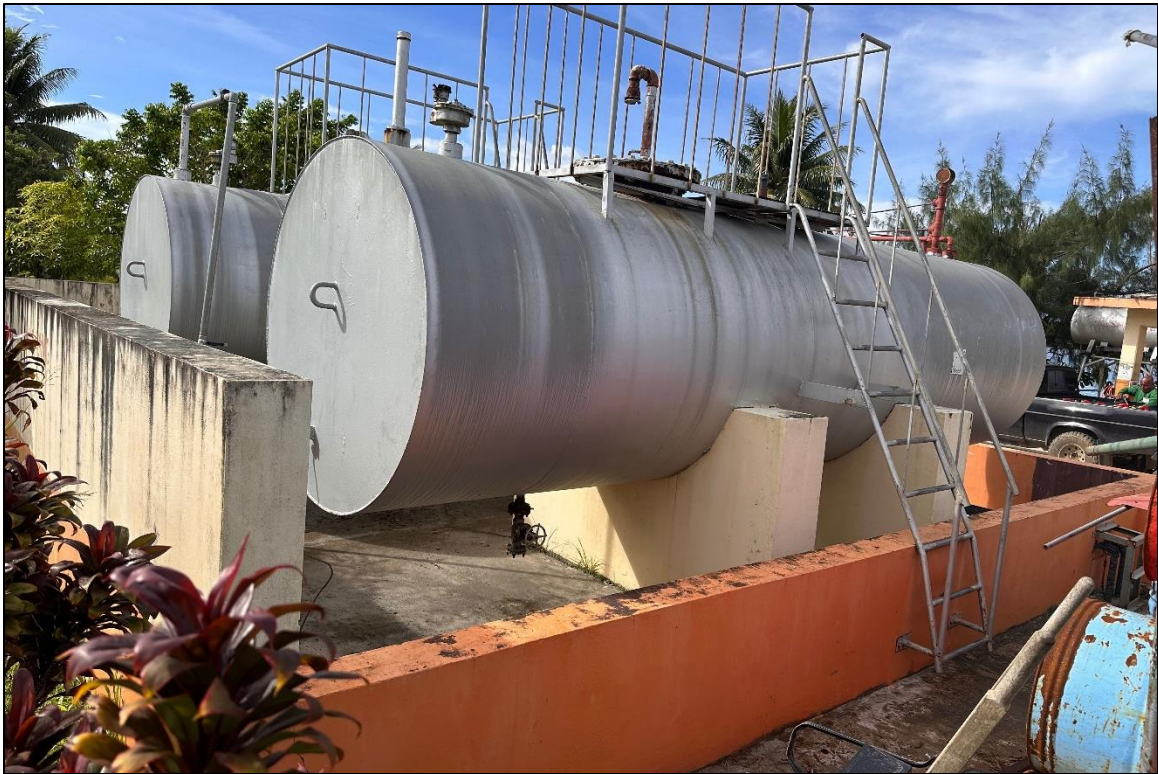
Photo 27: Overview of two steel ASTs containing diesel (3,700 gallons) and unleaded gasoline (4,010 gallons) in a concrete secondary containment observed at YCA Rufan Gas Station. Photo is looking north.

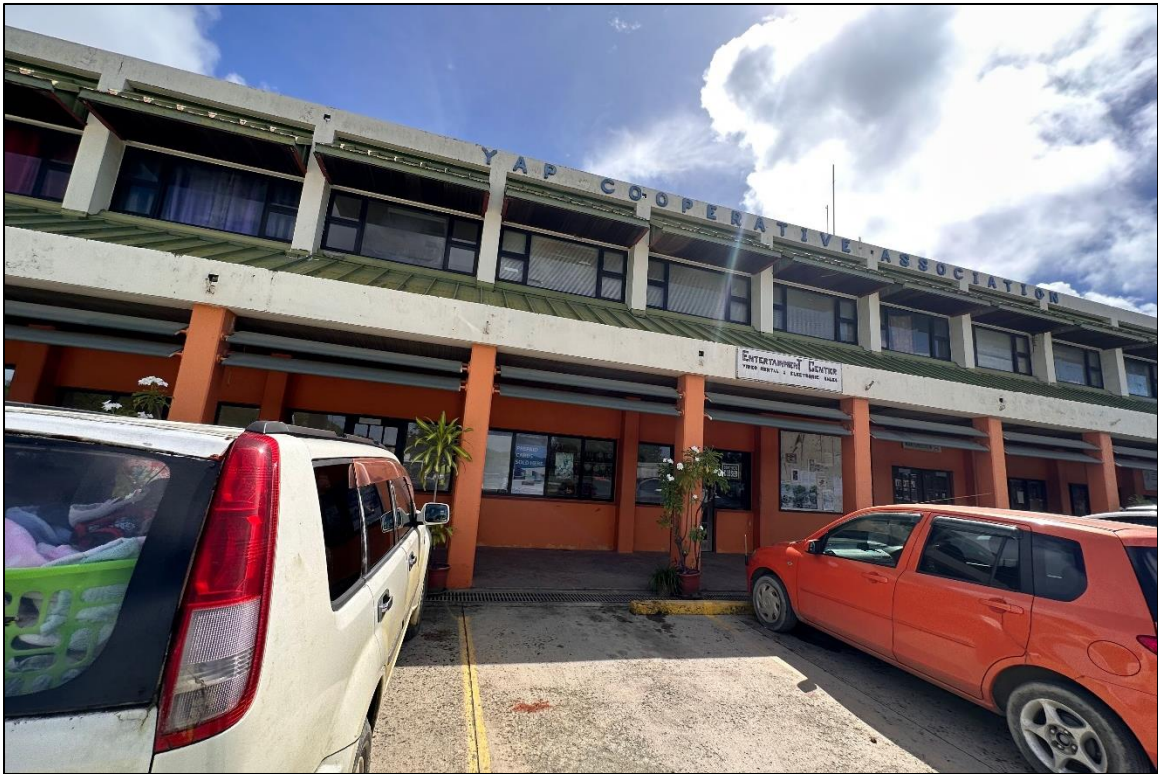
Photo 29: YCA structure, which borders the subject property to the north. Photo is looking northeast.

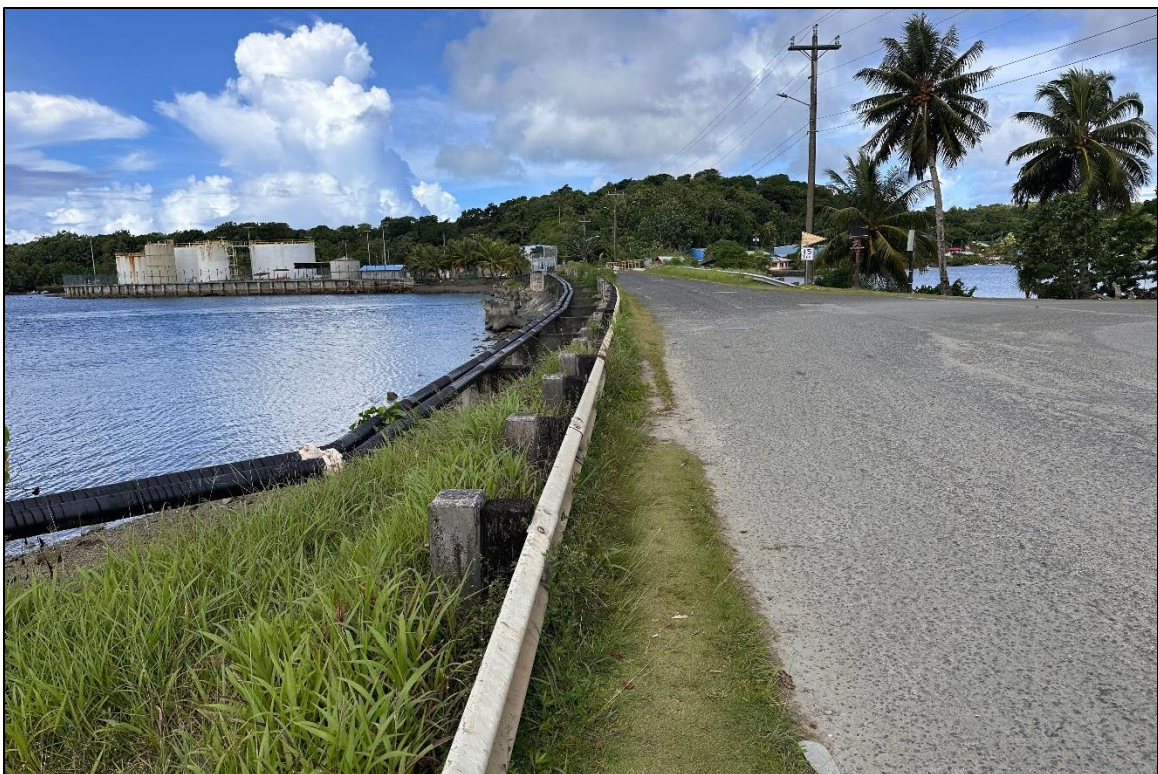
Photo 30: Small overpass leading to FSM Petroleum Corporation. Note: The subject property road is on the right and the fuel line is on the left. Photo is looking southwest.

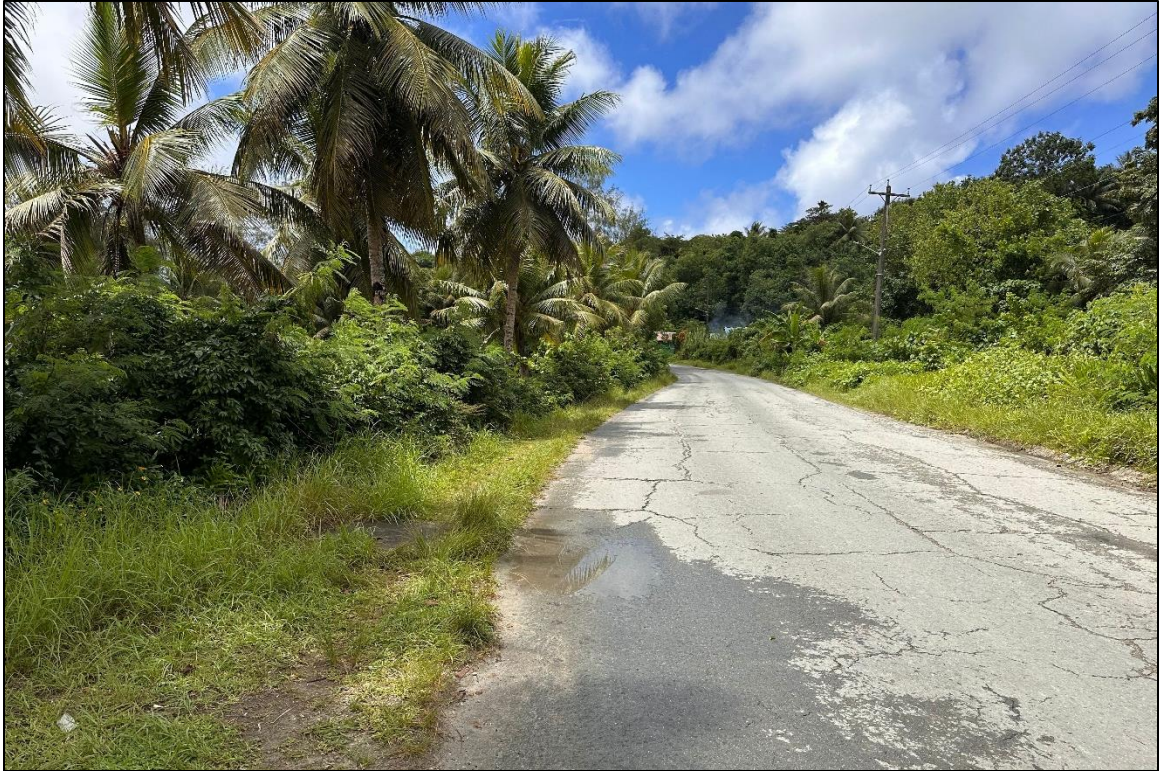
Photo 31: Subject property road. Photo looking northwest.

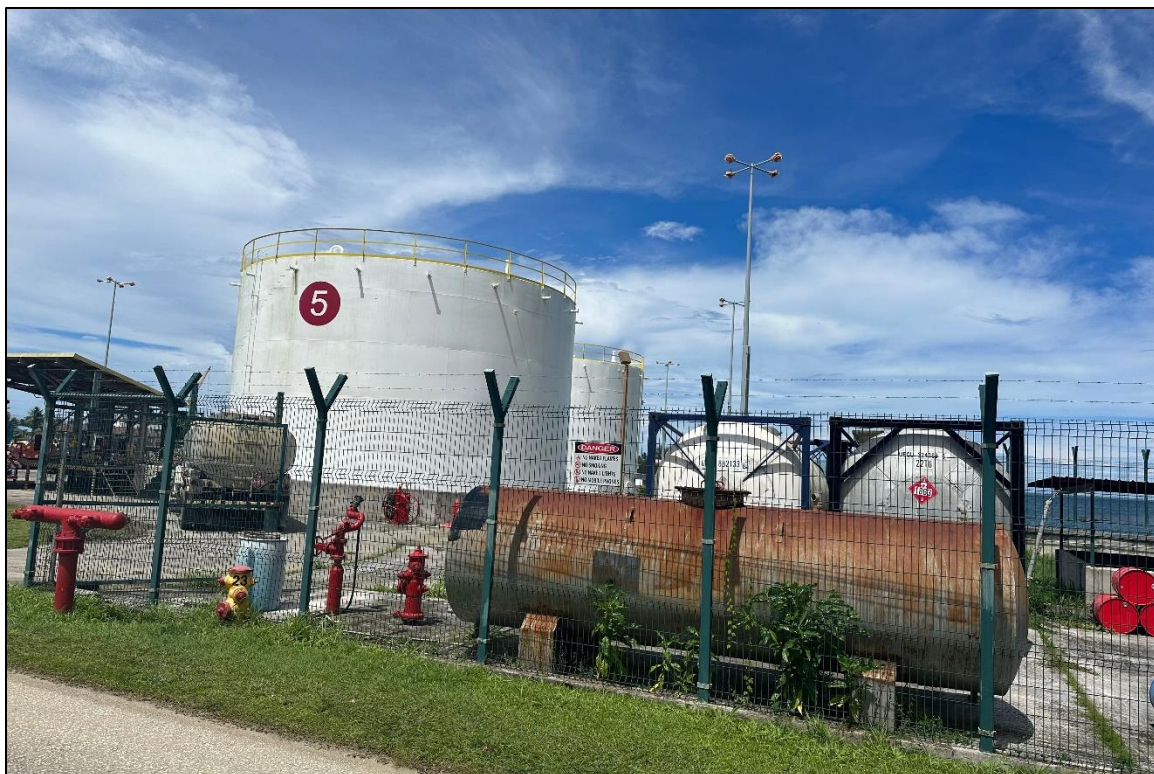
Photo 33: View of bulk fuel storage from outside the secured gates of FSM Petroleum Corporation. Photo is looking east.

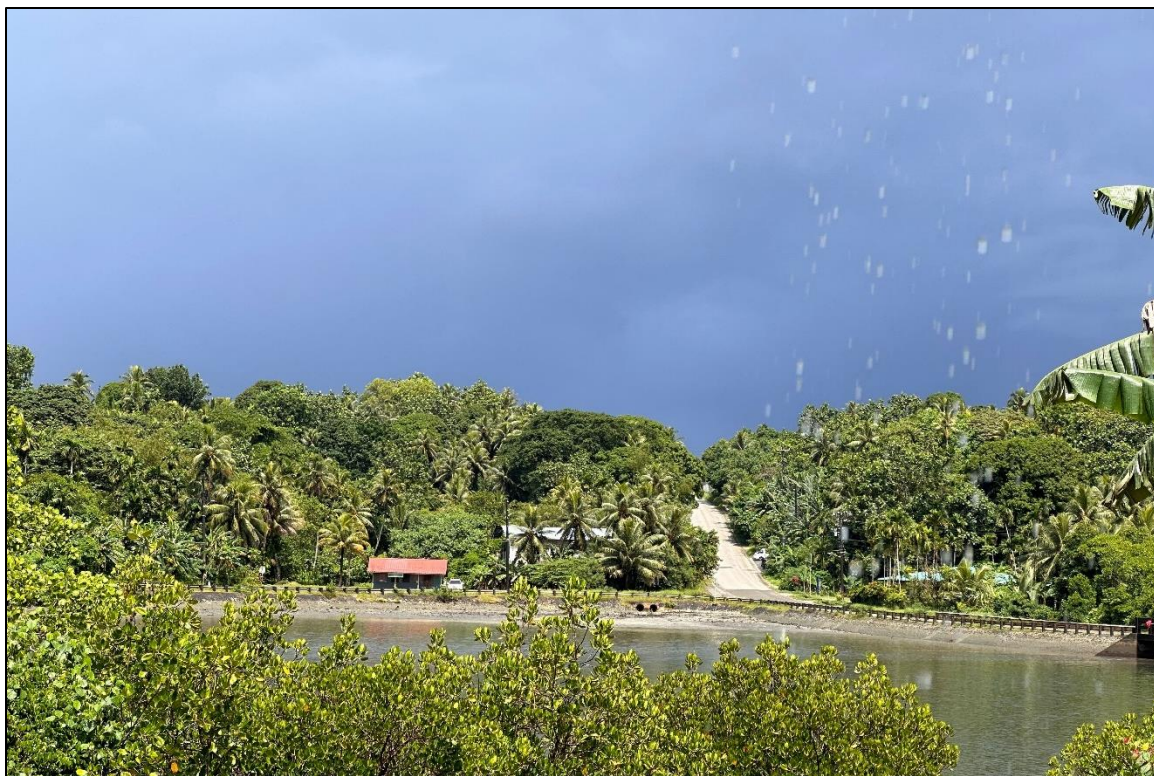
Photo 34: Overview of the western border of the subject property road. Photo is looking west.

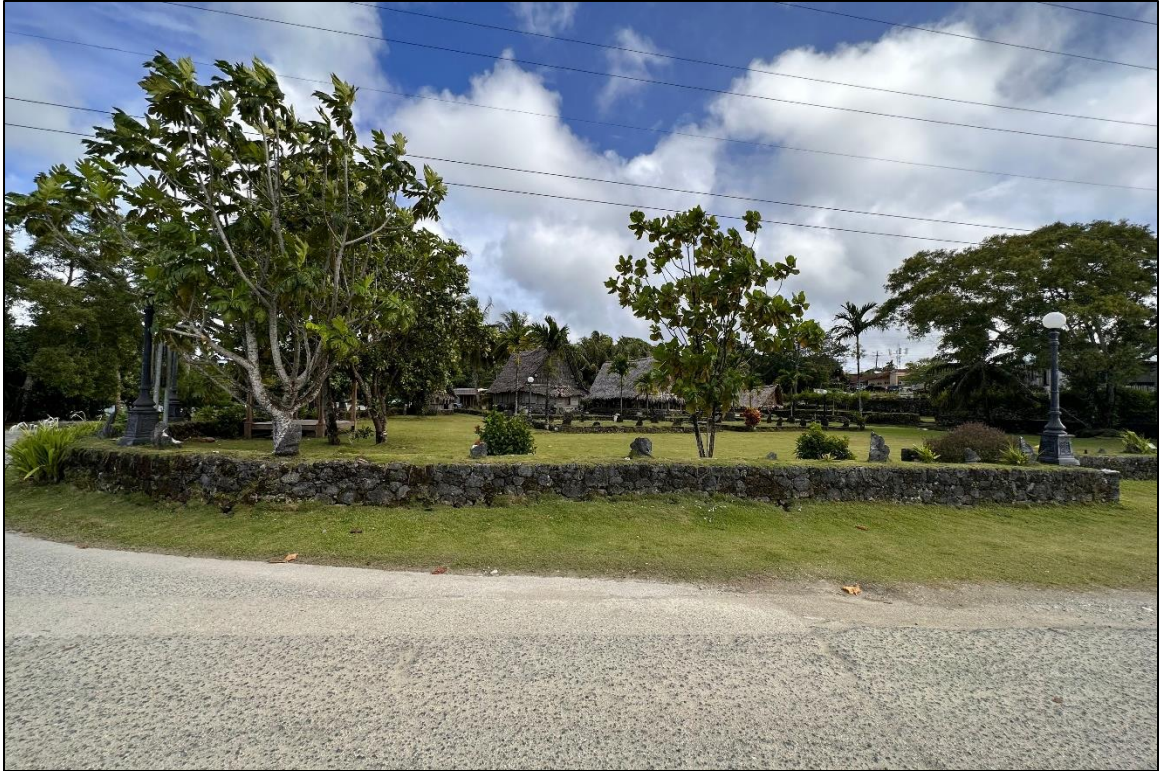
Photo 35: Overview of northern boundary of the subject property, the Yap Living Museum.
Photo is looking north.

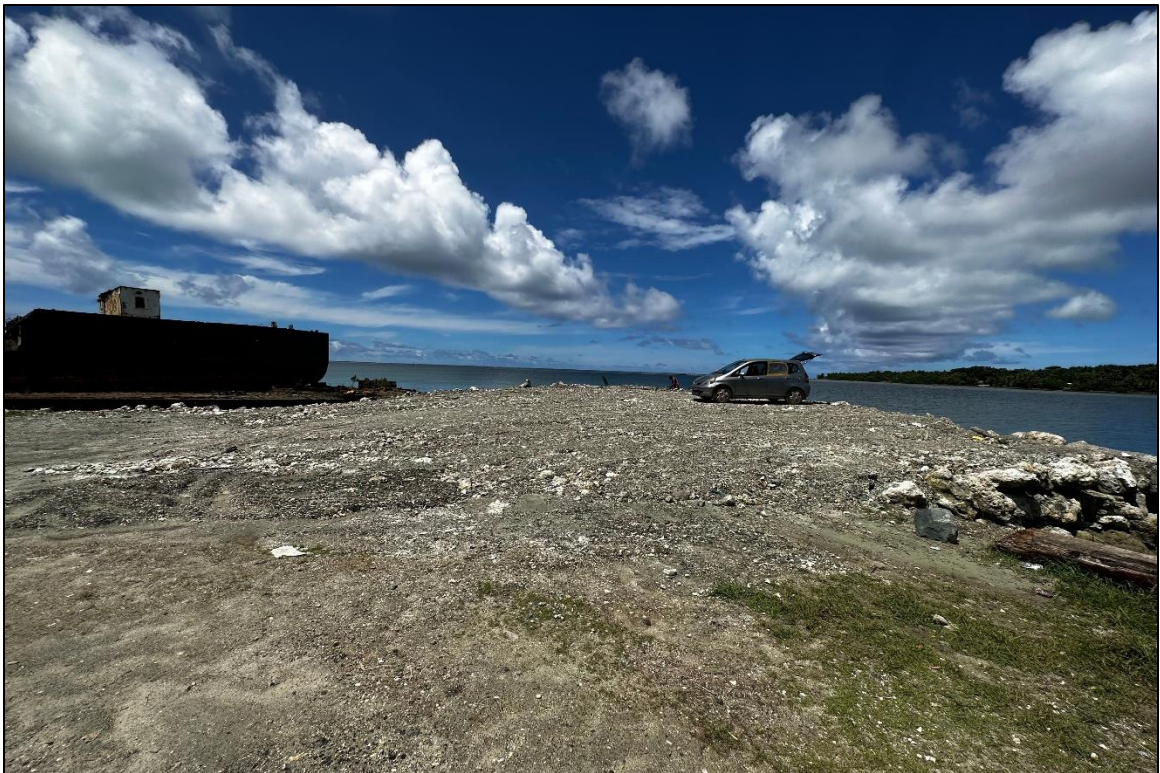
Photo 36: Southeasternmost point with an overview of the eastern border—the Pacific Ocean.
Photo is looking northeast.

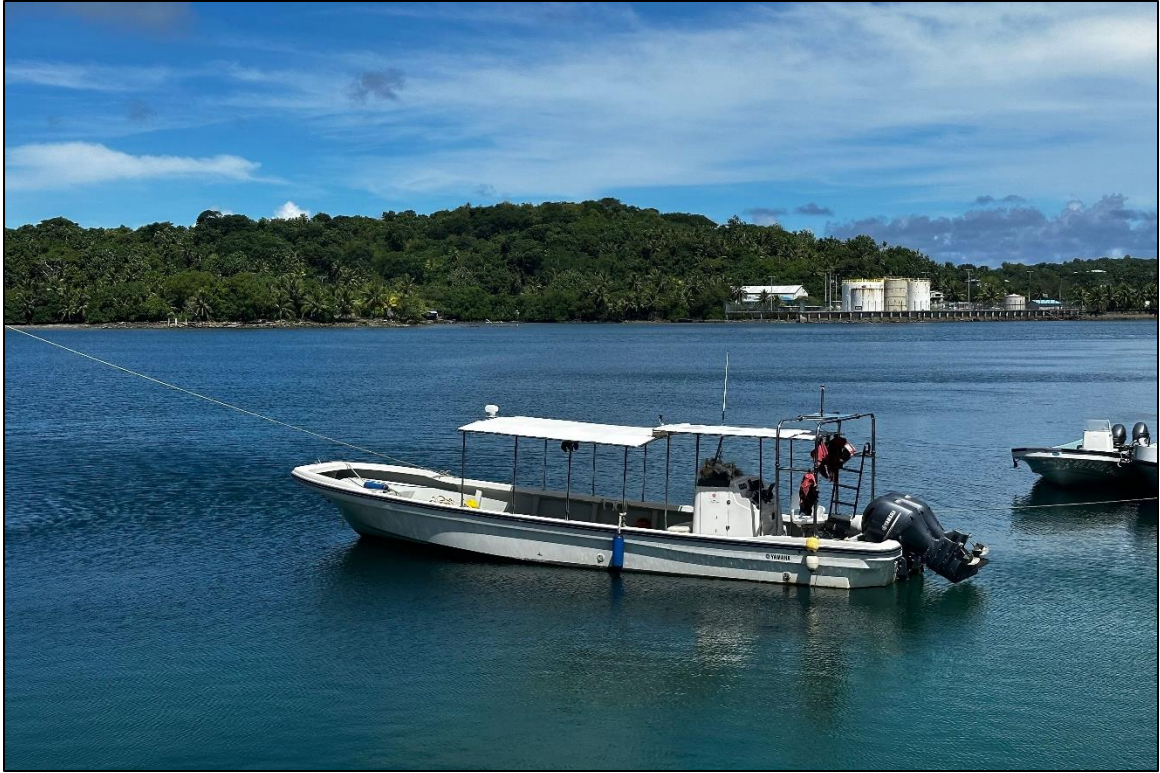
Photo 37: Overview of the southern and southwestern border—ocean, and beyond—FSM Petroleum Corporation and undeveloped land. Photo is looking southwest.
