**Naval Facilities Engineering Systems Command Pacific
JBPHH HI**

Phase I Environmental Site Assessment

Yap Seaport

May 2024

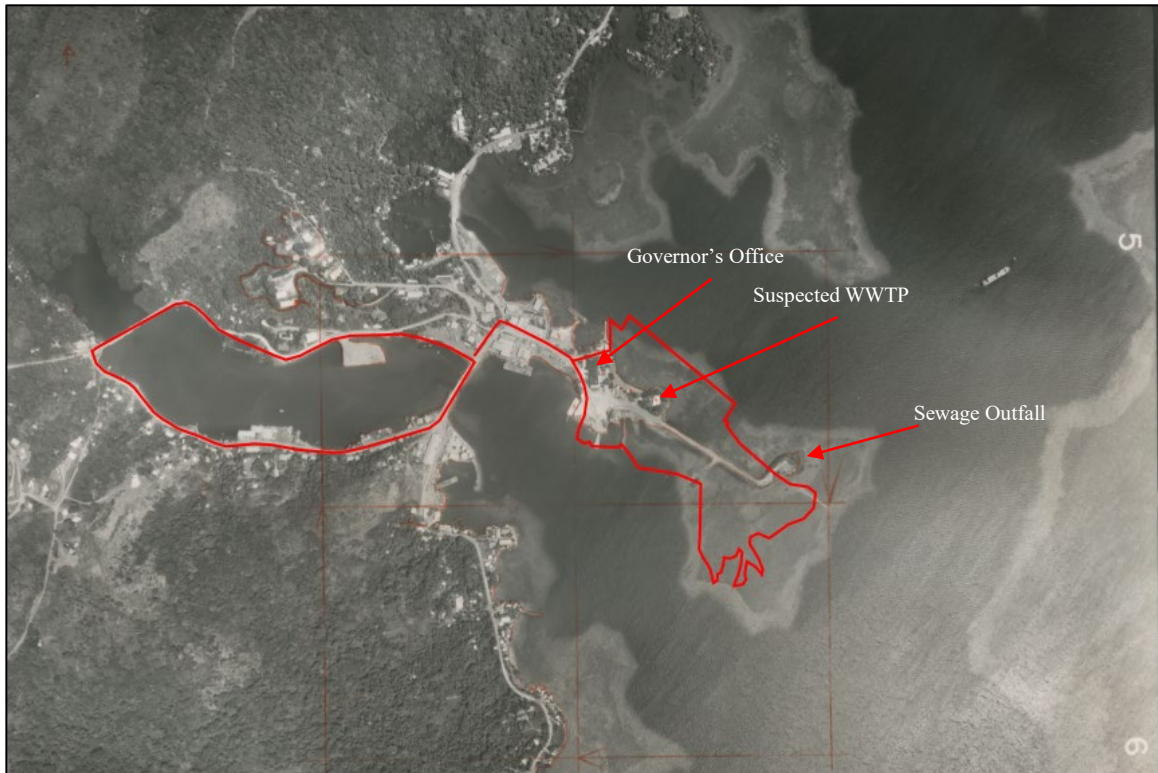
Historical aerial photographs indicate that the subject property, including the road encircling Chamorro Bay, was already partially developed by 1976. Visible structures include the Yap State Government and Administration Building, smaller structures in its vicinity, and the WWTP (Appendix B.1, Photo 1). The majority of the port area of the subject property is not yet in existence in the 1976 photo (i.e., the area is still ocean) and subsequently not illustrated in the 1983 topographic map. According to Mr. Yow, land reclamation and the construction of most of the port's buildings were completed in the 1980s. A review of the Yap Fishing Harbor Preparation Project at the Yap Fisheries Authority indicates that the FYA building was constructed after 1988.

Photo 1: 1976 – Subject property, Colonia. The majority of the subject property in the port area is undeveloped, with the exception of the governor's office and other features in the vicinity, including the suspected WWTP and its sewage outfall.

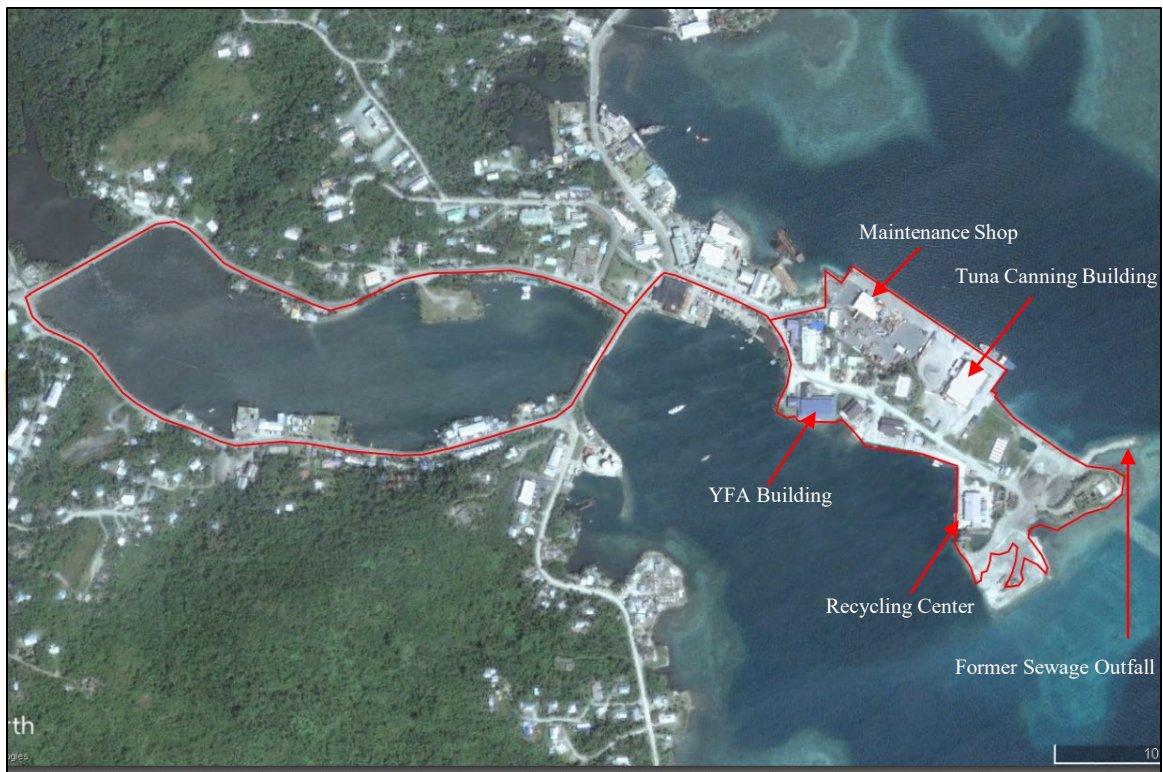
Photo 2: 2005 – Subject property, Colonia. The subject property appears fully developed. The wharf inside the gated area has been filled. The maintenance shop, YFA building, recycling center and tuna canning building are denoted by the red arrows. The majority of the former sewage outfall is now underwater.

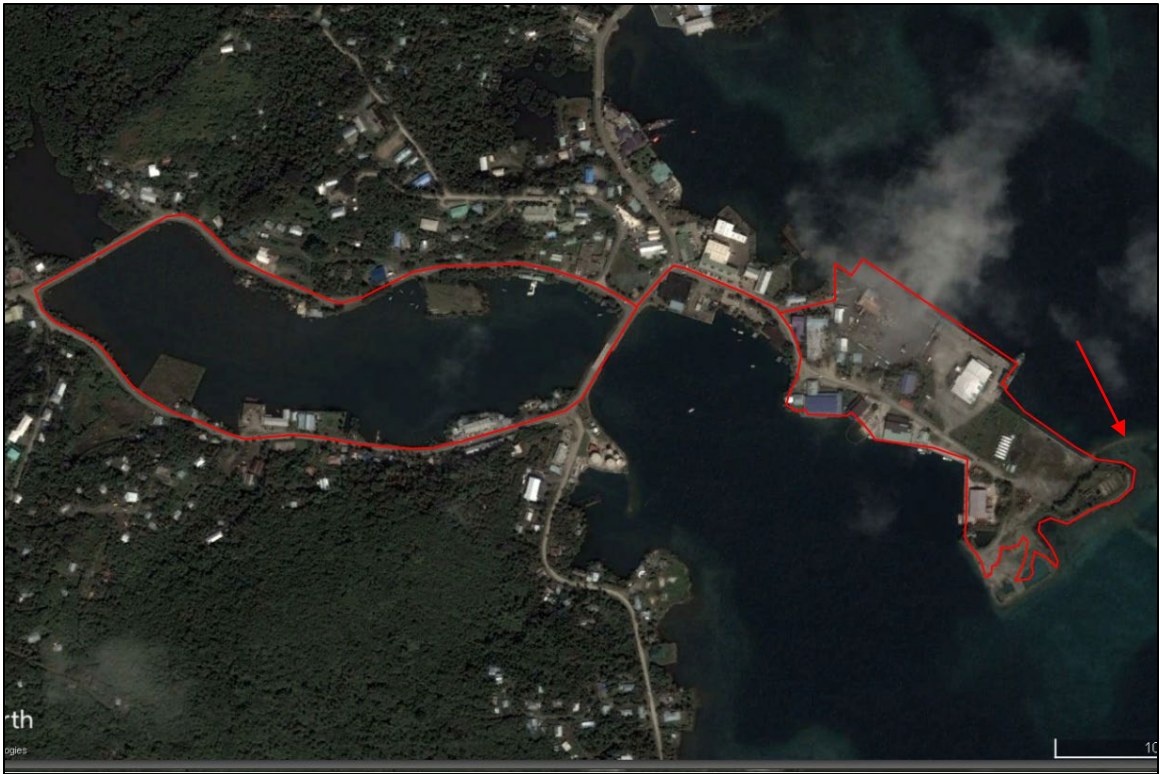
Photo 3: 2008 –Subject property, Colonia. The subject property looks generally the same from the last photo. Some portions of the easternmost point of the peninsula are now underwater. Red arrow points to the underwater strip of land associated with former sewage outfall

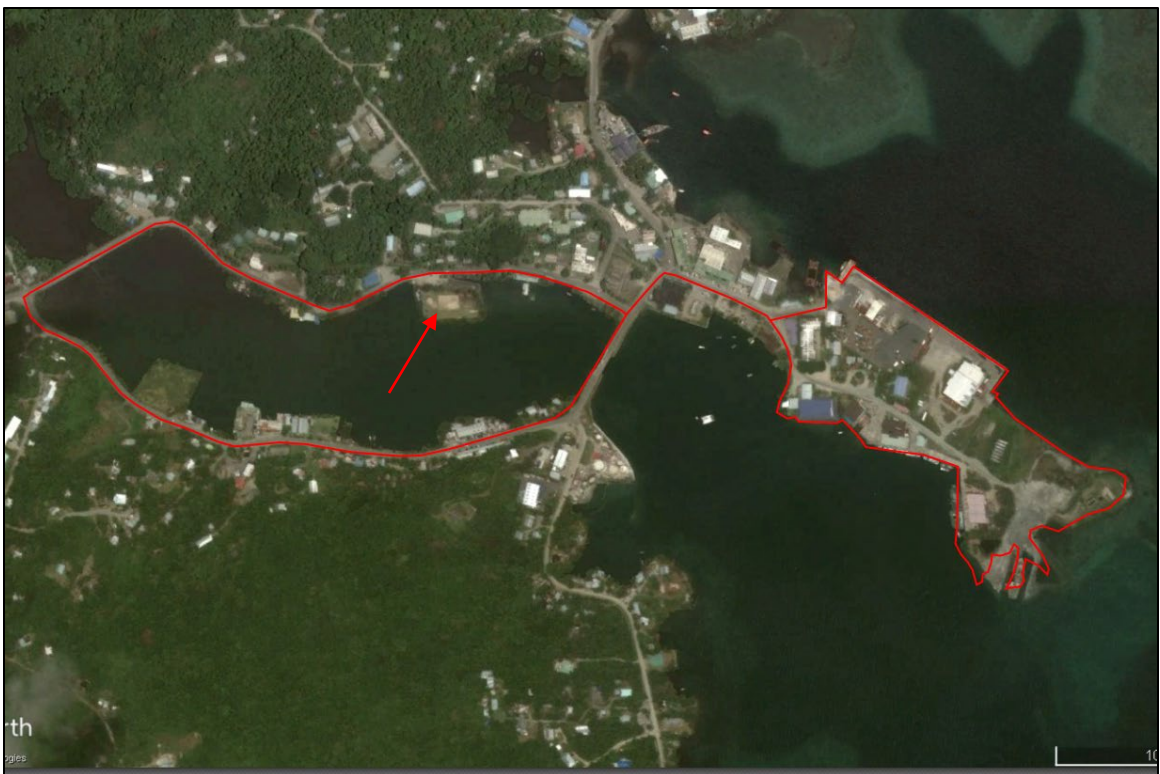
Photo 4: 2013 – Subject property, Colonia. The subject property looks generally the same from the last photo. There appears to be more shipping containers stored inside the gated area. There appears to be development in the adjacent area to the road denoted by the red arrow.

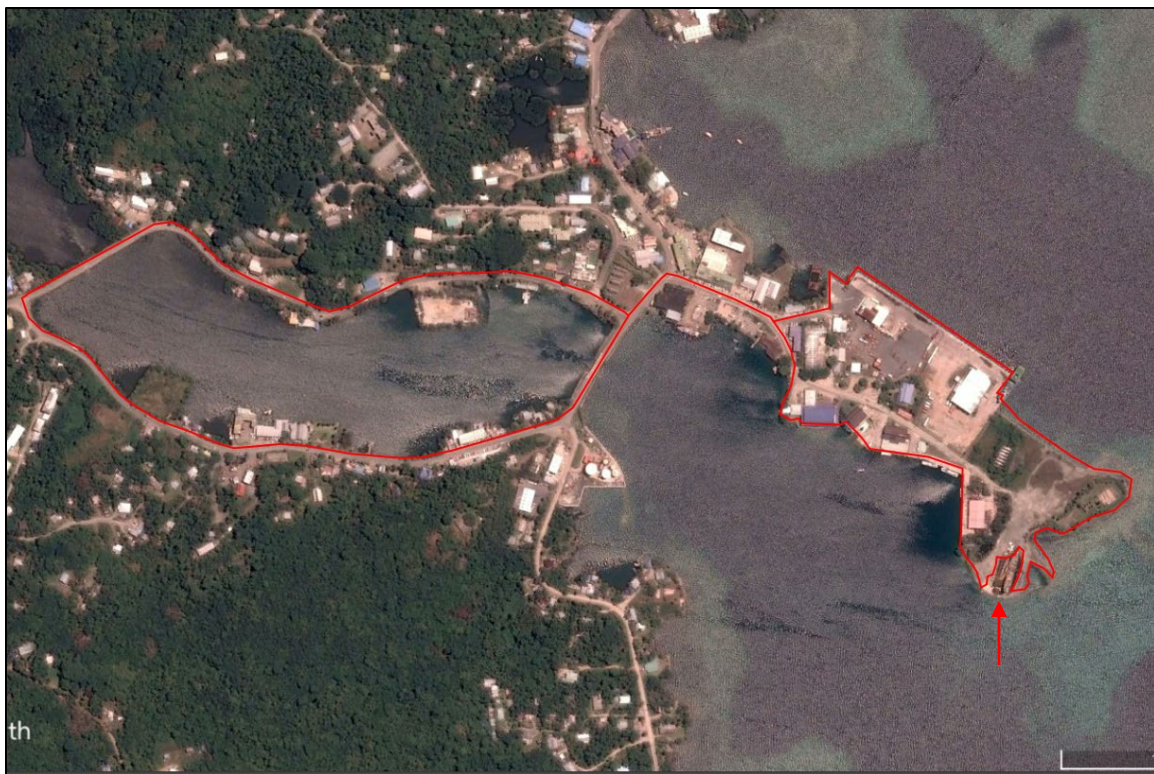
Photo 5: 2014 – Subject property, Colonia. The subject property looks generally the same from the last photo. The southeasternmost region of the subject property appears to be eroding. Red arrow points to region underwater.

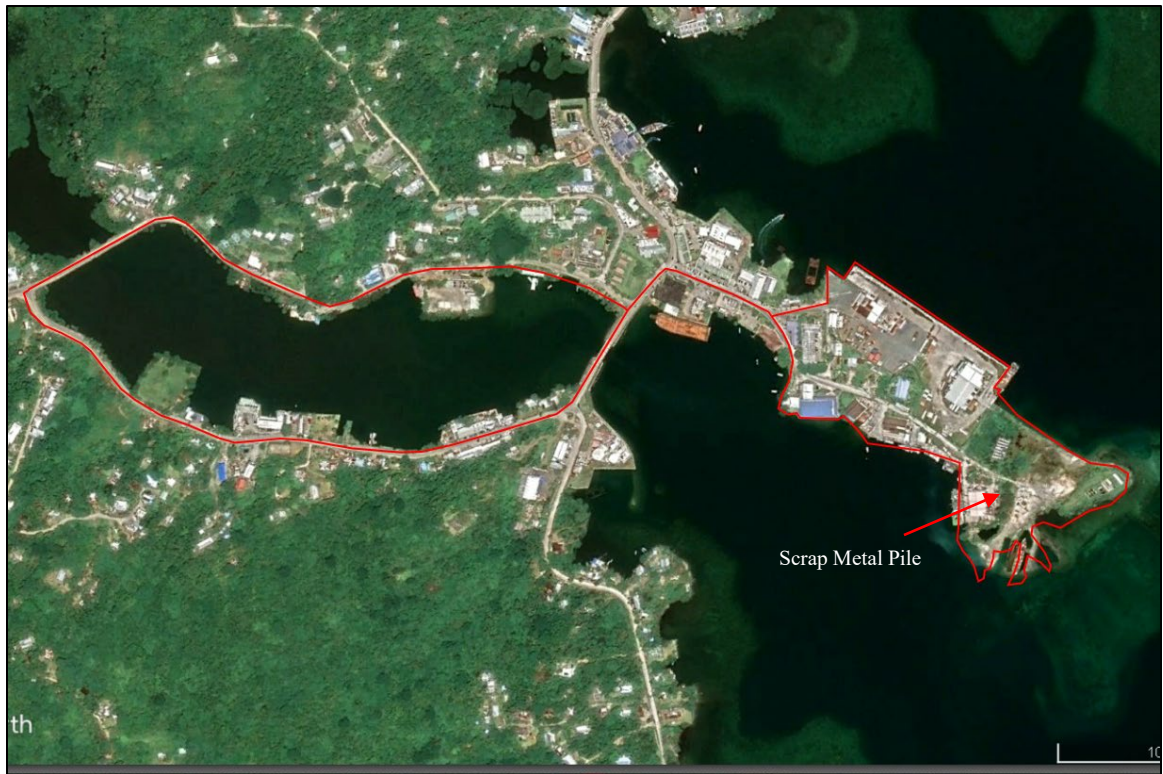
Photo 7: 2017 – Subject property, Colonia. The scrap metal pile adjacent to recycling center is now visible. Both piles are denoted by the red arrows.

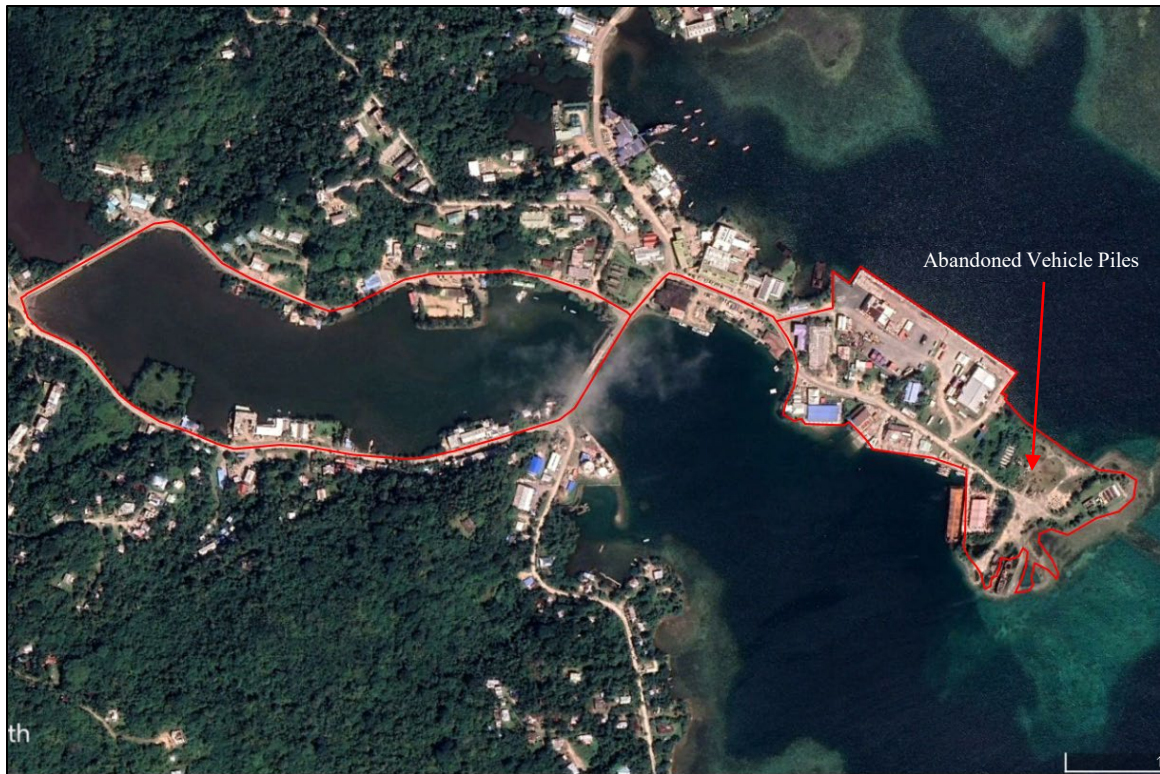
Photo 9: 2019 – Subject property, Colonia. The subject property looks generally the same from the last photo. The abandoned vehicle piles are beginning to accumulate (denoted by red arrow).

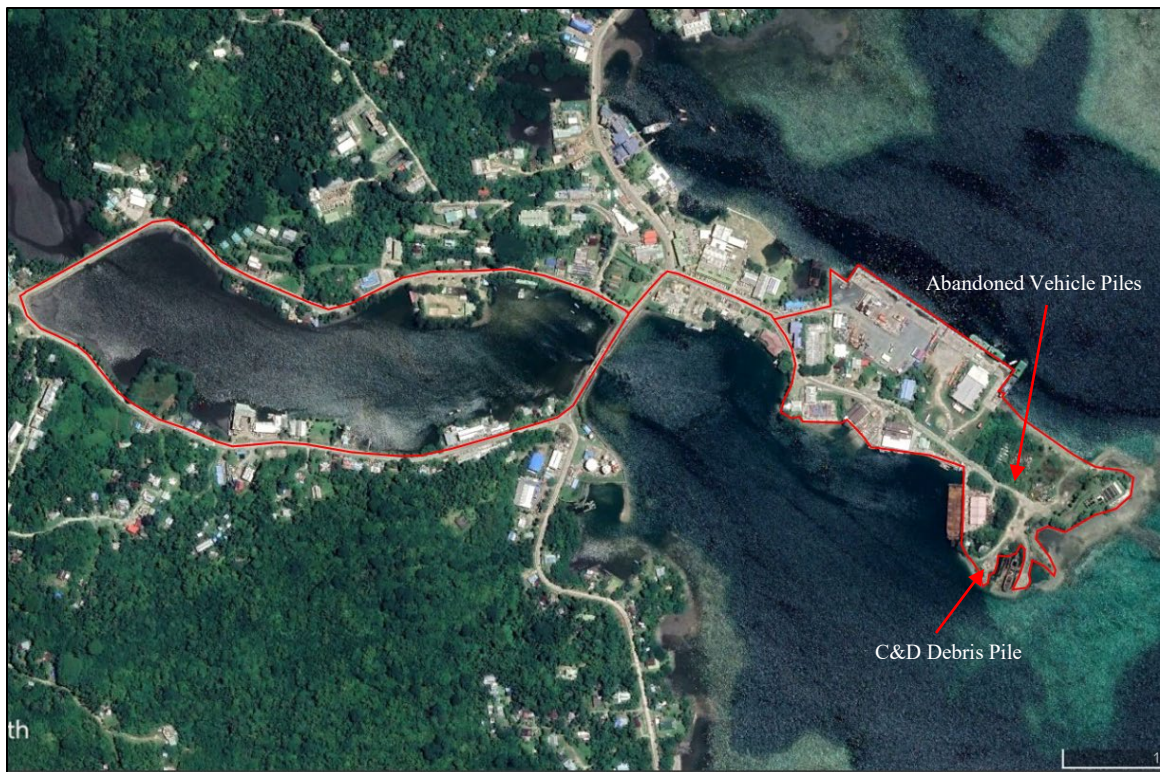
Photo 10: 2022 – Subject property, Colonia. The subject property looks generally the same from the last photo. More abandoned vehicles appear to be accumulated. Construction and demolition (C&D) debris pile is now visible (both areas denoted by red arrow).
